**Fatality #23 - October 23, 2004**  
**(Victim Died October 29, 2004)**  
**Electrical - Bituminous - VA**  
**Omega Mining, Inc. - Southern Crescent Mine**

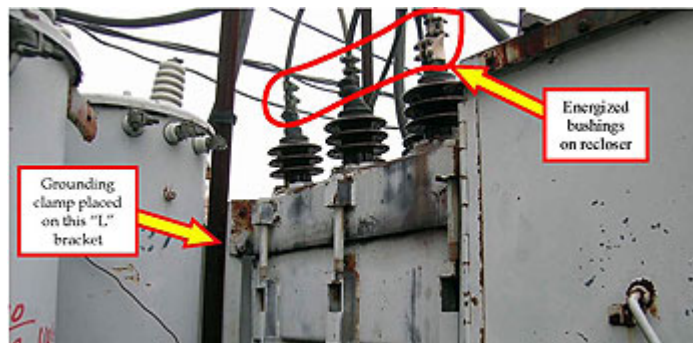
**Coal Mine Fatality** - On Saturday, October 23, 2004, a 57-year old chief electrician with 40 years mining experience, sustained severe burn injuries while he and two other miners were installing transformers in a substation. They connected the primary side of the transformers to the incoming power wires, removed the grounding clamps, and energized the transformers. After about 15 minutes, they returned to connect the secondary side of the transformers. While the other miners went to the transformers, the chief mounted a small platform, and without de-energizing the transformers, attempted to reinstall the grounding clamps. He connected one grounding clamp to a grounded "L" bracket. With a second grounding clamp, he contacted an energized connection on the recloser. A high energy arc resulted that injured the victim. The victim expired on Friday, October 29 2004.

- Ensure that high-voltage lines are de-energized and grounded, and visual disconnecting device(s) are locked out and tagged before performing electrical work.
- Install grounding devices only on the load side of open visual disconnects.
- Use personal protective equipment (gloves, etc.) when performing electrical work.
- Ensure that all circuit breakers and disconnecting switches are properly marked for identification purposes.
- Never assume that you know how a circuit is wired. Ask for help and/or consult a wiring diagram/schematic if you are unsure.
- Use properly rated non-contact voltage testers to ensure that circuits are de-energized.
