REPORT OF INVESTIGATION

Fatal Powered Haulage Accident
January 22, 2004

Pinnacle Mine
Andalex Resources, Inc.
Price, Carbon County, Utah
ID No. 42-01474

FATAL POWERED HAULAGE ACCIDENT
PINNACLE MINE, ID NO. 42-01474
ANDALEX RESOURCES, INC.
PRICE, CARBON COUNTY, UTAH
JANUARY 22, 2004

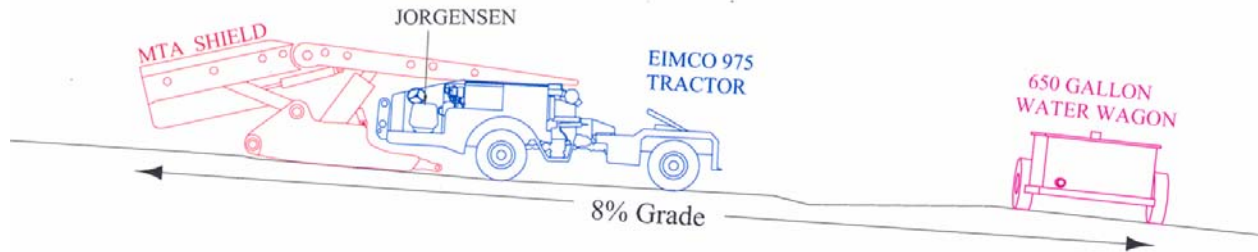
SIDE VIEW OF ACCIDENT SCENE SHOWING
TRACTOR UNDER SHIELD CANOPY

- 6) The longwall shield involved in the accident was a MTA transitional type G738-13.72/33.52 and weighed 21.4 tons. It was located at the left-hand edge of the access way through the storage yard. There was approximately 30 feet of road available to the right of the shield. After leaving the water trailer, the tractor traveled approximately 26 feet when it contacted the tip of the shield. During a re-enactment of the accident, the time taken to travel this distance was approximately 6 seconds. The distance from the ground to the tip of the shield canopy was approximately 57 inches. The maximum height of the Eimco tractor was 60 inches, but the front, which contained the operator's compartment, angled up and was less than 57 inches high.

Corrective Action: Management should evaluate and assure the safe storage of equipment at the upper material storage yard. Equipment should be stored and located so as not to present a hazard to vehicle operators traveling through the storage yard.

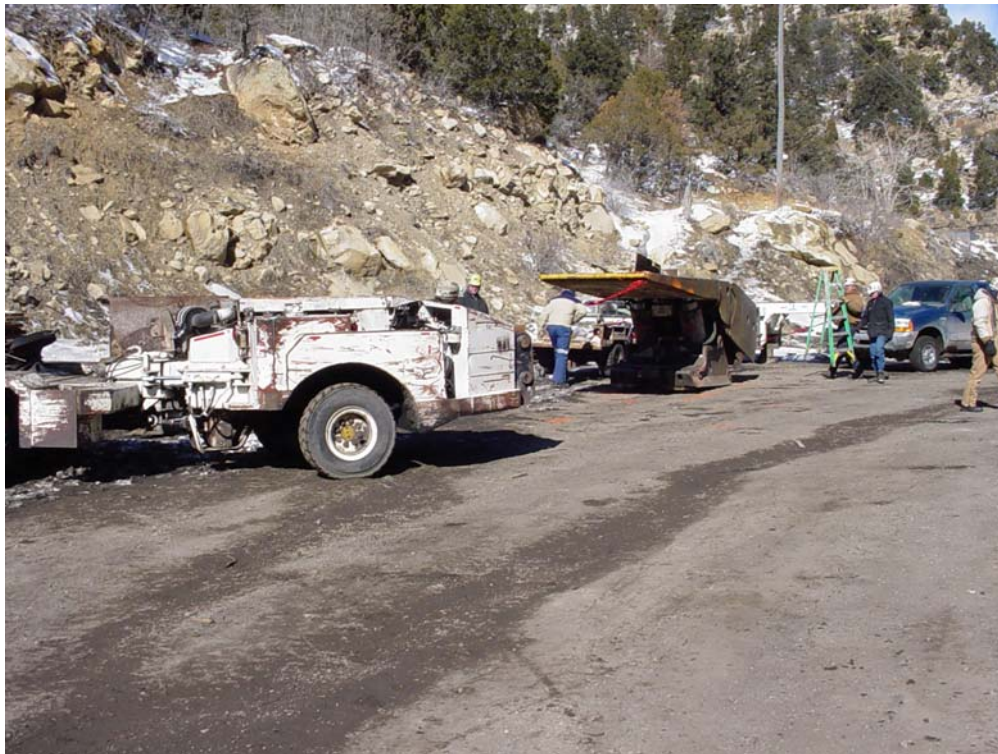
RE-ENACTMENT SHOWING TRACTOR AT DROP OFF POINT FOR WATER WAGON
AND FRONT OF TRACTOR FACING UPGRADE TOWARD SHIELD

- 12) A re-enactment of the accident was conducted during the accident investigation. This re-enactment indicated that there was adequate room in the operator's compartment for Jorgensen to have lowered his head and avoided the pinch point with the shield, had he been aware of the oncoming hazard.
