REPORT OF INVESTIGATION

Fatal Sliding Material Accident  
March 2, 2004

Brooks Run Processing Plant No. 1  
Brooks Run Mining Company, LLC  
Sutton, Webster County, West Virginia  
ID No. 46-06045

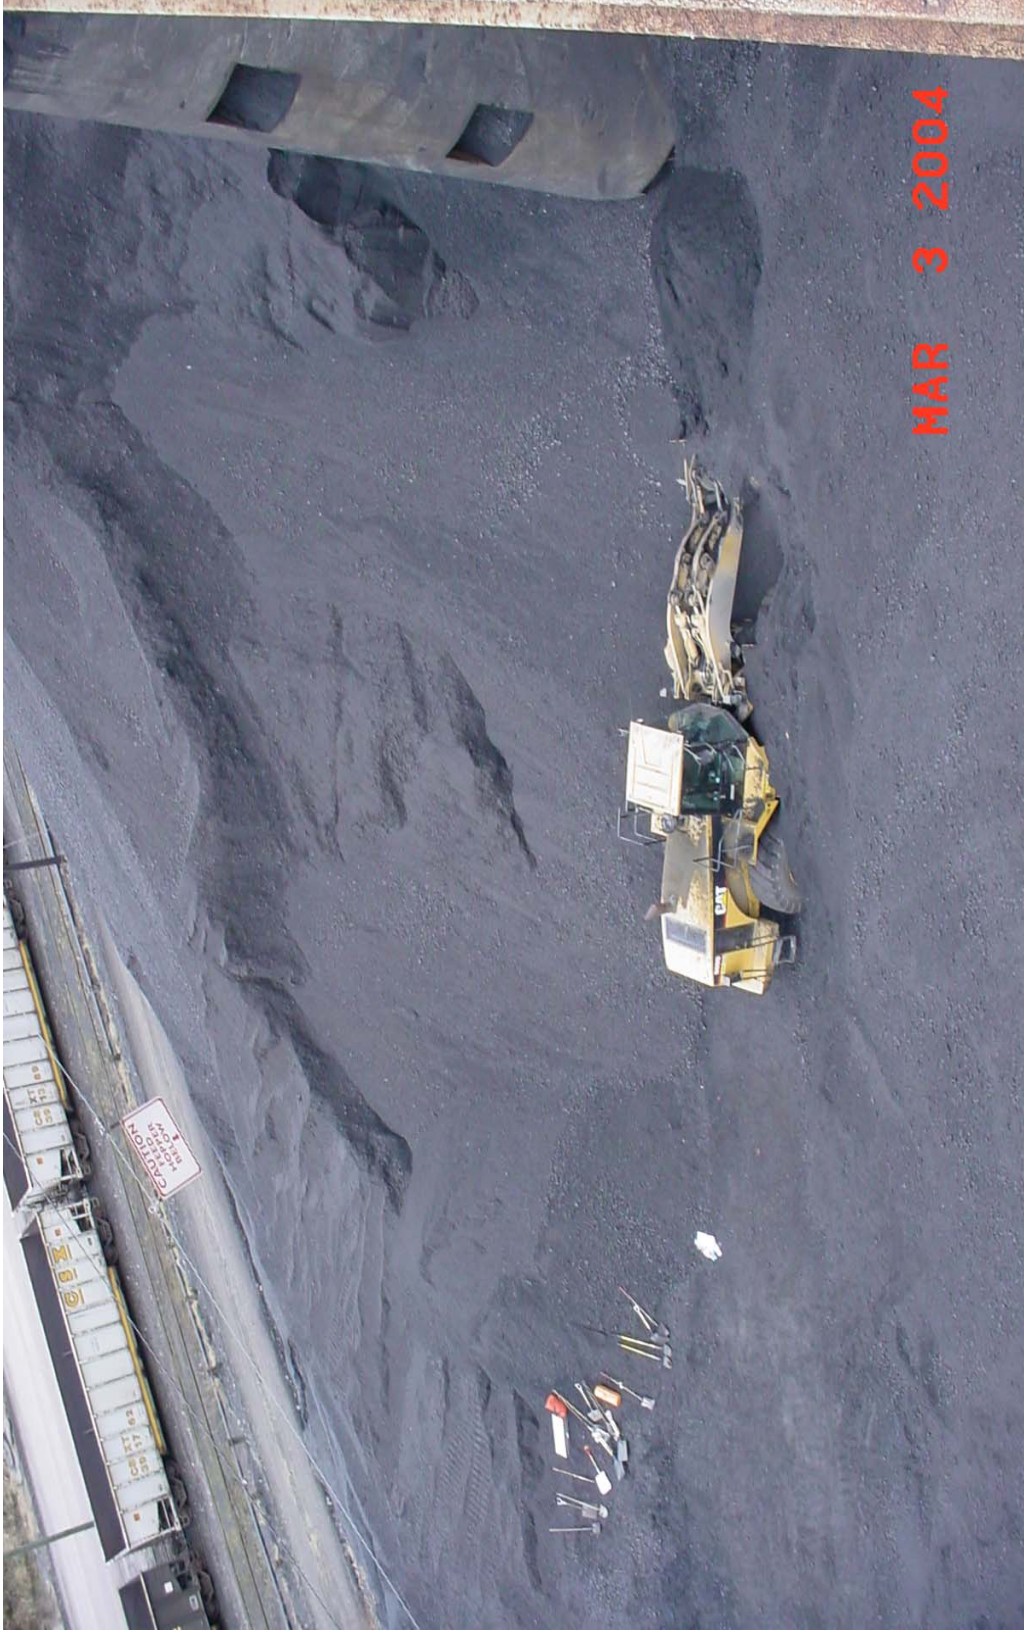
Photograph of accident site, taken one day after the accident.

Holcomb was waiting to unhook the plate for Holliday. He started walking along the right side of the end loader towards the feeder. As he neared the center of the end loader loose coal slid from the No. 2 Stockpile bank on the right side of the end loader. The sliding coal came from the midpoint of the stockpile and extending up towards the top of

Holliday looked up as the coal started to slide out of the bank. He saw that coal had blocked his exit down the right side of the end loader. As he stepped to go under the end loader boom between the right front tire and the bucket, he was knocked down by more sliding coal. The sliding coal buried Holliday at a depth of approximately three feet. Coal piled up to the top of the right front tire of the end loader, to the side of the machine at the swivel area, and to the top of the side of the bucket.

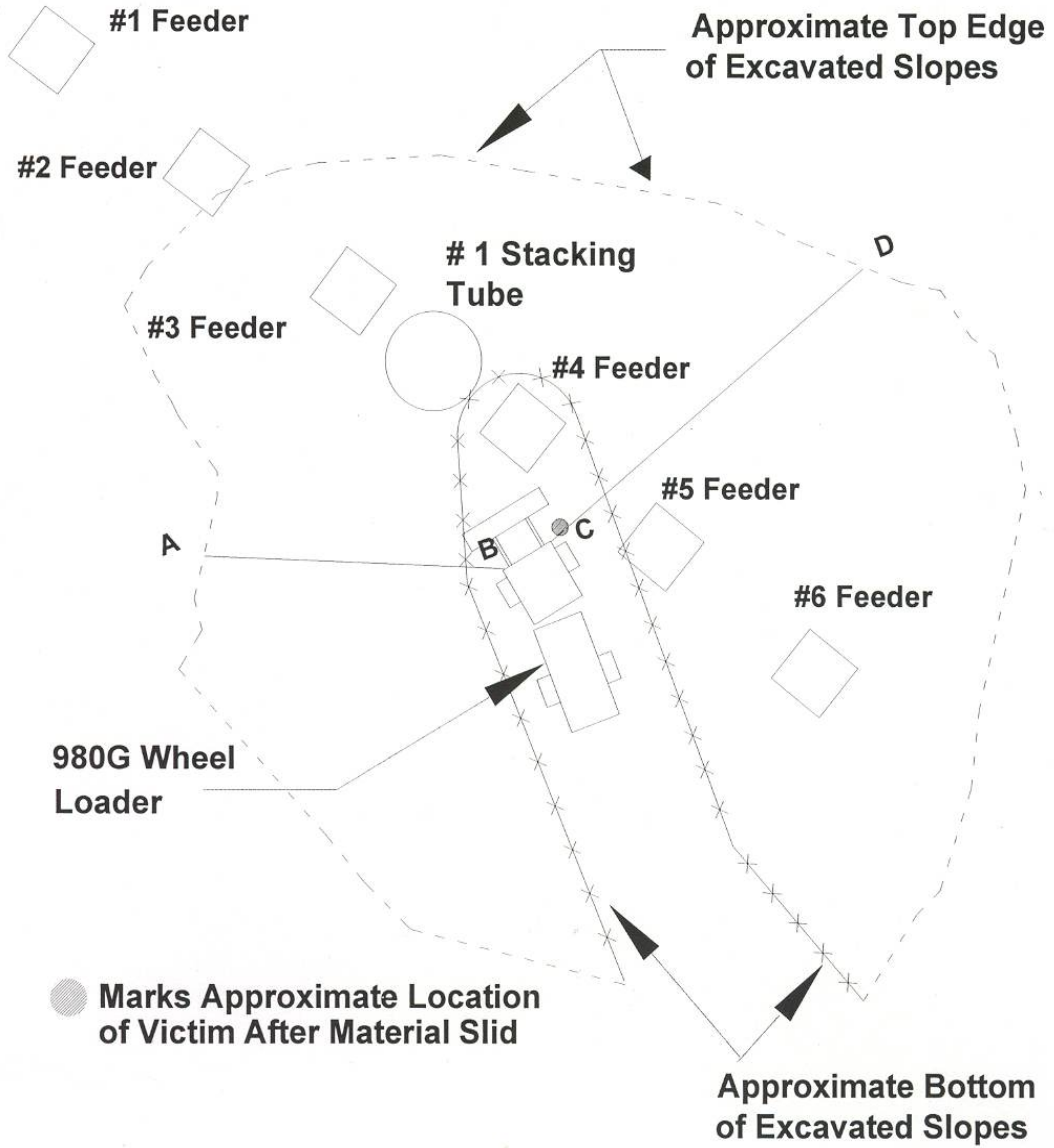
# Plan View of Accident Scene

The clean coal enters the feeders through chutes, which have 8-foot by 8-foot openings at ground level. The centerline of Feeder No. 4 was located approximately 8 feet from base of the stacker tube. Feeder No. 5 was located 25 feet from Feeder No. 4, and Feeder No. 6 was spaced 25 feet from Feeder No. 5.

A contour map of the clean coal pile was prepared based on an aerial survey performed approximately 24 hours after the accident. When the accident occurred, the two Clean Coal Stockpiles, No. 1 and No. 2, at their highest points were approximately 60 feet above the feeder opening level.

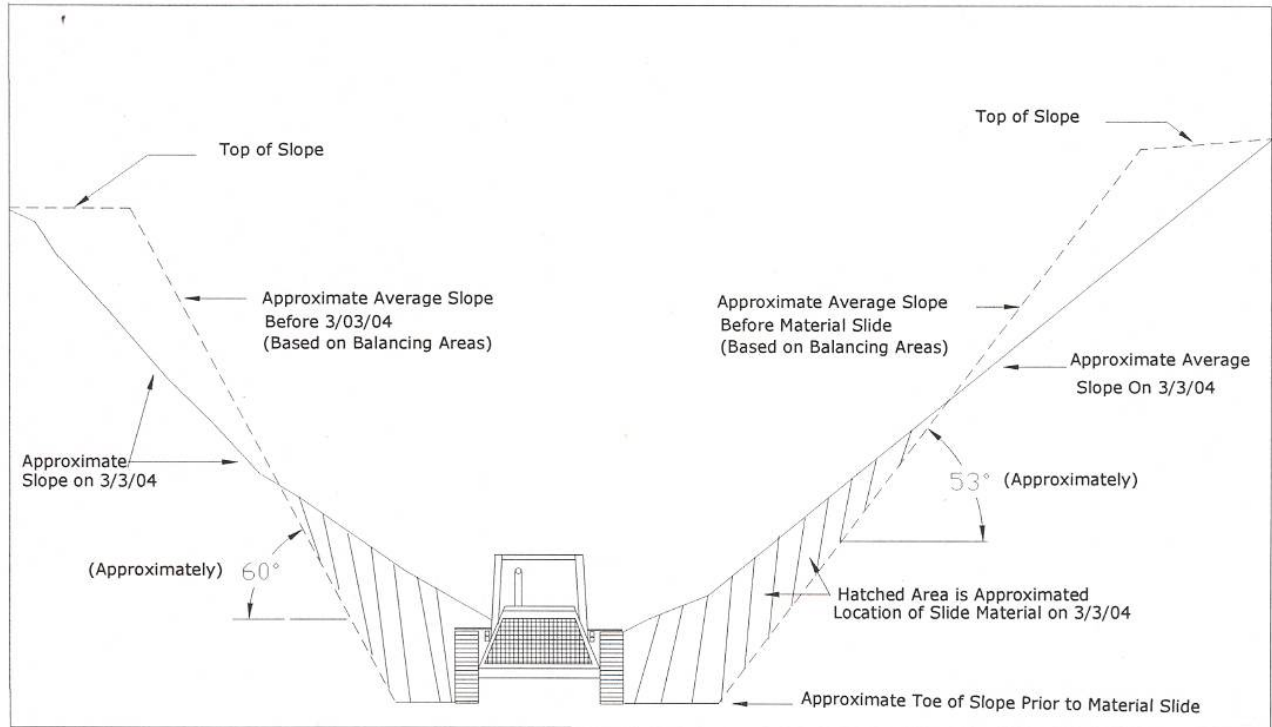
**Approximate Slopes of Coal Pile**  
Corresponds to Section A-B-C-D on Plan View

When Withrow made the examination of the work area at the No. 4 feeder, the approximate configuration of the stockpile was 41 feet high on the left of the feeder, with an average slope of 60 degrees, and 47 feet high on the right of the feeder with an

average slope of 53 degrees. The angle of repose of a coal stockpile is typically 34-37 degrees which may vary according to the composition of the pile. The reclaiming operations of the bulldozer and the end loader in the stockpiles to uncover the No. 4 feeder left the banks in the piles steepened to an angle exceeding the angle of repose of the coal. The banks on both sides of the No. 4 feeder were not stable. This was a hazardous condition. Withrow did not report finding any hazardous conditions. No action was taken to correct this hazardous condition. A record of this examination was not made. Holliday examined the work area around the No. 4 feeder. He told Withrow the area looked alright.

Based on the pile contours after the accident, and the descriptions of the conditions prior to the accident, it was determined that the pile, in the area where the slide occurred, was approximately 47 feet high and sloped at an average or overall angle from 53 to 56 degrees. This is based on estimating the amount of material that slid and determining how steep the slope would have been if that quantity of material was back in place, with the toe of the slope being 8 to 10 feet from the loader (Appendix C-2). The actual slope was likely steeper in some portions and flatter in others.

Factors that can allow a coal stockpile to stand at angles steeper than its normal angle of repose include dozer traffic on the pile and the moisture content of the coal. Traffic packs the coal tighter, while moisture can add “apparent” strength by providing surface tension. Less strength is exhibited in portions of the pile receiving less traffic, or where the surface tension effect is lost by drying. In general, anytime granular material is standing at an angle steeper than the material’s angle of repose, the slope material is marginally stable and should be considered in danger of sliding.
