REPORT OF INVESTIGATION

Underground Coal Mine

Fatal Machinery Accident
May 18, 2004

Air Quality #1 Mine
Black Beauty Coal Company
Wheatland, Knox County, Indiana
I. D. No. 12-02010

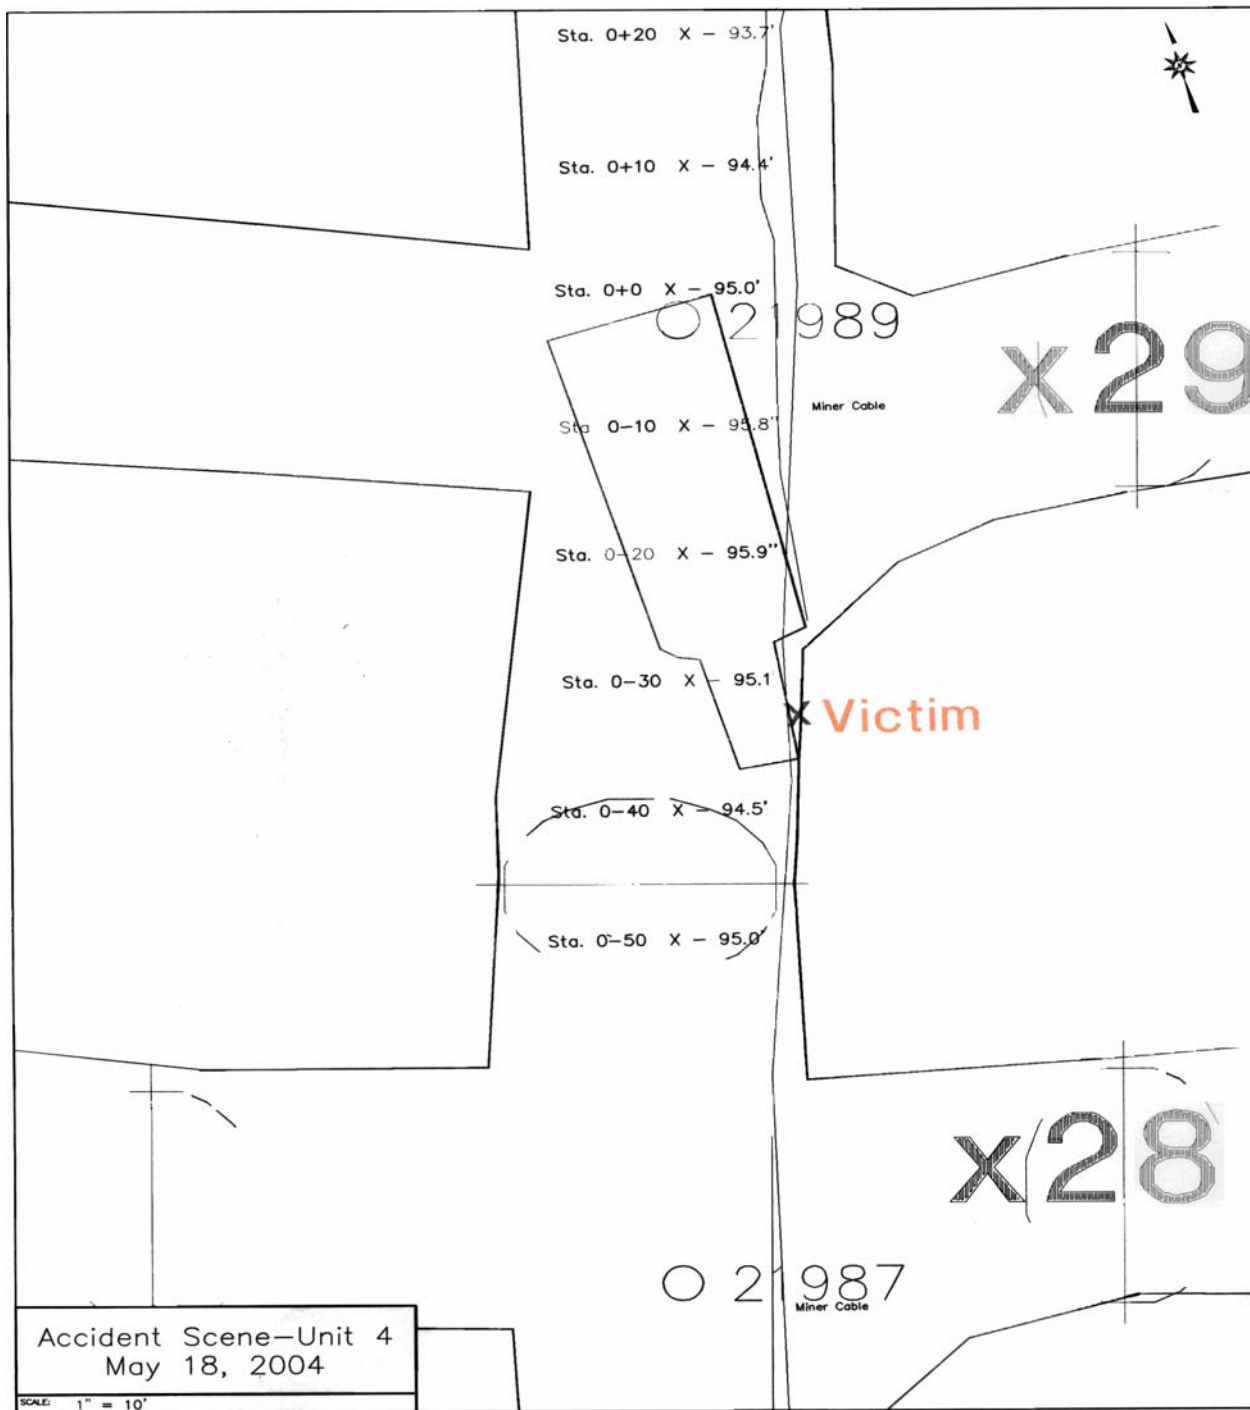
UNIT NO. 4 LOCATION

1. There were no eyewitnesses to the accident.
2. The victim was moving the left-side continuous mining machine located in the No. 3 Entry back from the working face. At the accident location, the victim may have been trying to reposition or change direction of the machine when the accident occurred. (See Appendix C)

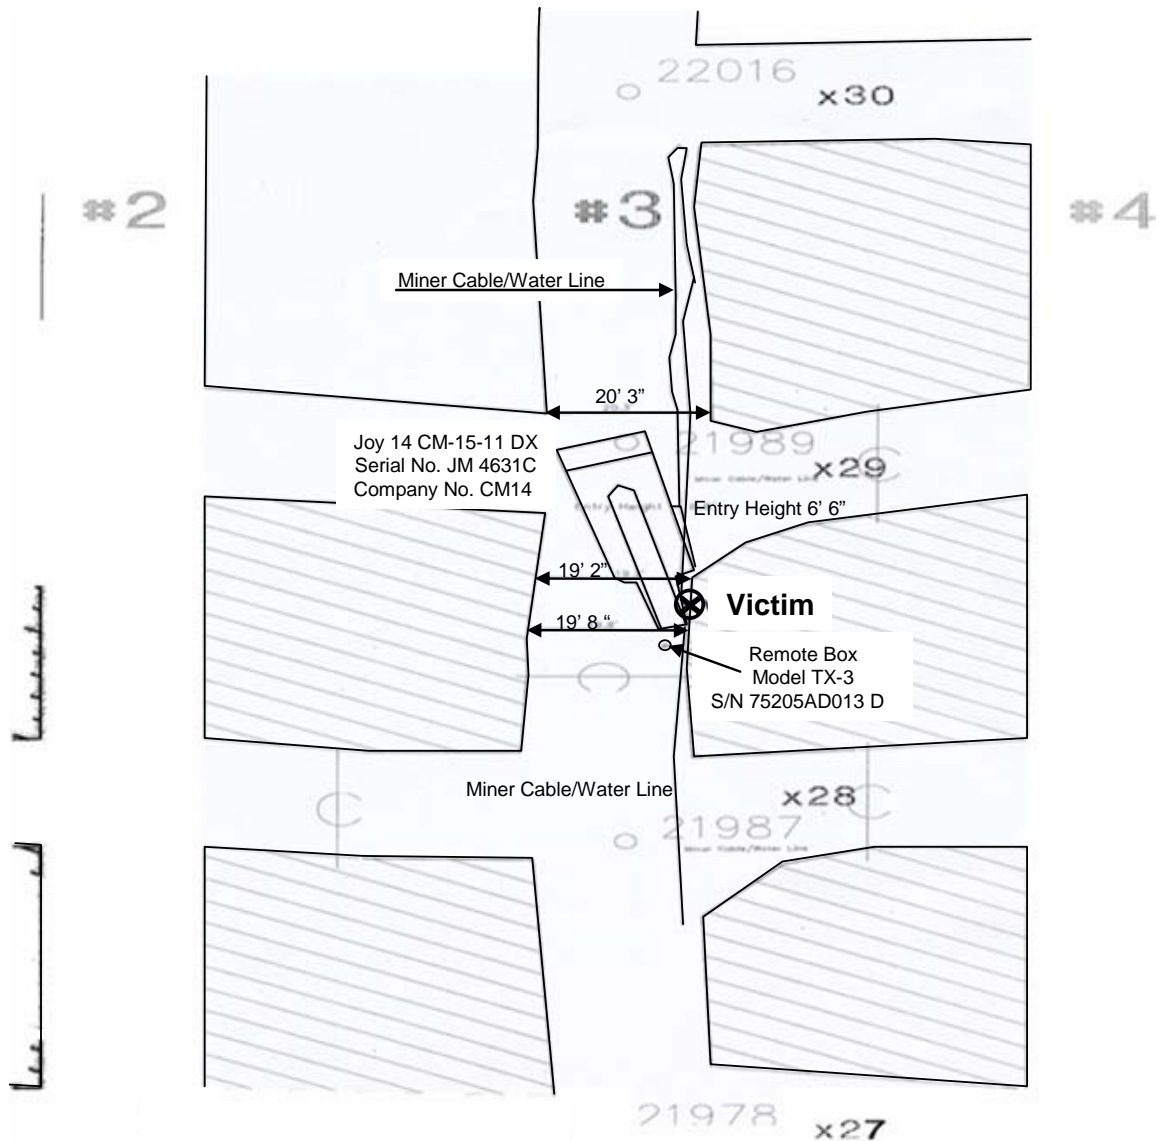
**Location of No. 4 Unit Accident Site
Black Beauty Coal Company
Air Quality # 1 Mine
I.D. 12-02010**

5. The seam height in the immediate area was 6 ½ feet.
6. The entry width at the rear bumper of the continuous mining machine was 19-feet 2-inches (See Appendix D) . The diagonal measurement of the No. 29 Crosscut intersection averaged 31-feet.
