**UNITED STATES
DEPARTMENT OF LABOR
MINE SAFETY AND HEALTH ADMINISTRATION**

REPORT OF INVESTIGATION

**Fatal Powered Haulage Accident
June 10, 2004**

Tug Valley Coal Processing Company
Tug Valley Coal Processing Company
Naugatuck, Mingo County, West Virginia
ID No.46-05890

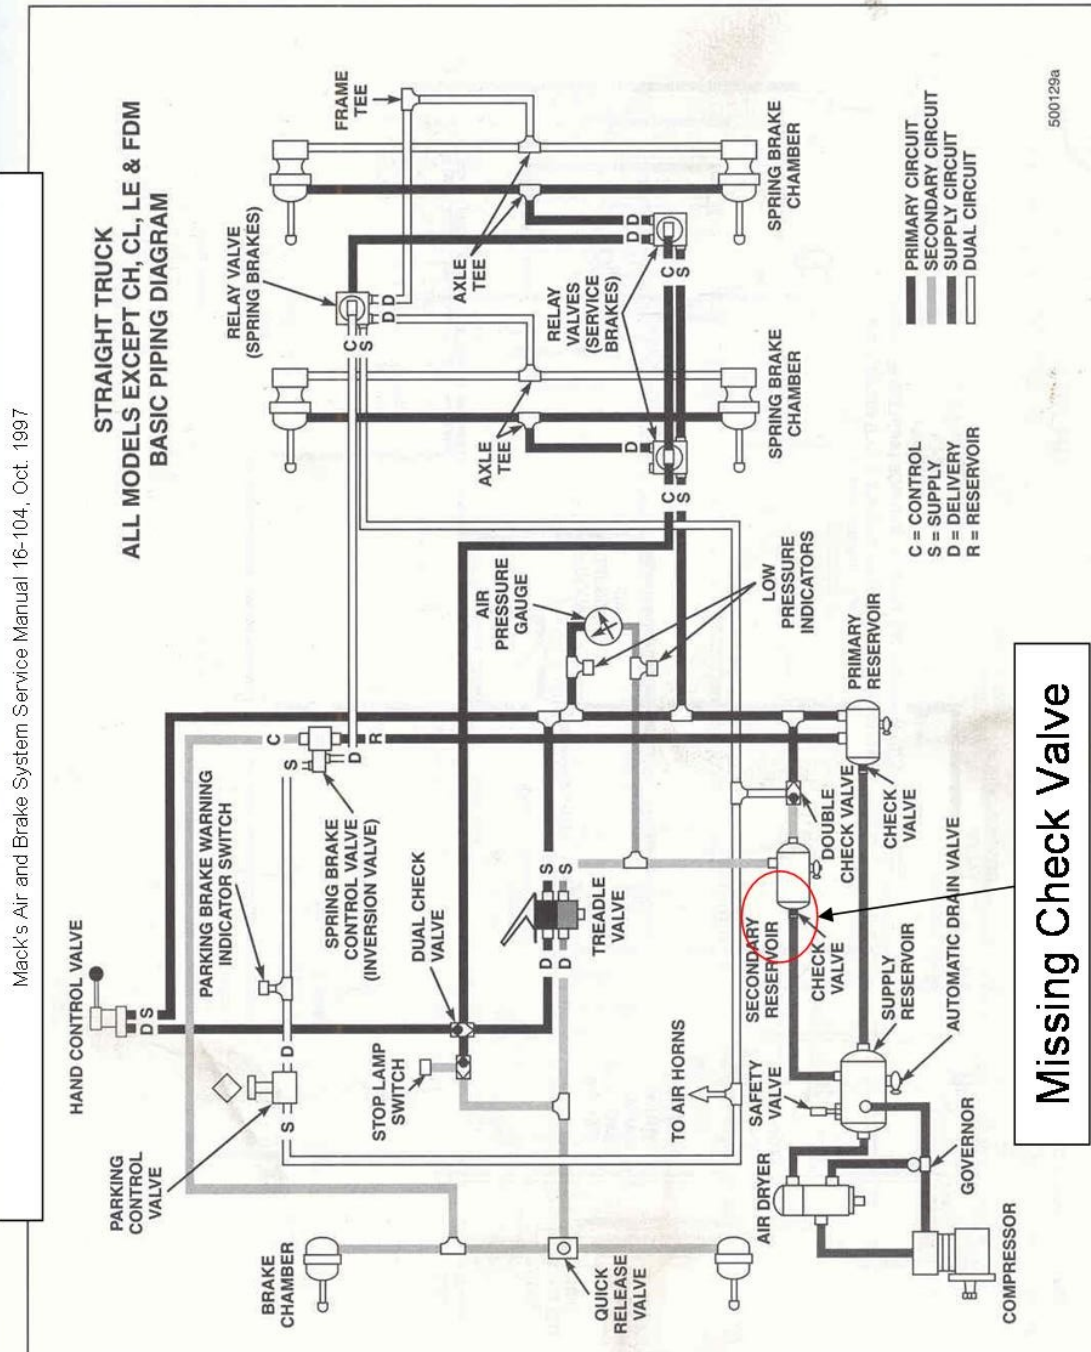
BASIC PIPING DIAGRAMS

The right front tandem drive axle brake chamber had an audible leak with the foot pedal and parking brake released. The leak rate was 60 times the maximum acceptable level of leakage as specified by the manufacturer (Mack). The chamber would also leak if the foot pedal (treadle valve) was applied when the parking brake was engaged, due to the anti-compounding feature within the parking brake system.

The magnitude of the air leak in the parking brake portion of the brake chamber for the right front tandem drive axle, would result in a relatively rapid reduction in the capacity of the service brakes, even though four of the six service brakes were capable of providing some degree of braking. This reduction in braking capability would start as soon as the parking brakes were released, and would deplete all of the reserve air until the spring brakes automatically applied. This would occur even without the service brakes applied. The only operational mode in which this air leak would not occur is when the parking brakes are applied and the service brakes are released.
