REPORT OF INVESTIGATION

Fatal Roof Fall Accident  
August 2, 2004

Mine No.25  
Reedy Coal Company Inc.  
Pinetop, Knott, Kentucky  
ID No. 15-18740

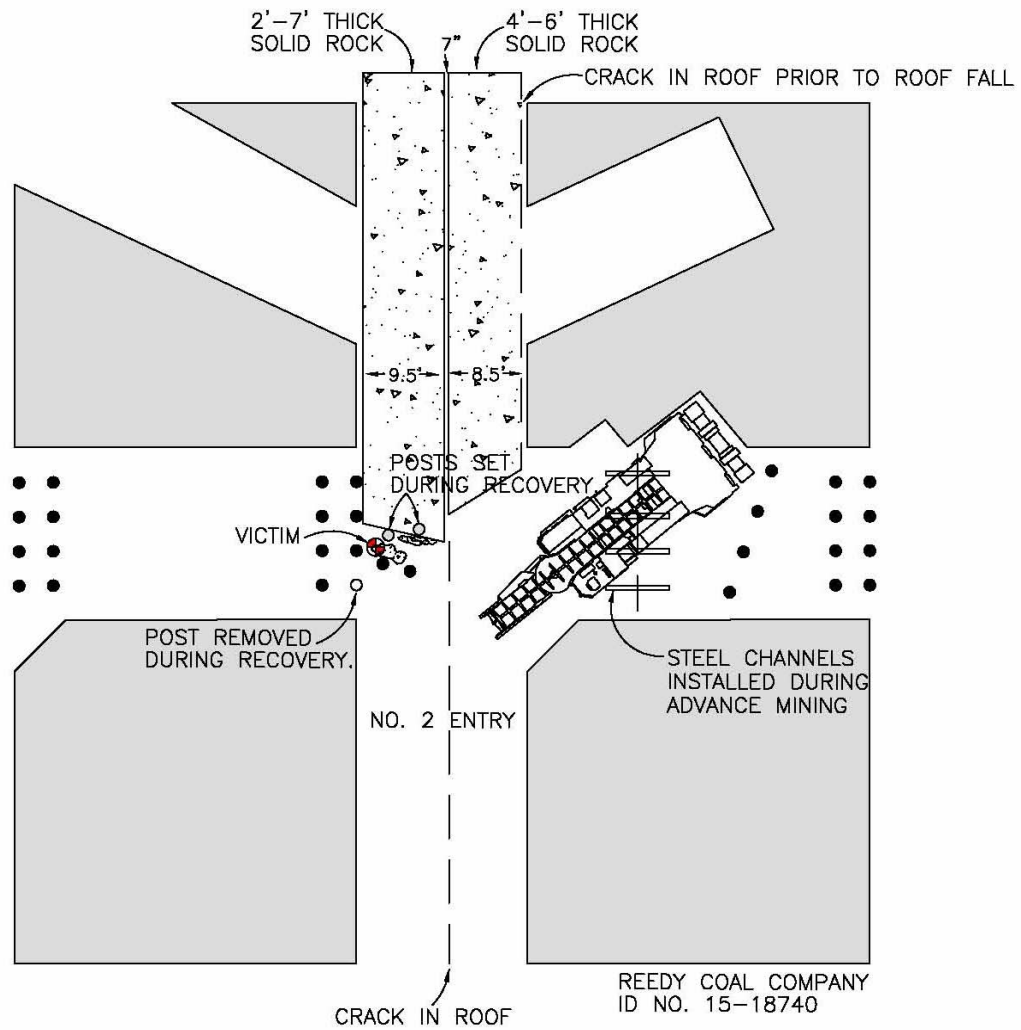
## ACCIDENT SITE

The accident occurred in the No. 2 entry at crosscut 20 intersection, near the left rib line. The victim was positioned on the intersection side of a double row of breaker posts installed along the left rib line of No. 2 entry in crosscut 20.

9. Roof failure nearly spanned No. 2 entry, from rib to rib. The outby edge of the roof fall ended approximately halfway through the crosscut 20 intersection. The fall appeared to extend inby an estimated 50 to 70 feet, with eleven rows of bolts visible along the right rib line, protruding approximately 2 feet from the fallen material. Several bolts on the left side protruded 2 to 3 feet.
