REPORT OF INVESTIGATION

Fatal Electrical Accident  
September 24, 2004

Fork Ridge Mine  
Cumberland River Coal Company  
Dunbar, Wise County, Virginia  
ID No. 44-07074

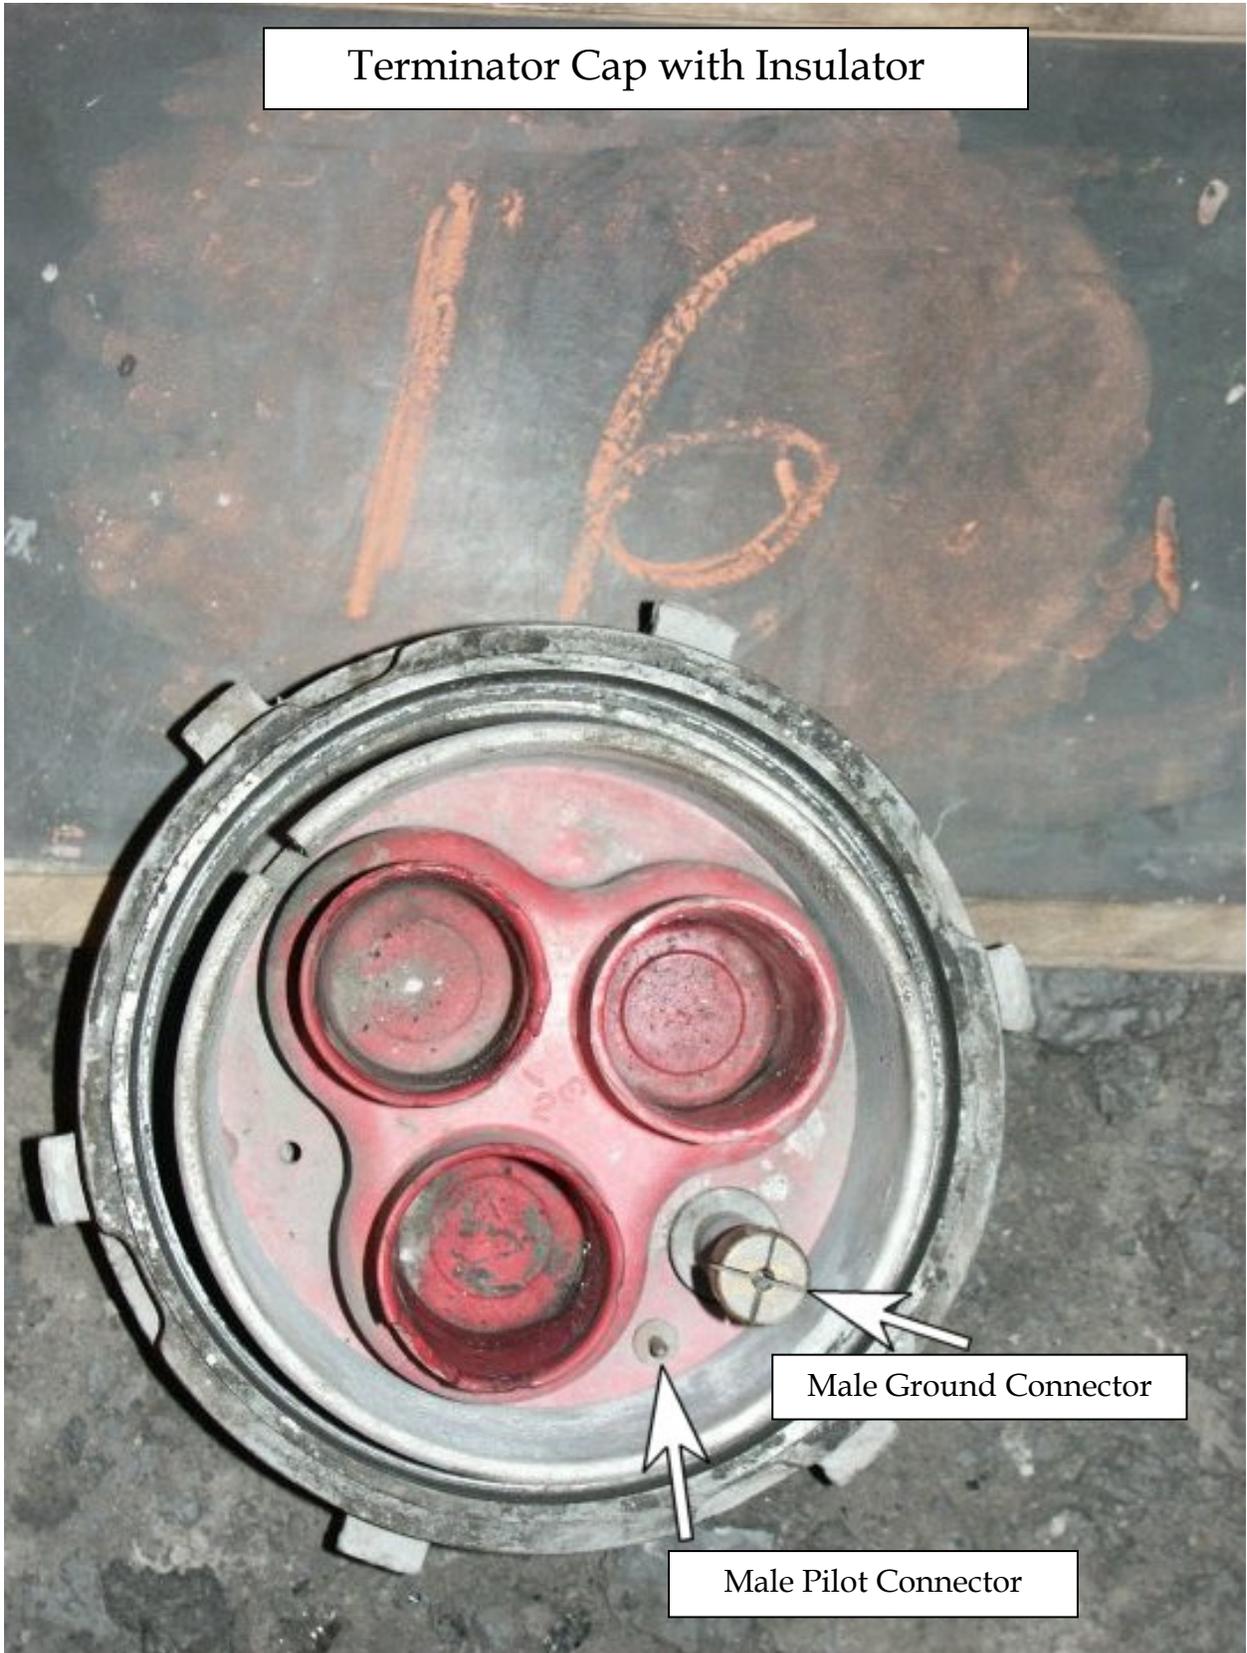
Terminator Cap with Insulator

All high-voltage resistance grounded systems are required to have a fail safe ground check circuit that continuously monitors the grounding circuit to assure continuity. This system causes the circuit breaker to open when either the ground or pilot check wire is broken or intentionally opened. When the high-voltage circuit comes to an "end", which would be the feed-through receptacle in this case, a terminator cap must be installed on that receptacle to complete the fail safe ground check circuit. The terminator cap has a pilot and ground pin which connect to the pilot and ground of the receptacle thus completing the circuit (see Appendix B, page 20). If this circuit is broken by removing the terminator cap or a rock falling on the cable, etc., the high-voltage circuit is de-energized by the circuit breaker. (See Appendix D, page 24 for a sketch and description of a fail safe ground check circuit.) The dust cap's only purpose is to prevent dust and other foreign materials from accumulating in the receptacle.

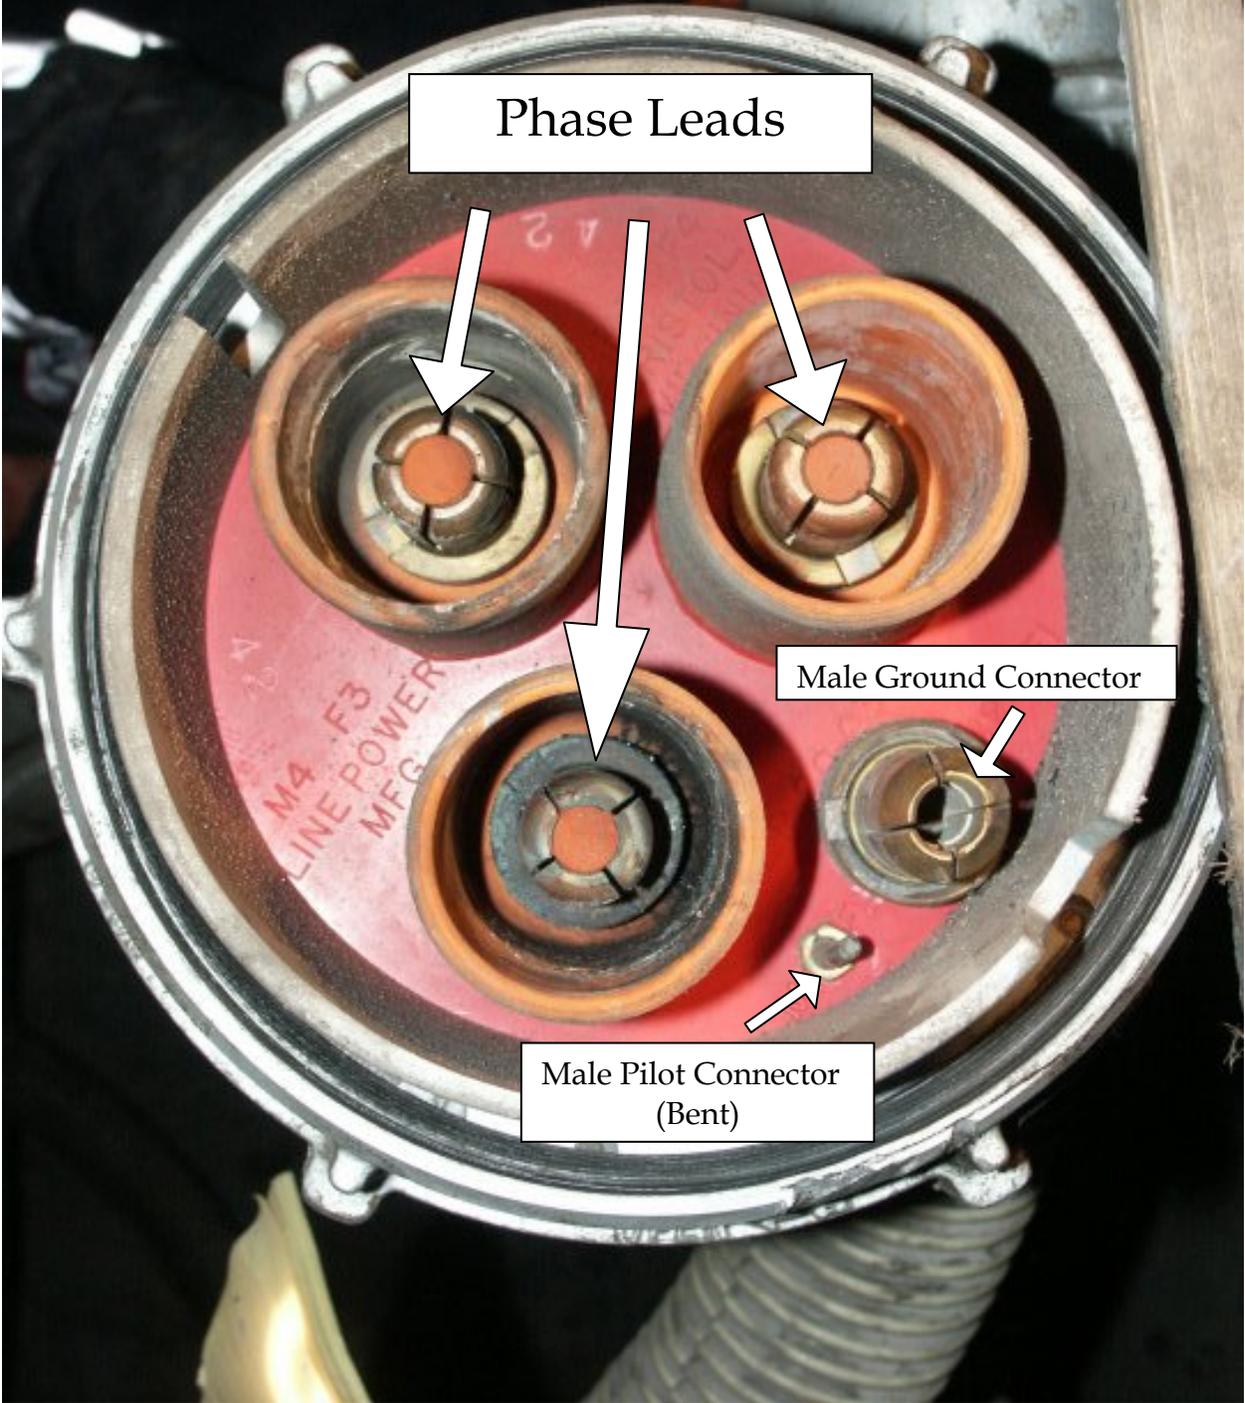
# High Voltage Coupler

The pilot (monitor) pin in the high-voltage coupler that was connected to the output of the No. 5 Power Center (Belt Transformer) was bent (see Appendix B, page 20). Due to the condition of the pilot pin, it had come in contact with the frame and had effectively short-circuited the fail safe ground check circuit. This condition removed the fail safe ground check protection from the No. 4 Switch House feed-through receptacle. This condition allowed the No. 4 Switch House to remain energized without a terminator cap on the feed-through receptacle.

Causal Factor: The pilot (monitor) pin, in the high-voltage coupler attached to the No. 5 Belt Power Center, was bent short-circuiting the fail safe ground check circuit.

Corrective Actions: An action plan has been submitted and implemented by the company. The plan requires more extensive retraining of all electricians and helpers in high-voltage system testing, operation and maintenance.

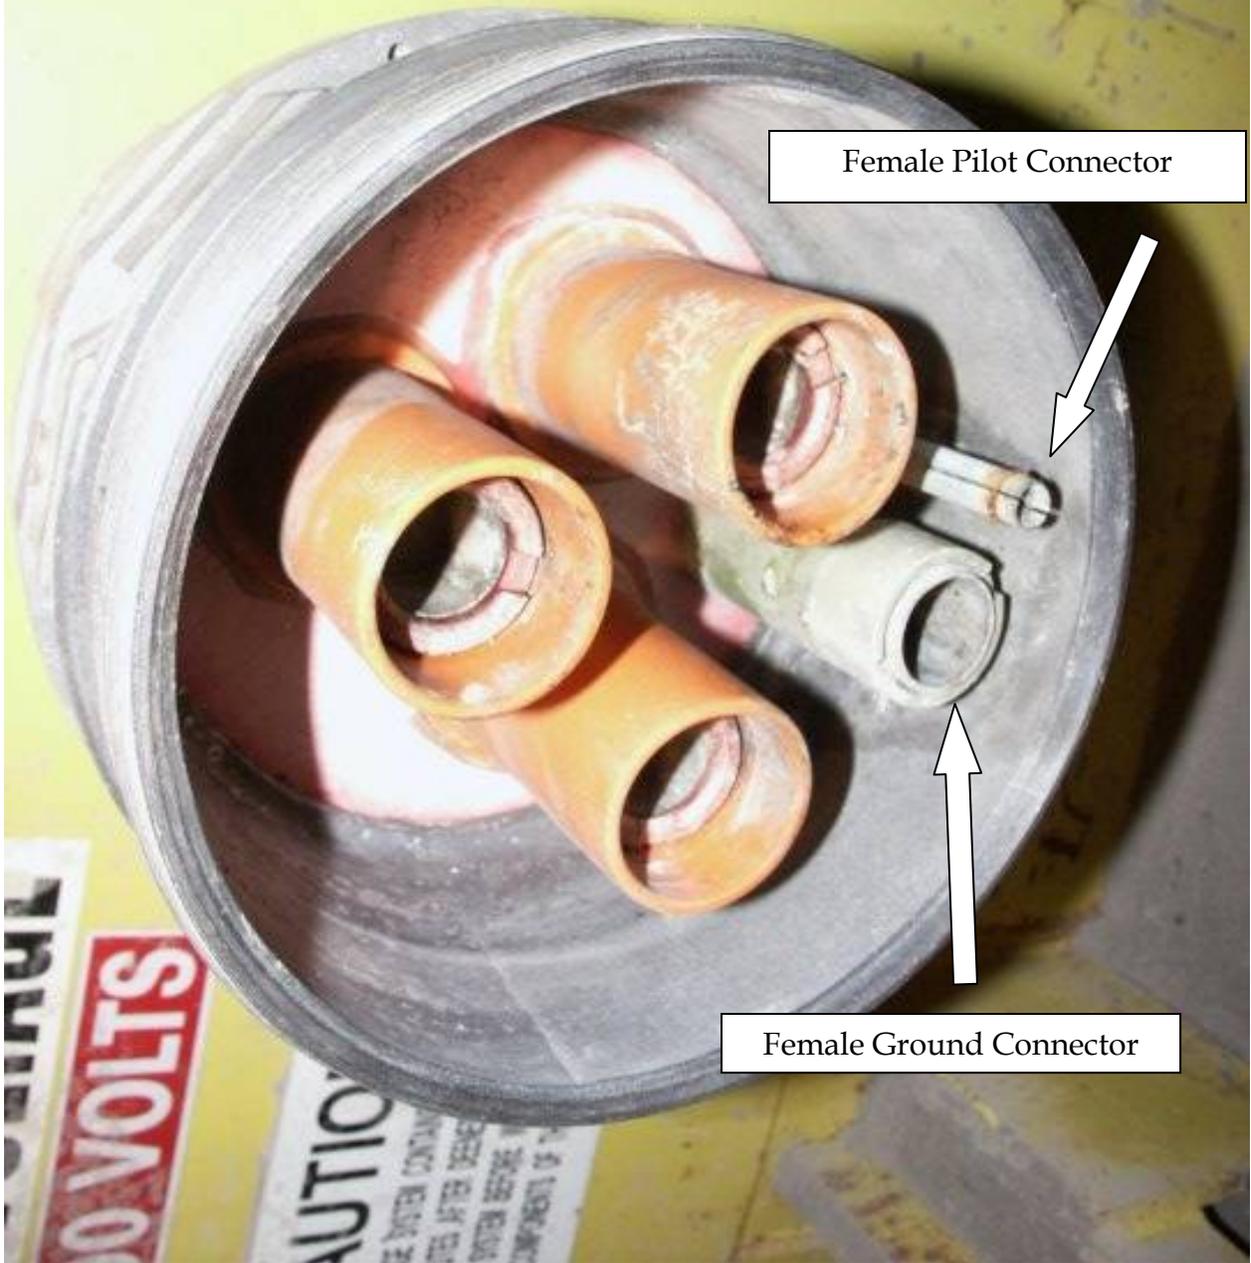
# High Voltage Receptacle

Most high-voltage electrical installations, which use couplers, come equipped with a guide screw which assists in the alignment of the three phase leads, and the ground and pilot (monitor) pins installation. The guide screw is located on the female feed-through receptacle. The male coupler is correspondingly designed with a slot to accommodate the screw and thus maintain proper alignment. The guide screw that originally came in the No. 5 Belt Power Center (Belt Transformer) output receptacle (or one similar to it) was not maintained. This factor probably contributed to the bent ground fault circuit pin.

The guide screw that originally came in the No. 5 Belt Power Center output receptacle (or one similar to it) was not maintained. If this guide screw had been maintained it could have assisted in aligning the pilot (monitor) pin, reducing the possibility of the pin being bent.

Causal Factor: A guide screw (alignment pin) for the No. 5 Belt Power Center Feed-Through Receptacle was not maintained.

Corrective Actions: An action plan has been submitted and implemented by the company. The plan required all electrical high-voltage receptacles to be inspected for the presence of guide pins. If pins are missing or inoperative, new guide pins will be reinstalled. All cathead receptacles will be inspected and corrected within 60 days, if repairs are needed.
