REPORT OF INVESTIGATION

Fatal Machinery Accident  
September 24, 2004

Barrackville Refuse Pile  
Wilson & Wilson  
Barrackville, Marion County, West Virginia  
I.D. No. 46-09064

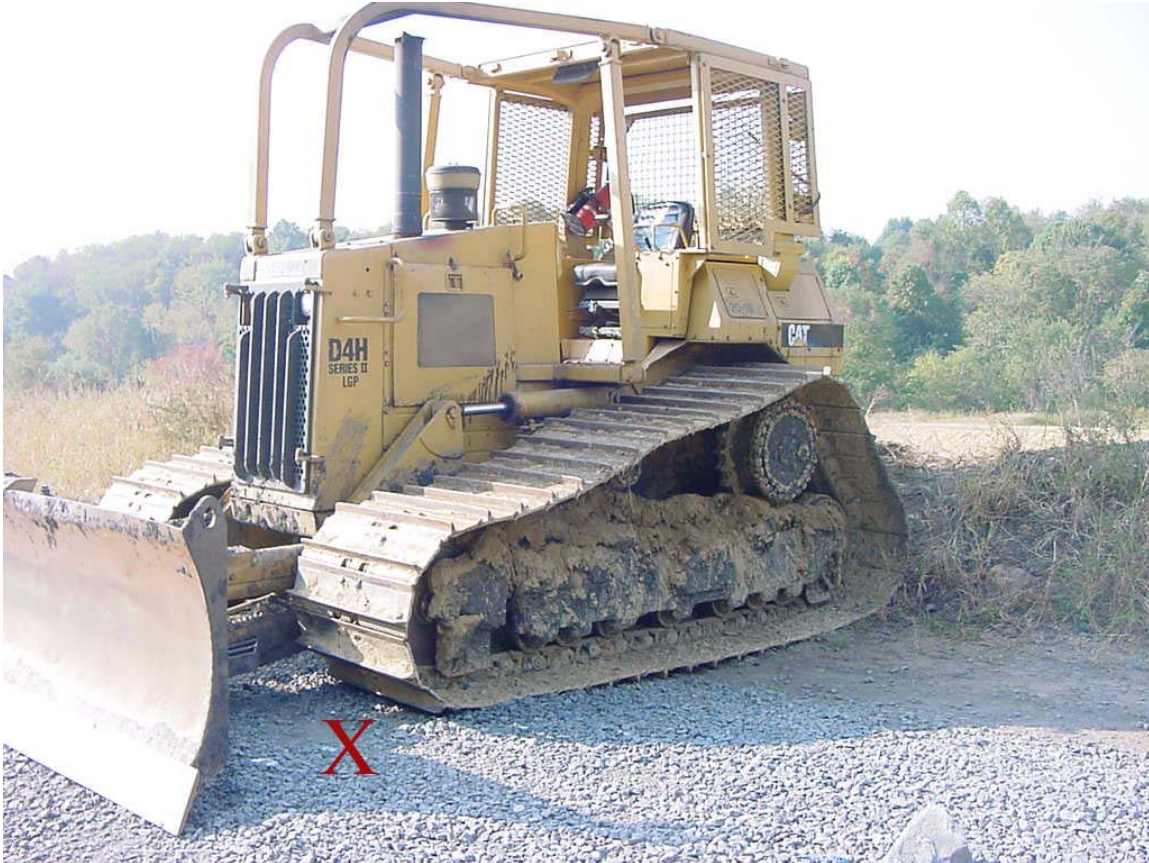
## ACCIDENT SCENE

**X** - Indicates where victim was found

There were no eye witnesses. For unknown reasons, Ott trammed his bull dozer just off the grubbing area and stopped the bull dozer on a sloped berm area adjacent to a level graveled roadway. It appears Ott then attempted to dismount the bull dozer with the blade elevated and the parking brake not engaged. During this process the bull dozer apparently began to drift forward and Ott slipped and fell to the ground in front of the moving bull dozer. Ott was struck by grouser(s) on the left track and received fatal injuries.

The dozer was found on a level, graveled roadway immediately adjacent to an elevated berm. The blade had been raised to a height of approximately 25 ½ inches, the engine was running, the transmission was in neutral, and the parking brake was not set or engaged.

Corrective Action: Management must enforce all mandatory safety regulations and safe work practices.
