UNITED STATES
DEPARTMENT OF LABOR
MINE SAFETY AND HEALTH ADMINISTRATION

REPORT OF INVESTIGATION

Fatal Powered Haulage Accident
November 9, 2004

Grays Fork
J R Mining
Manchester, Clay, Kentucky
ID No.15-18755

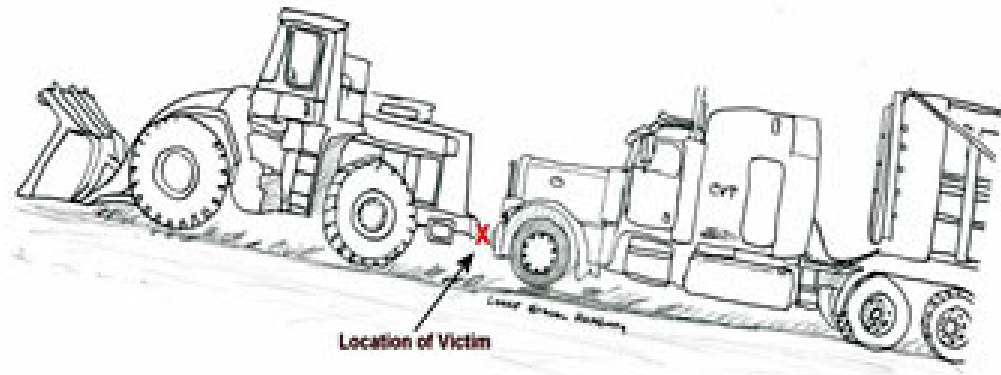
ACCIDENT SITE

1. *Causal Factor:* At the time of the accident, the victim was located in a hazardous position between the Caterpillar 980C front end loader and the Peterbilt coal haul truck with his back to the front end loader which was on a grade of approximately 19 percent.

Corrective Action: Procedures and work practices were developed to make it unnecessary for miners to work between mobile equipment. Training was provided for miners.
