REPORT OF INVESTIGATION

Surface Preparation Plant

Fatal Machinery Accident
December 28, 2004

Supreme Energy Prep Plant
ICG Knott County, LLC
Kite, Knott County, Kentucky
ID No. 15-16567

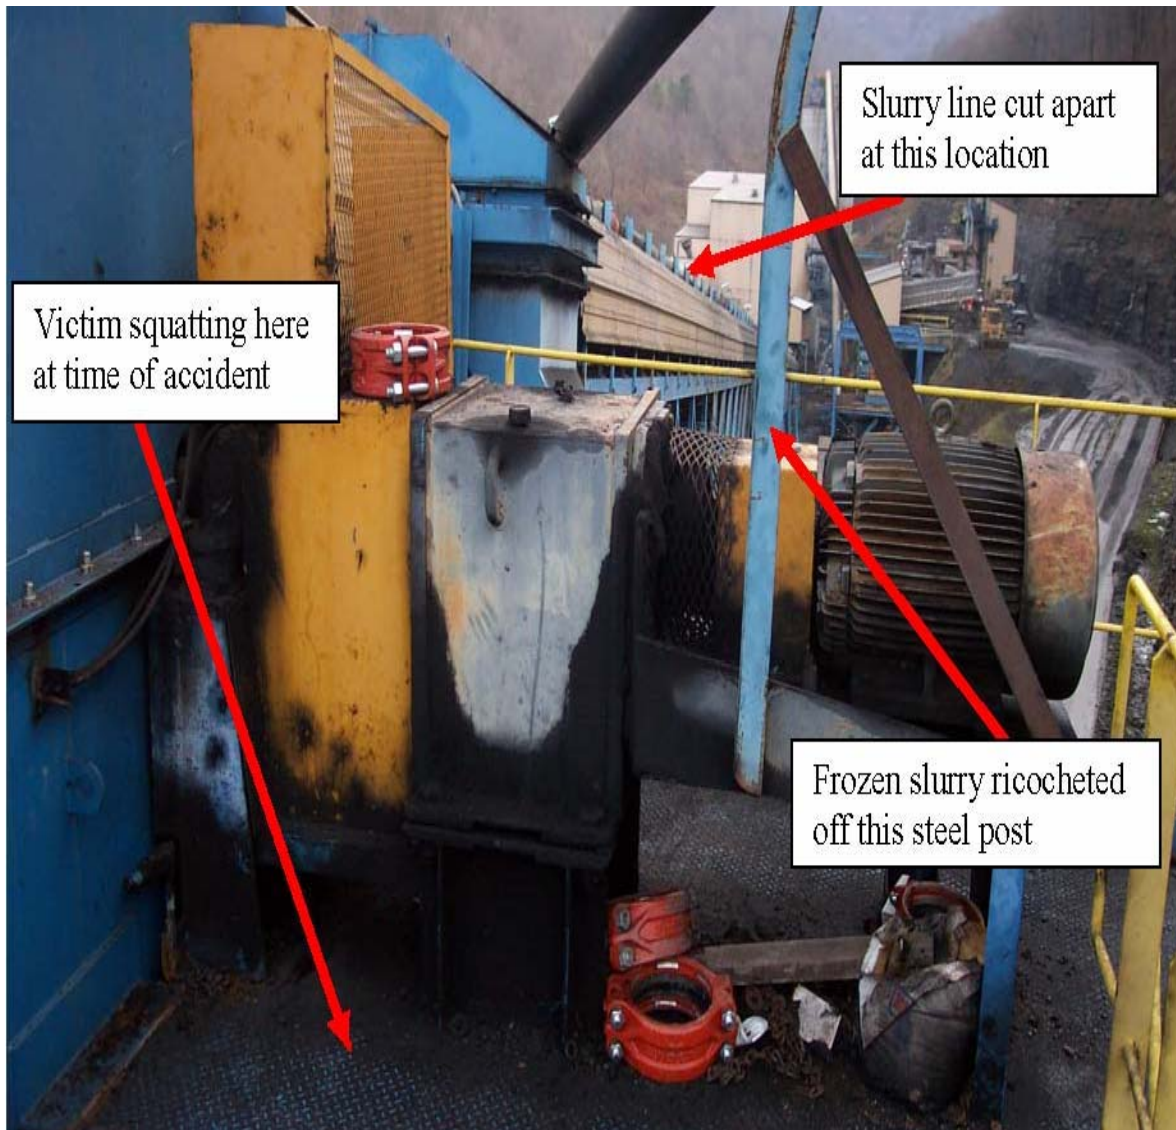
ACCIDENT SITE

View of No.102 belt drive unit looking toward direction of blowout.

COMPRESSED AIR: The drain valve located just outside of the preparation plant was opened by the crew to bleed the pressure from the line before each cut in the slurry pipe was made. The bleeding of the pressure from the line also allowed the slurry to drain from the line. When the pumps were restarted, air was trapped and compressed in the slurry pipeline between the pump and the ice blockage. With the pumps rated at 550 gallons per minute and 320 p.s.i., the trapped compressed air provided the force that violently discharged the ice that struck the victim.

Corrective Action: In accordance with 30 C.F.R. §77.1708, mine management established, implemented, and will enforce a detailed written procedure for unclogging slurry pipelines which requires all miners to be behind the open end of the pipe in the opposite direction of the discharged material, in a protected location, before attempting to blow ice and other blockages from the pipe. These procedures shall be incorporated into annual refresher and newly employed miner training.
