REPORT OF INVESTIGATION

Surface Nonmetal Mine
(Limestone)

Fatal Slip or Fall of Person Accident
February 26, 2004

Martin Marietta Aggregates
North Indianapolis Quarry and Mill
Indianapolis, Hamilton County, Indiana
Mine I.D. 12-00002

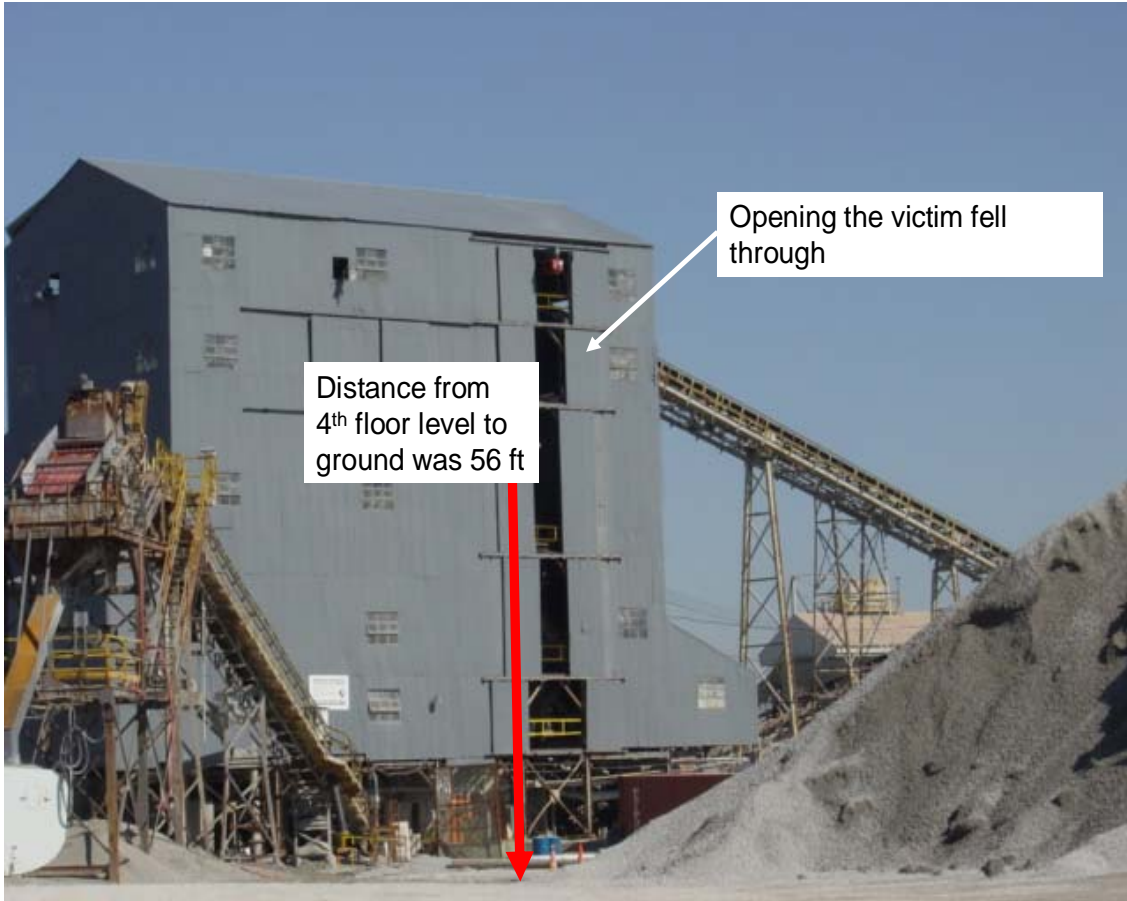
Opening the victim fell through

Distance from 4th floor level to ground was 56 ft

The accident occurred at the fourth floor access doorway of the mill screening tower, 56 feet above the ground. A sign was posted near the doorway opening instructing employees to use fall protection when the barrier railing was removed.

Causal Factor - The three man crew had not taken safety belts and lines to the fourth floor work site. The crew removed the barrier railing to lower a large pipe through the fourth floor doorway opening in the screen tower. The barrier railing was not reinstalled nor were restraints utilized to protect persons from the danger of falling.

The accident occurred because a barrier railing across a door opening had been removed and safety belts secured to restraints had not been utilized by the crew. After a large pipe had been lowered to the ground, the barrier railing was not replaced. The victim was positioned near the edge of the opening, lost his balance, and fell to the ground below.

Corrective Action - Management should review requirements for utilizing safety belts and restraints to ensure that miners understand the established procedures when working at elevated positions where there is a danger of falling. Approved anchor points or cable ties should be provided.

Corrective Action - Miners should discuss a task before performing work to identify possible hazards and initiate actions to ensure they are protected from possible injury. Management should monitor safety controls for effectiveness.

This citation was terminated on April 13, 2004, after mine management took the following actions to terminate the citation: 1) Placed locks which can now only be opened by a supervisor on all removable gates in the screen tower; 2) Held safety meetings with all employees and supervisors reemphasizing the topic of fall protection; 3) Obtained the services of a fall protection specialist. The specialist retrained all employees on the use, care, and maintenance of fall protection equipment. The training also included the identification of proper tie-off points.
