Report of Investigation

Surface Nonmetal Mine
(Limestone)

Fatal Machinery Accident
March 24, 2004

Bellco Materials, Inc.
Bellco #2
Claremore, Rogers County, Oklahoma
Mine ID No. 34-00410

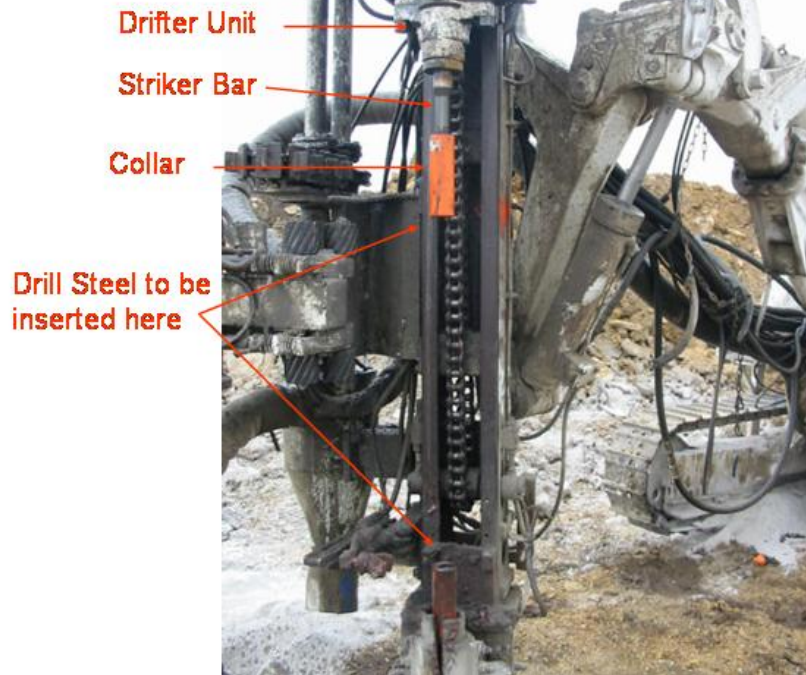
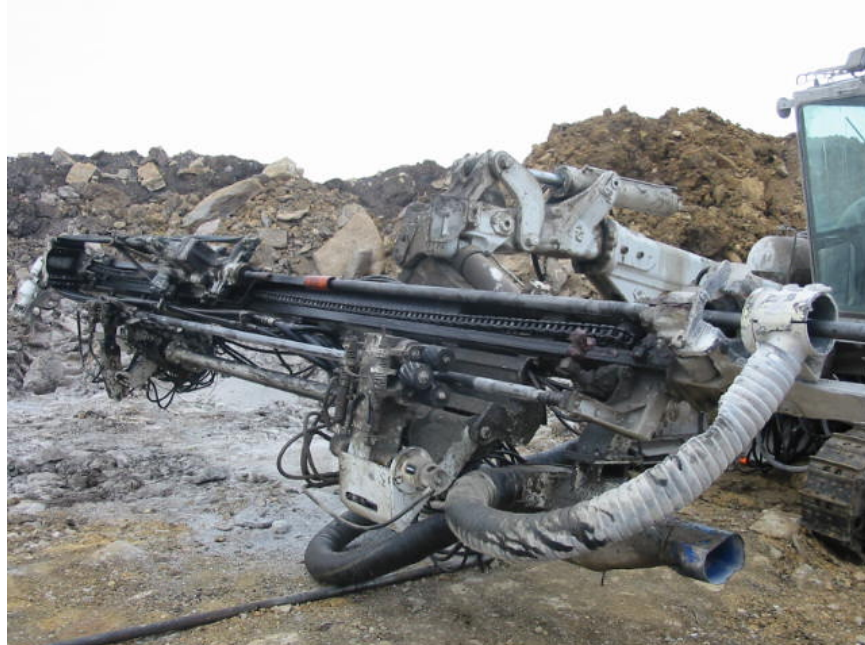
Overview of Drill

Sometime after that, Wheeler evidently seized a drill steel in the hole he was drilling. Wheeler then got a new bit, three new 12 feet long steels, and three new collars. He started drilling another hole with a 12 foot starter steel and continued drilling a second 12 foot steel. Apparently, Wheeler attempted to add a third drill steel on the rotating striker bar while the drill mast was in the vertical drilling position. (See Appendix B) The drill steel apparently cross threaded and Wheeler's clothing became entangled in it.

The drill steel being added to the drill string at the time of the accident did not come from the storage magazine on the drill. Wheeler was physically placing the drill steel on the rotating striker bar while the drill mast was in the vertical drilling position. The correct procedure would have required two workers to place the steel in the magazine with the drill mast in the horizontal position and the machine turned off. (See Appendix B)

Drill mast in lowered horizontal position for manually placing steels in the magazine.

Corrective Action: Procedures should be established to ensure that all drill operators understand any potential hazards associated with their work. The procedures should require that drill operators follow the manufacturer's recommendations for adding drill steels.
