REPORT OF INVESTIGATION

**Surface Nonmetal Mine
(Sand and Gravel)**

Fatal Slip or Fall of Person Accident

**Joe Bernert Towing Company, Inc.
Willamette River
Wilsonville, Clackamas County, Oregon
Mine ID No. 35-00807**

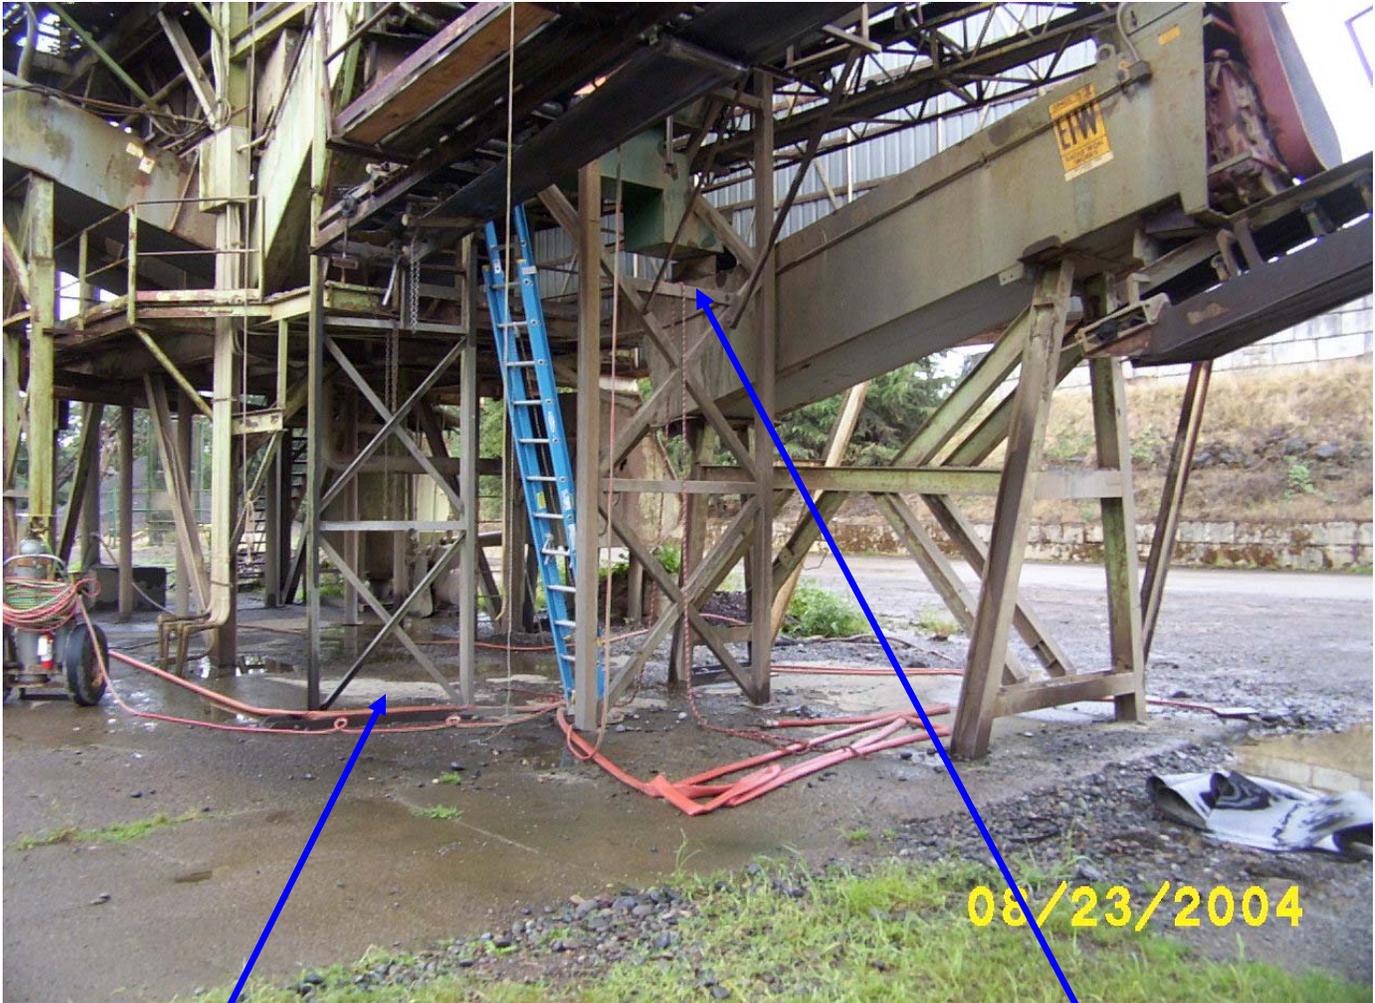
Where victim landed
when he fell

Where victim was
standing

Robert L. Peterson, mine superintendent, age 63, was fatally injured on August 21, 2004, when he fell from an elevated cross beam to the concrete floor below. The victim and two co-workers were attempting to install a new conveyor belt on an elevated conveyor. He was standing on a conveyor leg cross beam, 12 feet off the ground. Peterson was pulling on a rope tied to the new belt when the rope unexpectedly came loose, causing him to fall.

By 8:15 a.m., they had threaded the new belt around the head pulley when the rope unexpectedly came loose, causing Peterson to lose his balance and fall backwards off the cross beam. He landed on the concrete floor 12 feet below.

Causal Factor: The rope was not properly attached to the device installed on the end of the new conveyor belt. As the belt was being pulled by the victim, the connection failed.

Corrective Action: To prevent the rope from loosening, clamps should be used to permanently attach the rope to the wire on the conveyor belt.
