## Coal Mine Fatal Accident 2005-21

Contractor:	Bodell Construction Company (YUD)
Operator:	Pacific Minerals
Mine:	Bridger Underground Coal Mine
Accident Date:	December 9, 2005
Classification:	Fall of Person
Location:	Dist. 9, Sweetwater County, WY
Mine Type:	Surface Area of UG Coal Mine

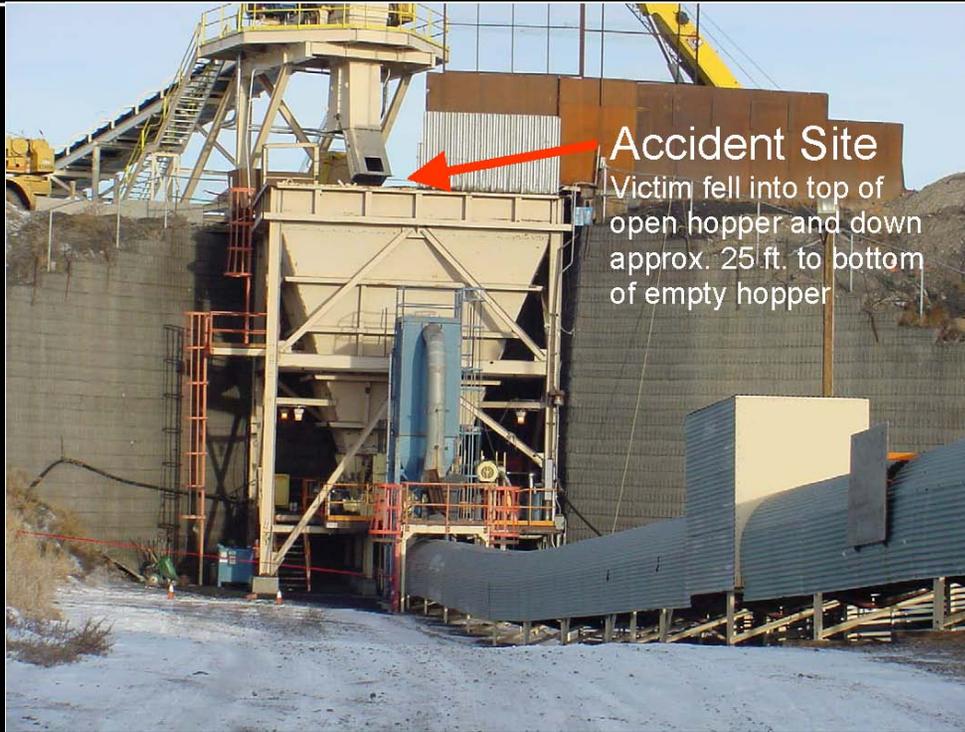
During the morning of the accident, a meeting was held in which the use of personal protective equipment and tying off 100% of the time when working in elevated areas was discussed. The victim and another journeymen ironworker/welder, were assigned the task of installing two steel covers, each 14- by 14-feet in size.

After initial preparatory work, a crane was used to place the first steel cover over the hopper. The cover was not welded in place, but sat loosely on the hopper and a I-beam. The second steel cover was positioned over the hopper but still remained attached to the crane.

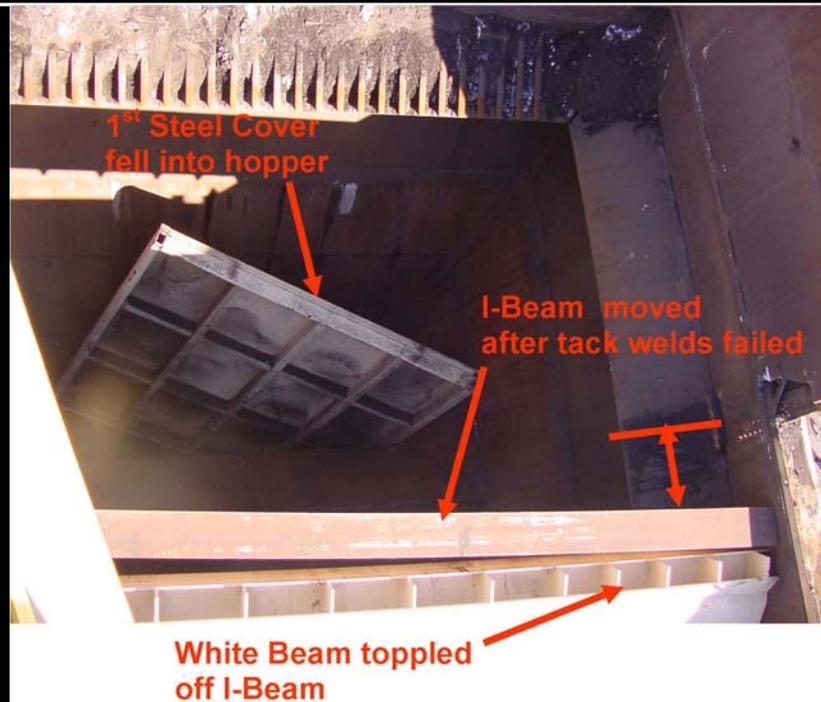
When the second cover did not sit on the white beam properly, the victim said that the steel cover needed to drop an inch into place and another white beam needed to move about two inches. The victim used a steel bar to cause the cover to drop in place and the white beam to move approximately two inches.

The victim was still not satisfied with the alignment and decided to go inside the handrail barrier at the hopper opening and into the hopper to make adjustments. Without wearing fall protection, he climbed out on the I-beam and cover and pried again with the steel bar. As he pried with the steel bar, the tack welds on the far end of the I-beam broke, allowing it to shift and the white beam to topple over, causing him to fall into the hopper.

2. *Root Cause:* Bodell management did not ensure that the loose beam fit-up procedures for installing the I- and white beams were followed. Failure of the tack welds on the south end of the I-beam allowed the beam to shift and the white beam to topple causing Oneida to fall.

*Corrective Action:* More substantial welds could have been made or the procedures outlined on the hand-written construction drawing for a loose beam fit-up should have been followed.

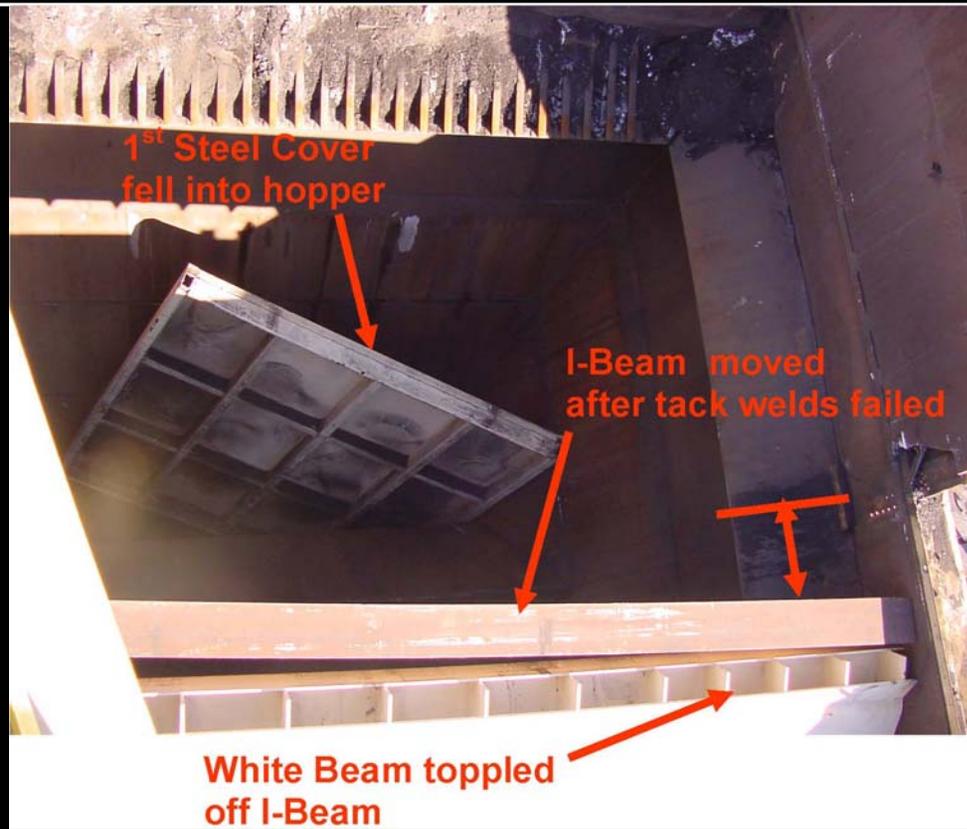
The hopper was approximately 28- by 28-feet square at the top. A steel I-beam was installed across the middle of the hopper dividing the top into two 14- by 28-foot openings. It was tack welded on each end to the hopper walls with angle iron clips. The I-beam was installed to support two steel covers, each 14- by 14-feet in size.

A prefabricated angled steel framework, referred to as the "white" beam, was placed on the top of the I-beam to receive the steel covers and hold them in place. This white beam was welded to the I-beam with clips to hold it in place. During the accident, this white beam flipped off the I-beam and came to rest beside the I-beam, also spanning the top of the hopper.
