MNM Fatal 2005-18

- Powered Haulage
- July 21, 2005 (Arizona)
- Sand and Gravel Operation
- Plant Operator
- 31 years old
- 2 years mining experience

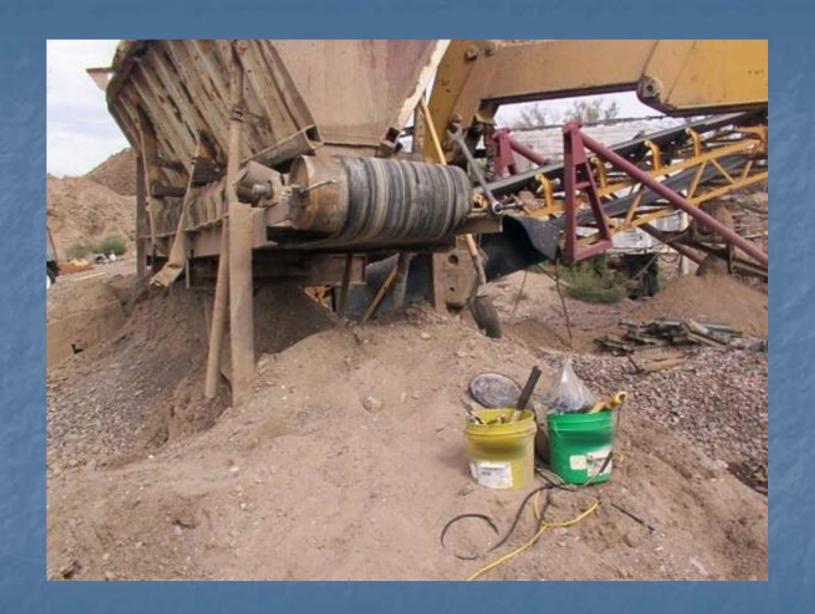
The victim made a splice on a conveyor belt and was making adjustments to the belt. He was found entangled in the tail pulley of the conveyor.

- Procedures had not been established that required guards to be installed upon completion of repair work. Guarding was removed to facilitate the splicing of the conveyor belt and had not been replaced prior to operating the conveyor.
- Management failed to recognize the hazards associated with performing work near moving conveyor belts

- Stop, Look, Analyze, and Manage (SLAM) each task.
- Keep all guards securely in place except when testing or making adjustments which cannot be performed without the removal of the guard.
- Align conveyor belts from a safe location where the moving parts can't grab you.
- Clean up excessive spillage before repairing a conveyor belt.
