MNMM Fatal 2005-34

- Machinery
- November 18, 2005 (Tennessee)
- Crushed Stone Operation
- Plant Operator/Repairman
- 52 years old
- 33 years mining experience

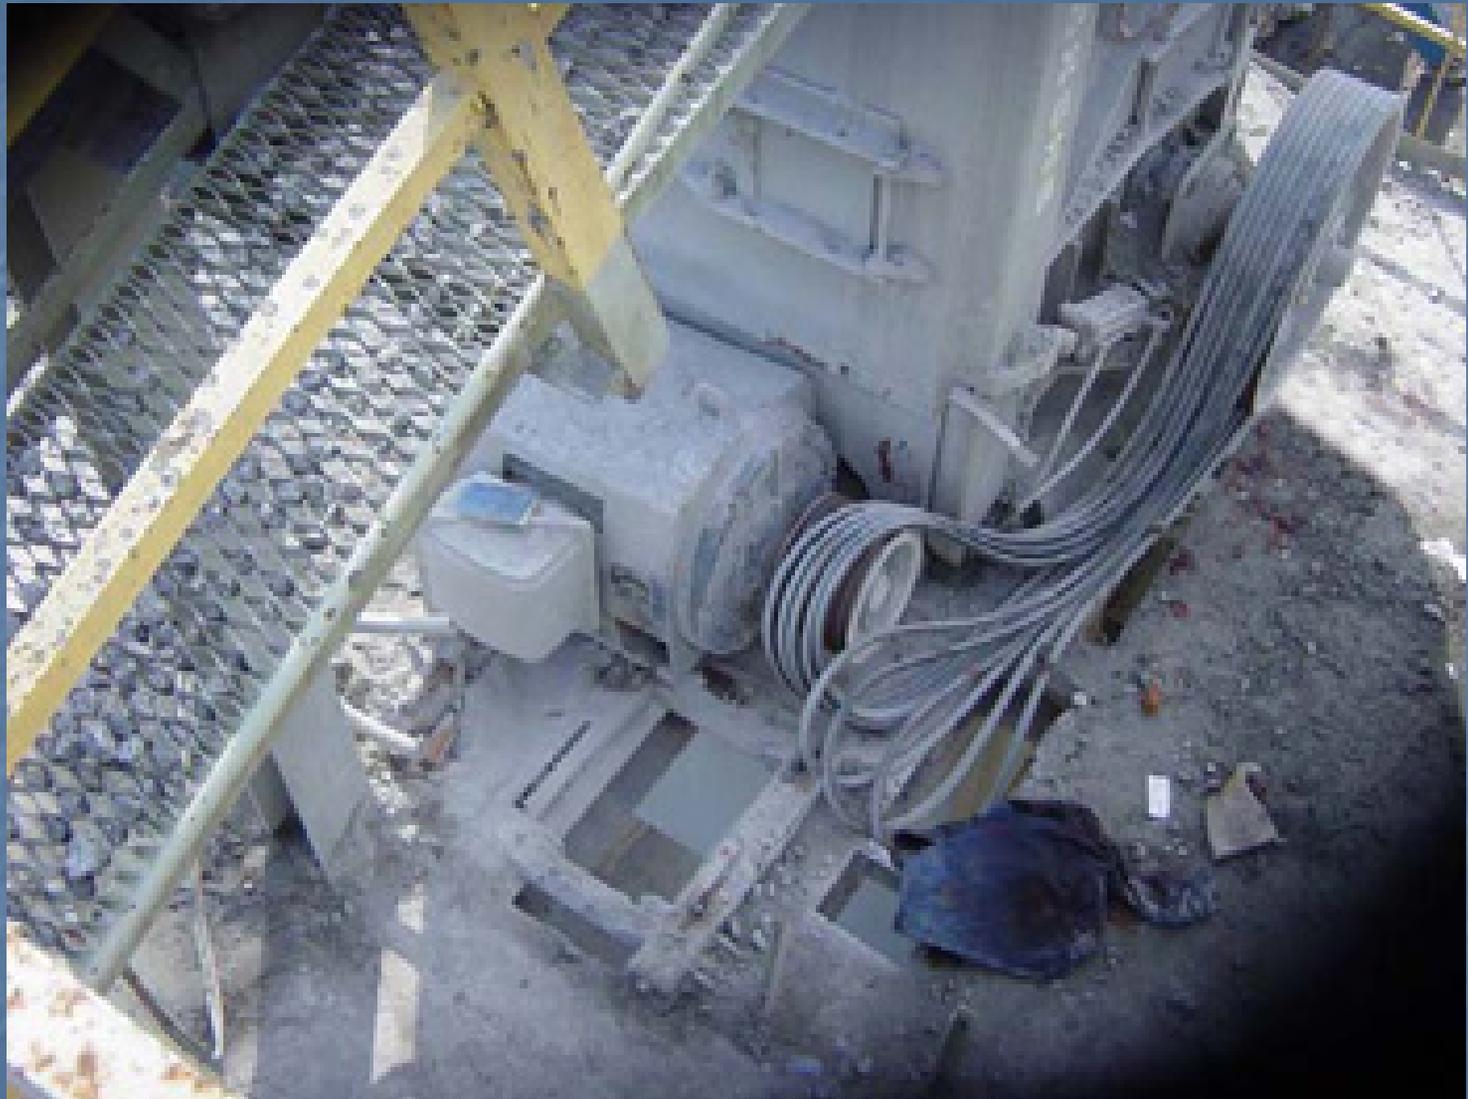
The victim was fatally injured when an electric motor suddenly moved as it was being lifted with a truck mounted mobile crane. He was standing between the motor and the crusher while a co-worker attempted to pry the motor off its mounting bolts.

- A risk assessment to determine all possible hazards and to establish safe work procedures was not conducted prior to attempting to lift the motor. No procedures were in place to ensure persons were clear of suspended loads. The motor was not being lifted in a manner that protected persons from the hazard of the suspended load.

- Standards and controls were inadequate and failed to ensure the crane was utilized properly. Instructions in the operator's manual were not followed prior to making the lift with the crane. The weight of the load being lifted was not within the manufacturer's specified lift capacity based on the angle and position of the boom.

- Stop, Look, Analyze, and Manage (SLAM) each task to identify all potential hazards. Practice safe work habits during the entire task.
- Disassemble all tensioned components to prevent a sudden release of energy before dismantling equipment.
- Position yourself only in areas where you will not be exposed to hazards resulting from a sudden release of energy.
- Train miners in safe work procedures and ensure they are familiar with manufacturer's recommendations before beginning repairs.
