Fatality #8 - April 4, 2005
Powered Haulage - WY - Trona
OCI Wyoming LP - Big Island Mine & Refinery

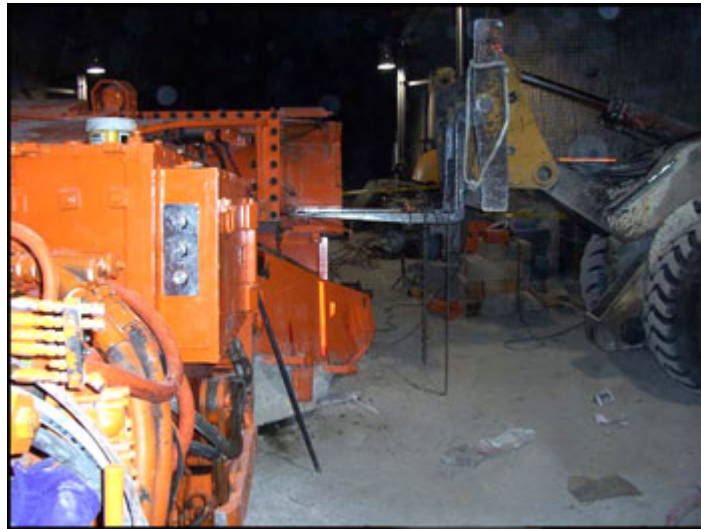
METAL/NONMETAL MINE FATALITY - On April 4, 2005, a 47-year-old mechanic, with 28 years mining experience, was fatally injured at an underground trona mine. A forklift was being used to position a motor that was being installed on a continuous miner. The forklift engine was shut off to facilitate communication. The service brakes failed; allowing the forklift to drift forward. The victim was pinned against the continuous miner.

- Ensure adequate pre-operational examinations are conducted on all self-propelled mobile equipment and defects affecting safety are promptly corrected.
- Before beginning a task, miners should discuss the work procedures, identify all possible hazards, and ensure steps are taken to safely perform the task.
- Ensure that all braking systems installed on mobile equipment are functioning properly with the engine operating and also when it is shut off.
- Always obtain Operator's Manuals and Service Manuals for all mobile equipment and ensure their use by mechanics and operators.
