REPORT OF INVESTIGATION

Fatal Roof Fall Accident  
March 31, 2005

Tiny Creek No. 2 Mine  
Coal River Mining, L.L.C.  
Alum Creek, Lincoln County, West Virginia  
I.D. No. 46-08835

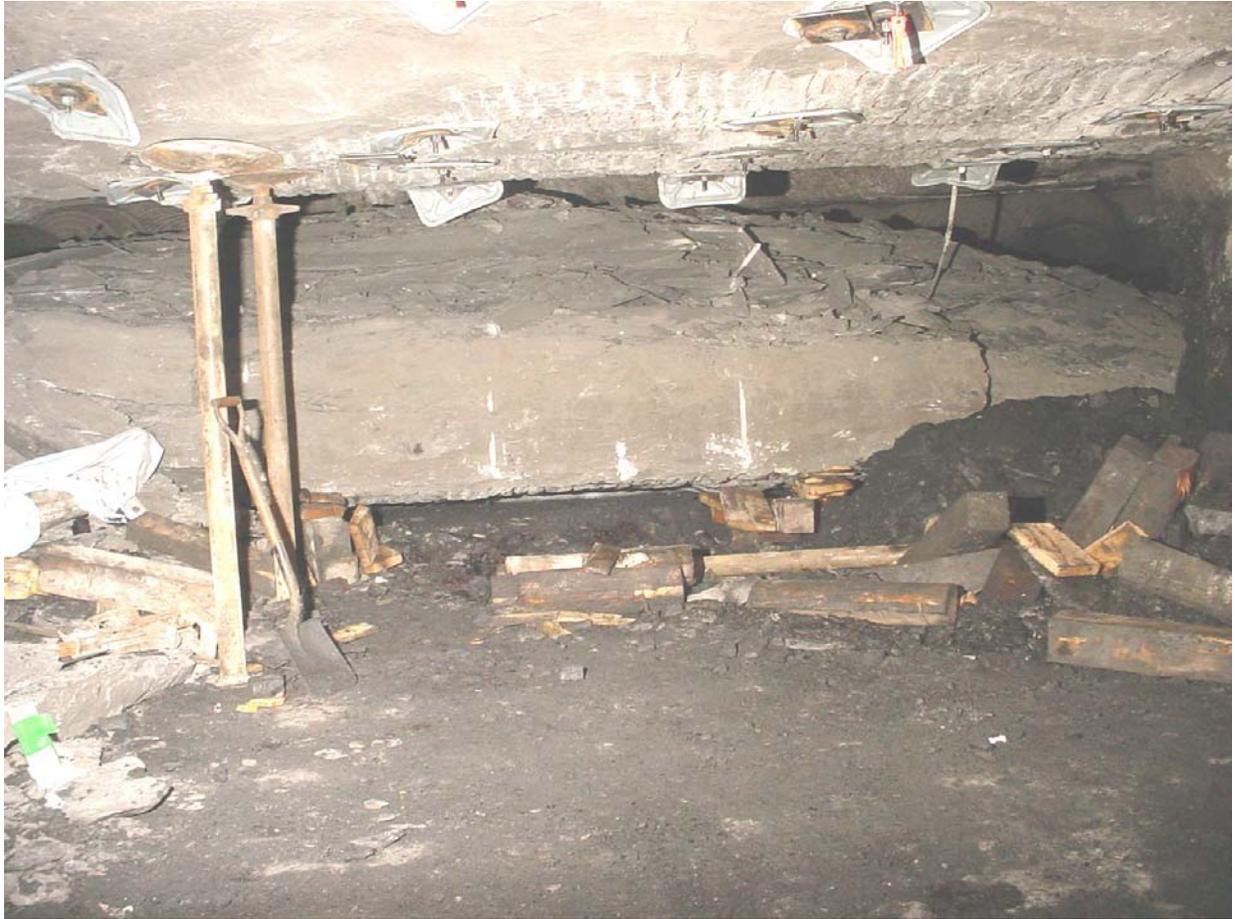
The roof fall was roughly centered in the number 6 entry intersection extending inby the crosscut rib line, 9 ft. into the left crosscut and along the outby rib of the right crosscut to the number 7 entry. Total length of the failure was approximately 68 feet. The fall cavity spanned the intersection and narrowed to about 5 feet in width in the right crosscut. Maximum height of the fall was estimated to be 7 feet in the number 6 entry.
