**COAL MINE SAFETY AND HEALTH
REPORT OF INVESTIGATION**

**Fatal Powered Haulage Accident
May 11, 2005**

**Shoemaker Mine
Consolidation Coal Company
Dallas, Marshall County, West Virginia
ID No. 46-01436**

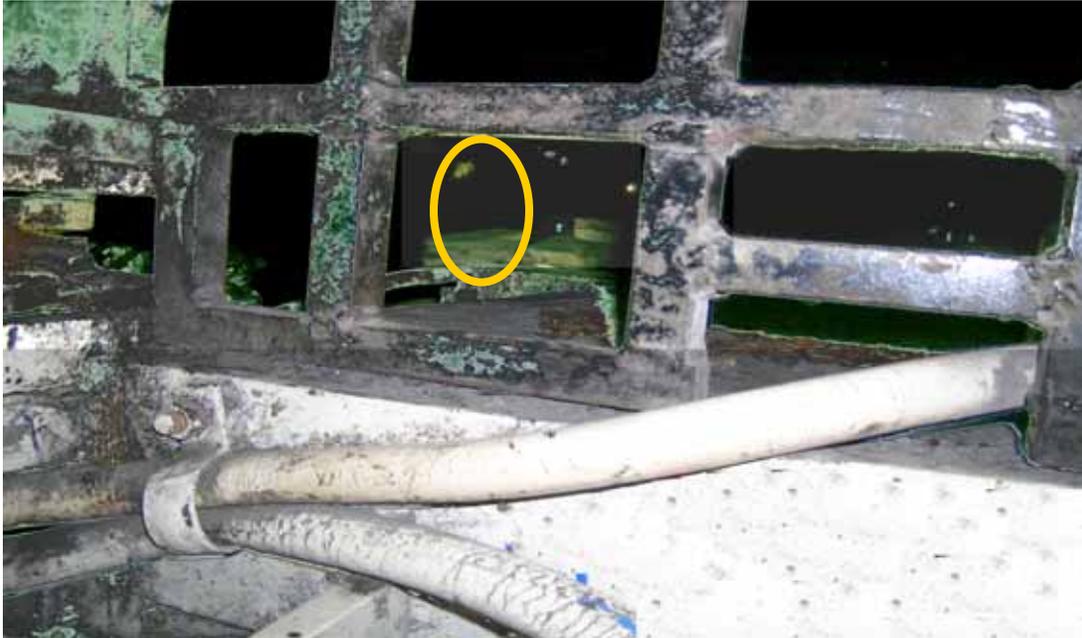
The photo above shows the view from the operator's compartment toward the victim's location. Only the cap lamp of an investigator, standing at the victim's location (indicated by the yellow ellipse), was clearly visible from this view.

Observations during this re-creation indicated that it would have been difficult to keep track of persons near the scoop.

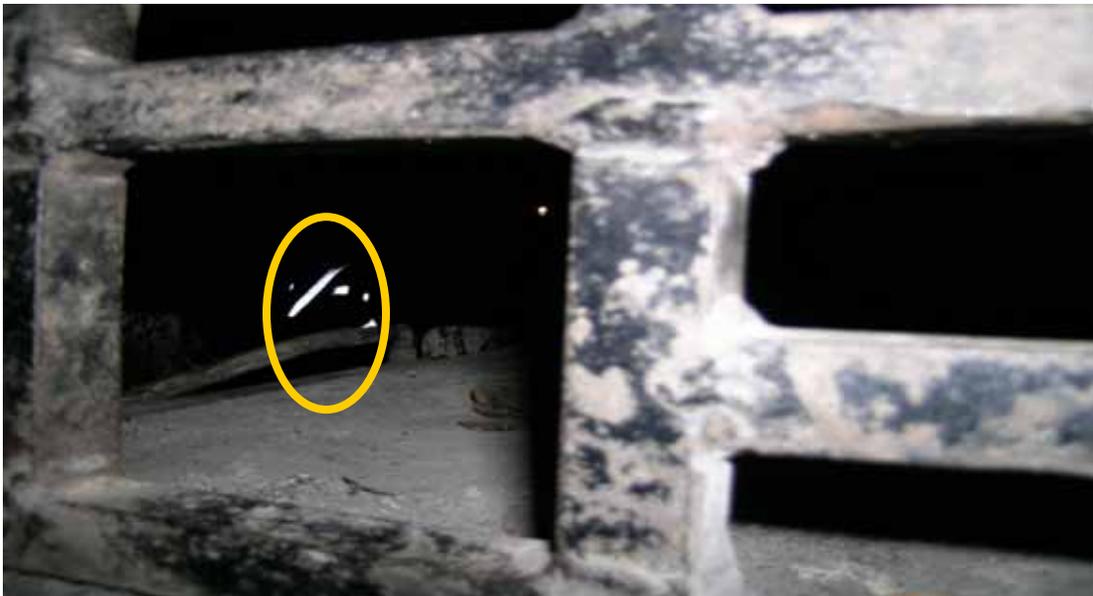
The photo above shows the same view from the operator's compartment toward the victim's location. In this case, the investigator standing at the victim's location wore reflective clothing (indicated by the yellow ellipse).
