REPORT OF INVESTIGATION

Fatal Fall of Roof Accident
June 10, 2005

Tracy Lynne
Rosebud Mining Co
Apollo, Armstrong County, Pennsylvania
ID No. 3608603

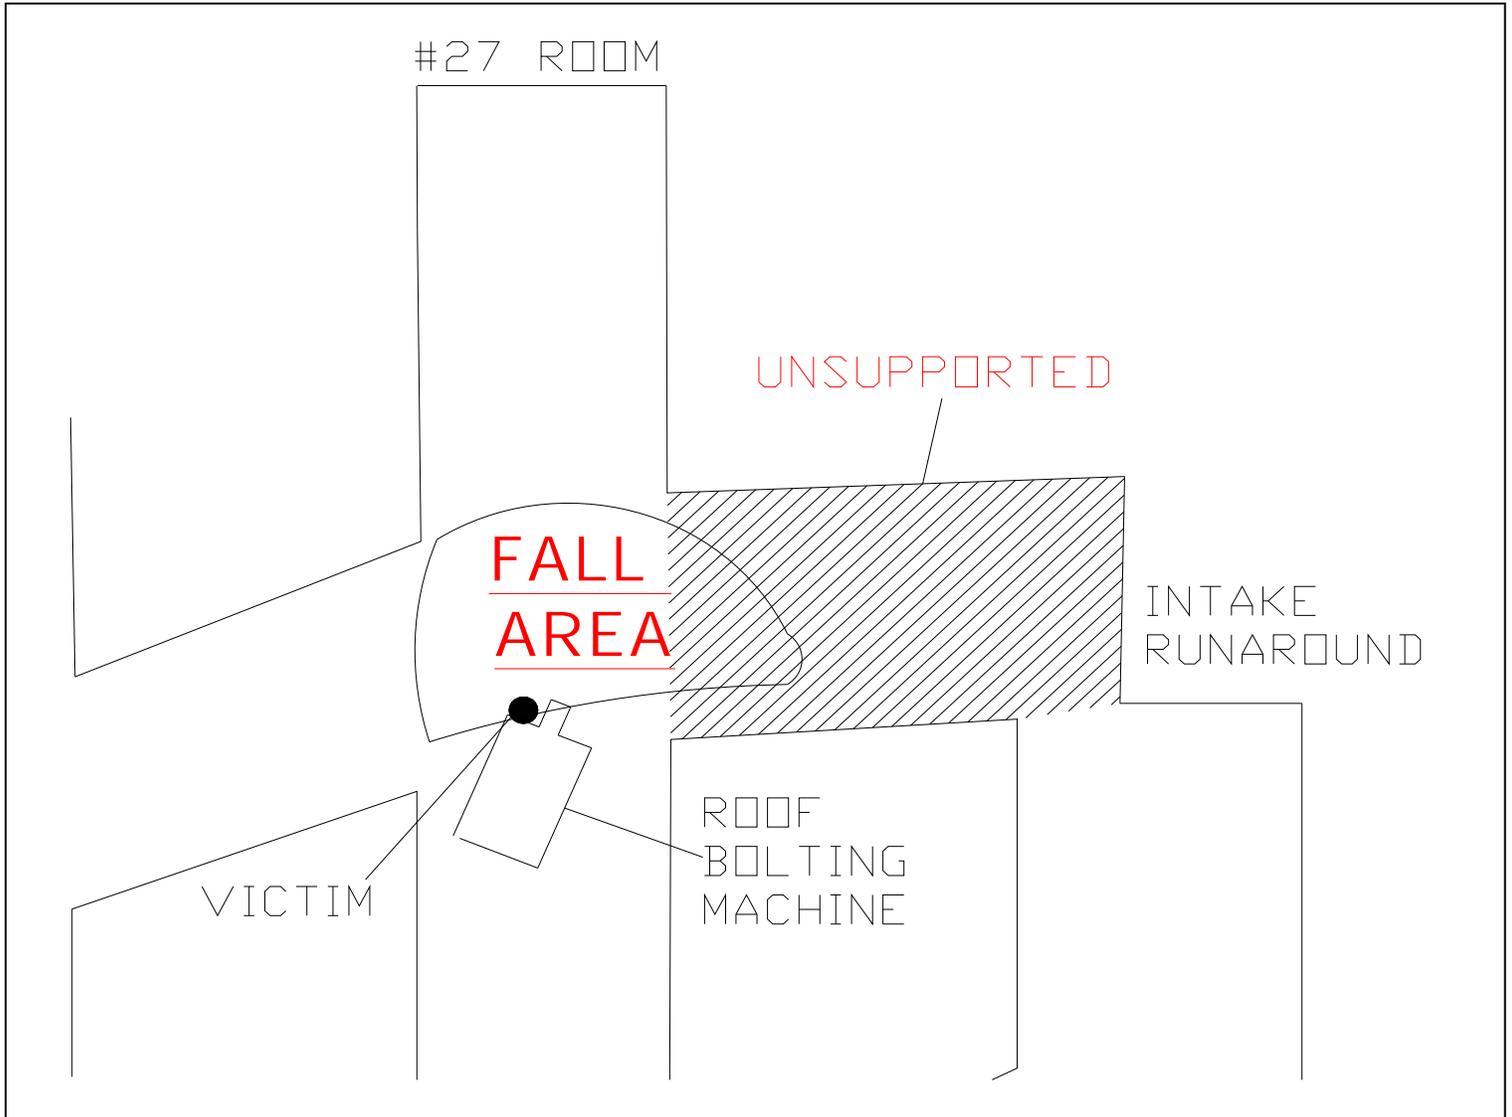
-ACCIDENT SITE

At approximately 5:50 p.m. on Friday, June 10, 2005, Boyd A. Beer Jr., a 26-year old roof bolter operator, with 14 months of mining experience, was fatally injured when a roof fall occurred in the No. 27 room intersection of the 3rd East Butt section. The accident occurred while the victim was installing 6-foot resin grouted roof bolts into the mine roof of the previously supported intersection. The mine roof in the intersection was originally supported with 36-inch resin grouted roof bolts. A visual roof defect (horseback) extended up and into the immediate roof strata for a distance of approximately five feet in depth.

through rooms 25-27. The 2nd slickenside zone represents a fault. Where the two zones intersect, a large wedge (commonly referred to as a horseback) was defined above the 27 room intersection. The roof fall cavity formed when the wedge dropped out of the roof.

The roof fall material fell out along a slickenside fault surface. The triangular-shaped wedge, bounded by the slickensides, was estimated to be approximately 26 feet in length, tapering from 15 feet to 13 feet in width, at the base, and tapering from five feet to less than one foot in height, along its length. The roof fall material, which consisted of recrystallized black shale, was estimated to weigh approximately 39 tons.

The single boom DBT LRB-15AR roof bolting machine involved in the accident was located on the outby side of the last intersection in the No. 27 room. It appeared only one side of the ATRS was under the area of the roof that fell due to the angle of the roof bolting machine. This caused the ATRS structure to be twisted and damaged.

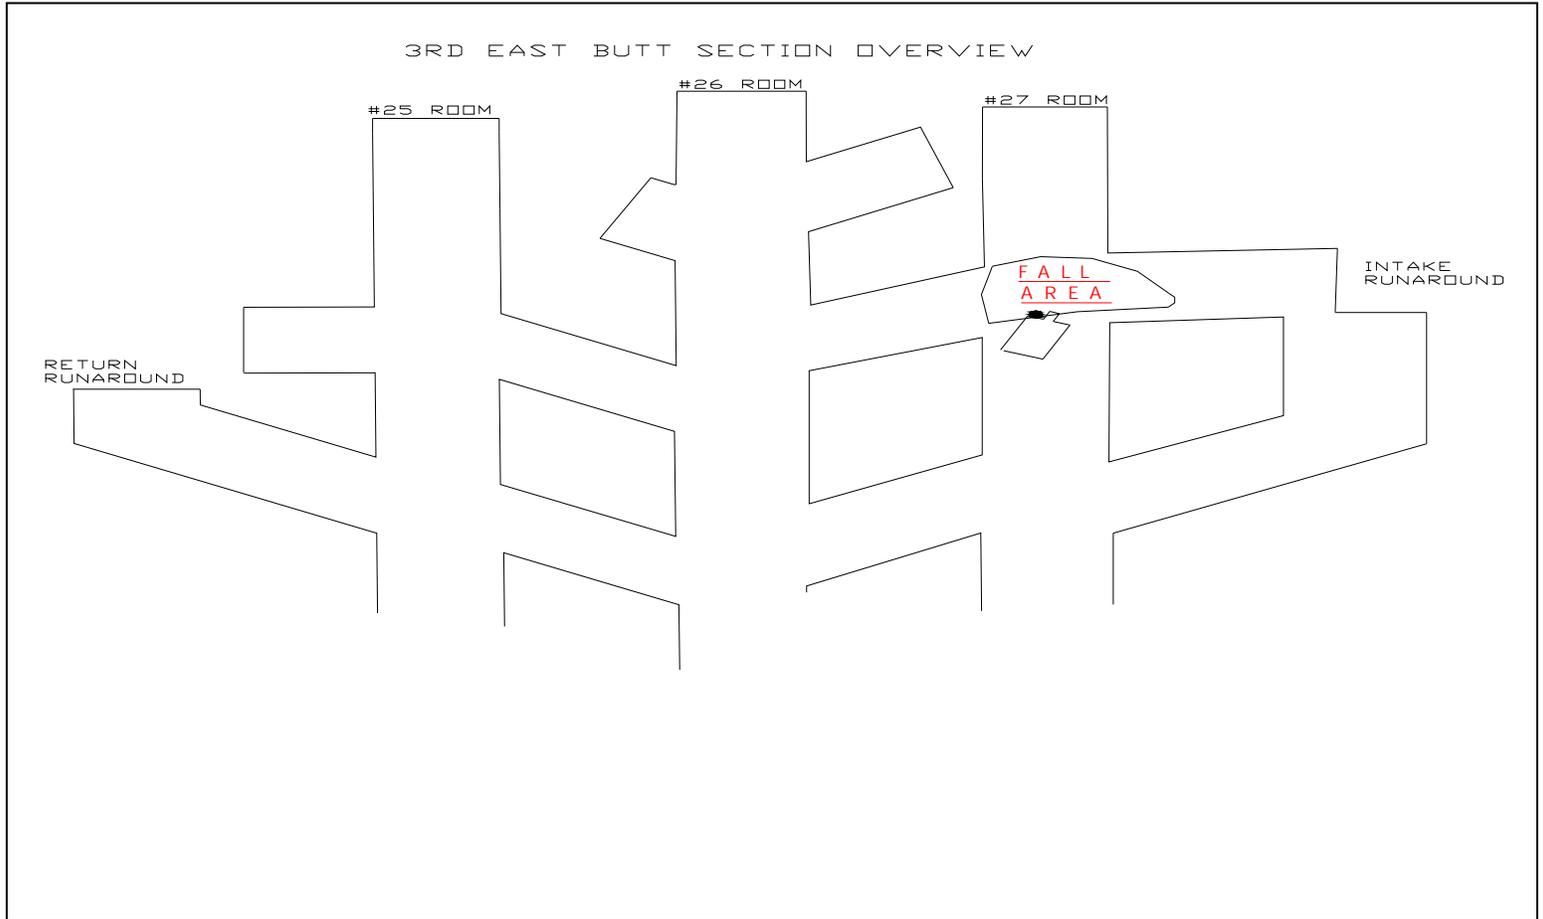
Appendix B
Overview of 3rd East Butt Section

The immediate roof generally consisted of gray shale ranging in thickness to 20 feet. However, as observed in the general vicinity of the accident site, the roof fall was sharply defined by two intersecting slickenside zones. The first slickenside zone represents a "drag fold" that was traced across the entire mining section, from the intake runaround,

Visual roof defects similar to the defect in the No. 27 Room were also observed in the Nos. 25 and 26 Rooms. These areas contained 42 and 72-inch roof bolts as supplemental support in addition to the normal 36-inch roof bolts installed throughout the section.
