AMENDED REPORT OF INVESTIGATION

**Fatal Electrical Accident
November 4, 2005**

**Mine #1
Enterprise Mining Company, LLC
Gordon, Letcher County, Kentucky
ID No. 15-18506**

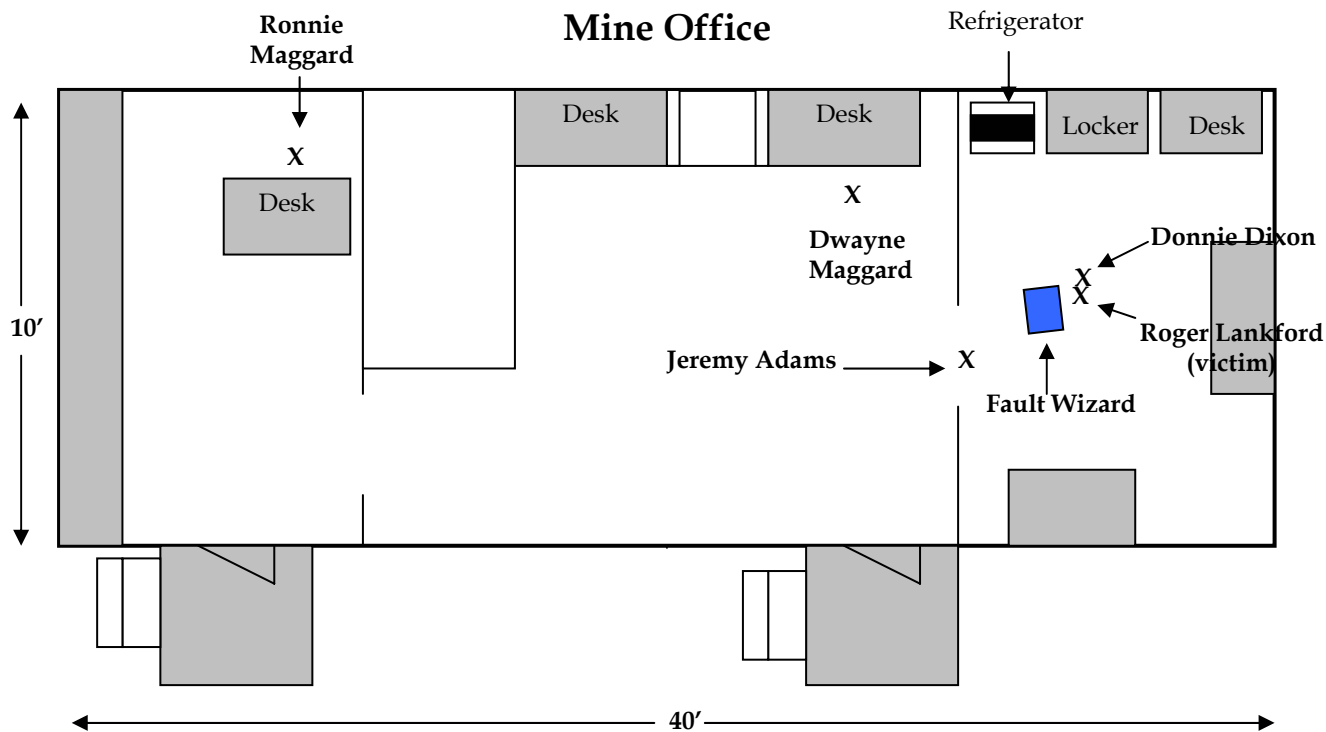
Sketch of Accident Scene
 Fatal Electrical Accident
 Mine # 1 (I.D. No.15-18506)
 Enterprise Mining Company, LLC
 Gordon, Letcher County, Kentucky
 November 4, 2005

At 4:30 p.m., Adams unlocked the door to the superintendent's office and entered the room, followed by Lankford and Dixon. Adams opened the cabinet located next to the desk and took measurements to determine whether or not the tester would fit in the cabinet. Lankford moved the tester from under the desk and measured it, concluding that it was too large to fit in the cabinet. Lankford said to Dixon "let's look at it". Lankford opened the lid on the tester and knelt directly in front of it. Dixon knelt beside of Lankford, on the left side of the unit.

The tester was not plugged into the electrical outlet in the office. The alligator clip for the grounding cord was lying on the left side of the lid and was unattached. The alligator clip for the black high-voltage output lead was attached to the metallic shorting bar, which was mounted in the lid of the unit.

The alligator clip for the red high-voltage output lead was located in the right side of the lid. (It is not clear whether or not the red alligator clip was attached to the shorting bar when the lid was first opened.)

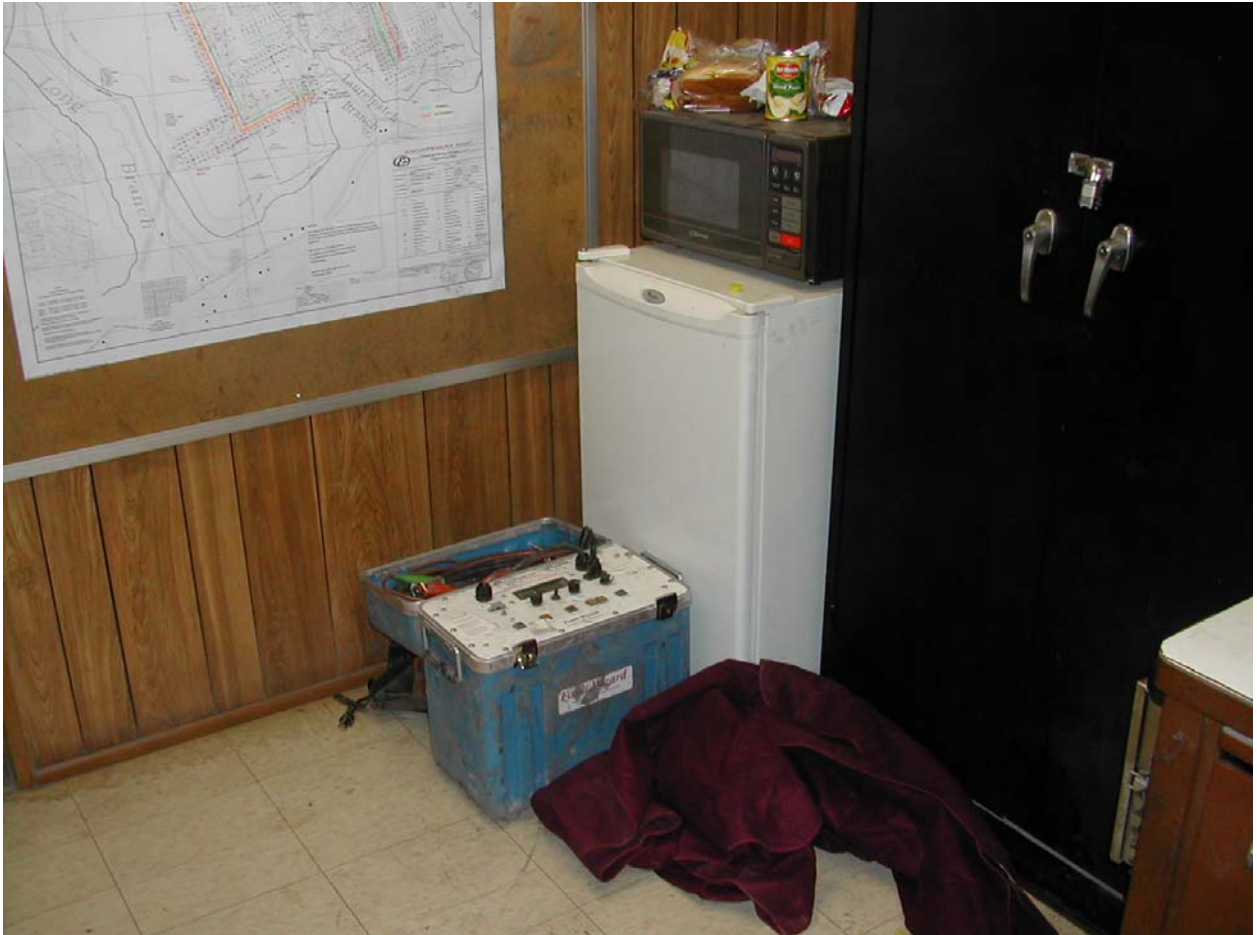
Photograph 1 - Accident Scene as Found by Investigators

When investigators first arrived at the scene of the accident, the controls and output leads of the tester were configured as follows:

- The main power switch was in the off position.
- The mode selector was in the “Cycle” position.
- The voltage control knob was adjusted to 10KV.
- The charging cord was not plugged into a 120-volt receptacle.

- The black output lead was attached to the shorting bar installed in the lid of the unit.
- The red output lead was unattached, lying in the left-hand side of the lid.
- The green grounding lead was unattached, lying in the left-hand side of the lid.

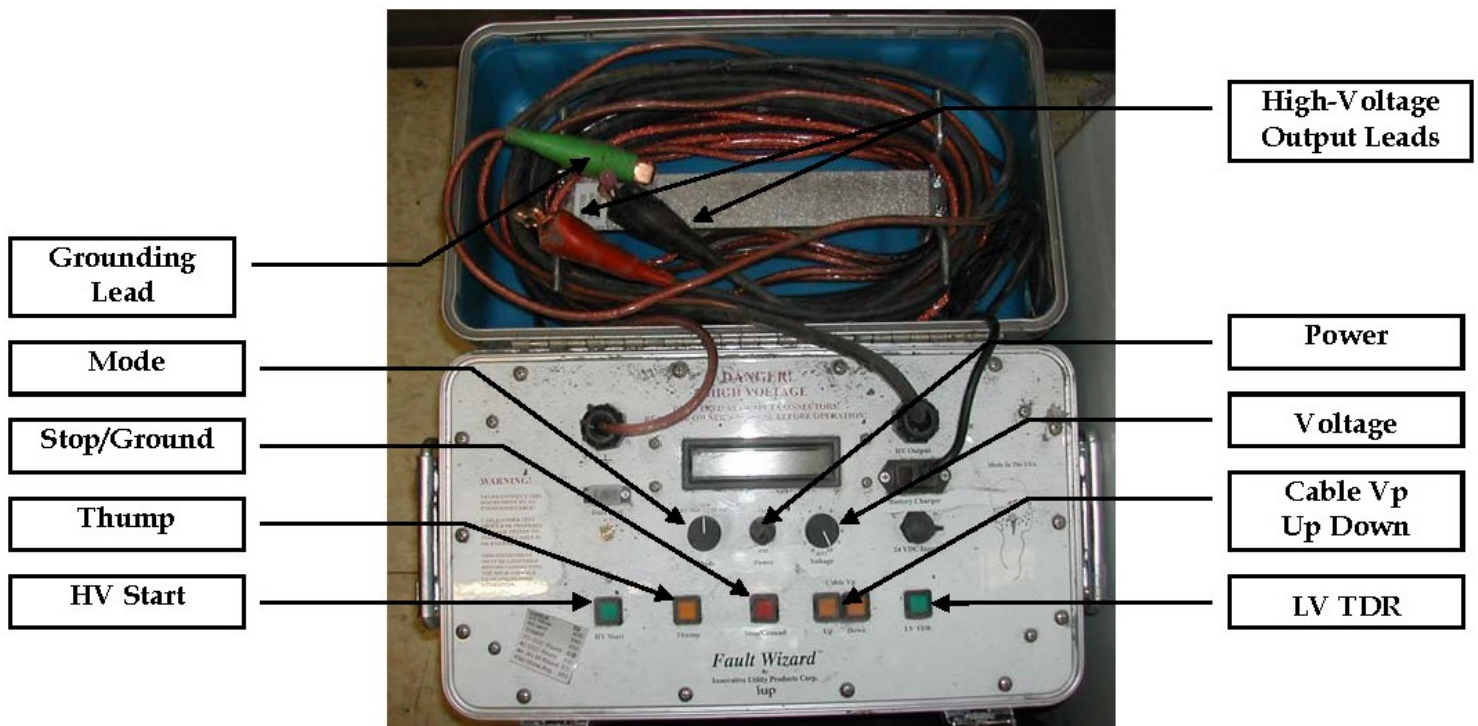
Photograph 2 - Tester Involved in the Accident

The tester involved in the accident was manufactured by Innovative Utility Products Corporation of Van Buren, Arkansas (see Appendix B, Photograph 2). This particular model of tester is currently used in the mining industry and in the power distribution (utility) industry. The model number of the unit involved in the accident was IUPFW1 and the serial number was FW0487. The manufacturer's published specifications for the tester are as follows:

The tester appeared to be undamaged and functional. A suspected burn mark was found on the exposed surface of the cable retention bracket and three of the case mounting screws showed signs of burning or melting consistent with electrical arcing. It could not be determined what caused these anomalous markings, or when they occurred.

The voltage decayed slowly, allowing significant energy to be available between the red test lead and the frame for an extended time. This energy was between

167 Joules (after 5 minutes) and 260 Joules (after approximately 30 seconds).

Corrective Actions: All of the electricians employed by the company received training, given by the manufacturer's representative, on the safe operation of the tester. The electricians were instructed that the use of high-voltage gloves is mandatory while operating the unit.
