REPORT OF INVESTIGATION

**Fatal Fall of Person Accident
December 9, 2005**

**Bodell Construction Company (YUD)
Salt Lake City, Utah**

**Bridger Underground Coal Mine
Pacific Minerals
Point of Rocks, Sweetwater County, Wyoming
ID No. 48-01646**

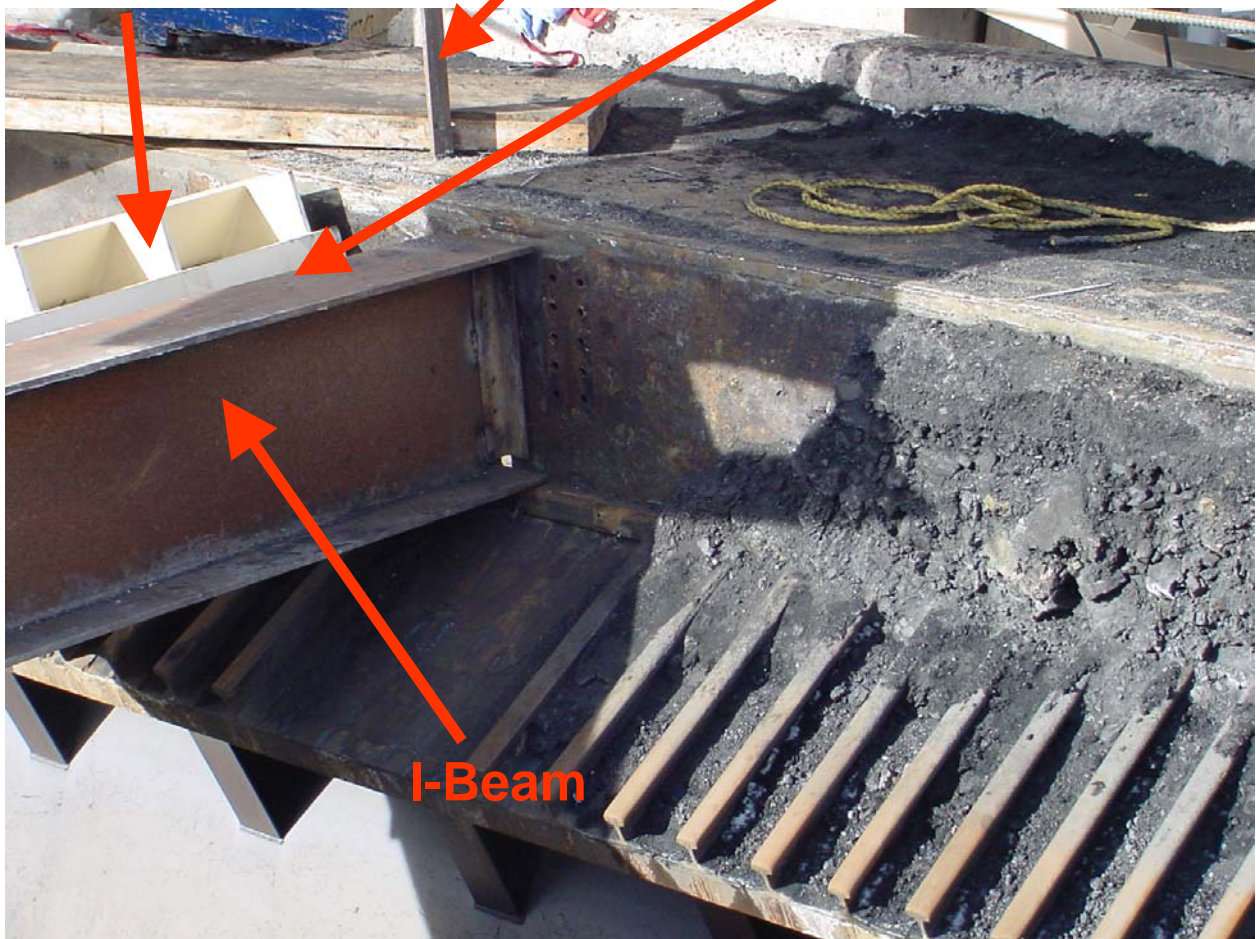
PICTURE OF ACCIDENT SITE AT TOP OF HOPPER

the I-beam with clips to hold it in place. During the accident, this white beam flipped off the I-beam and came to rest beside the I-beam, also spanning the top of the hopper.

**“White” Beam
toppled off I-Beam**

**Post of Handrail
Barrier**

**Oneida fell
from this area**

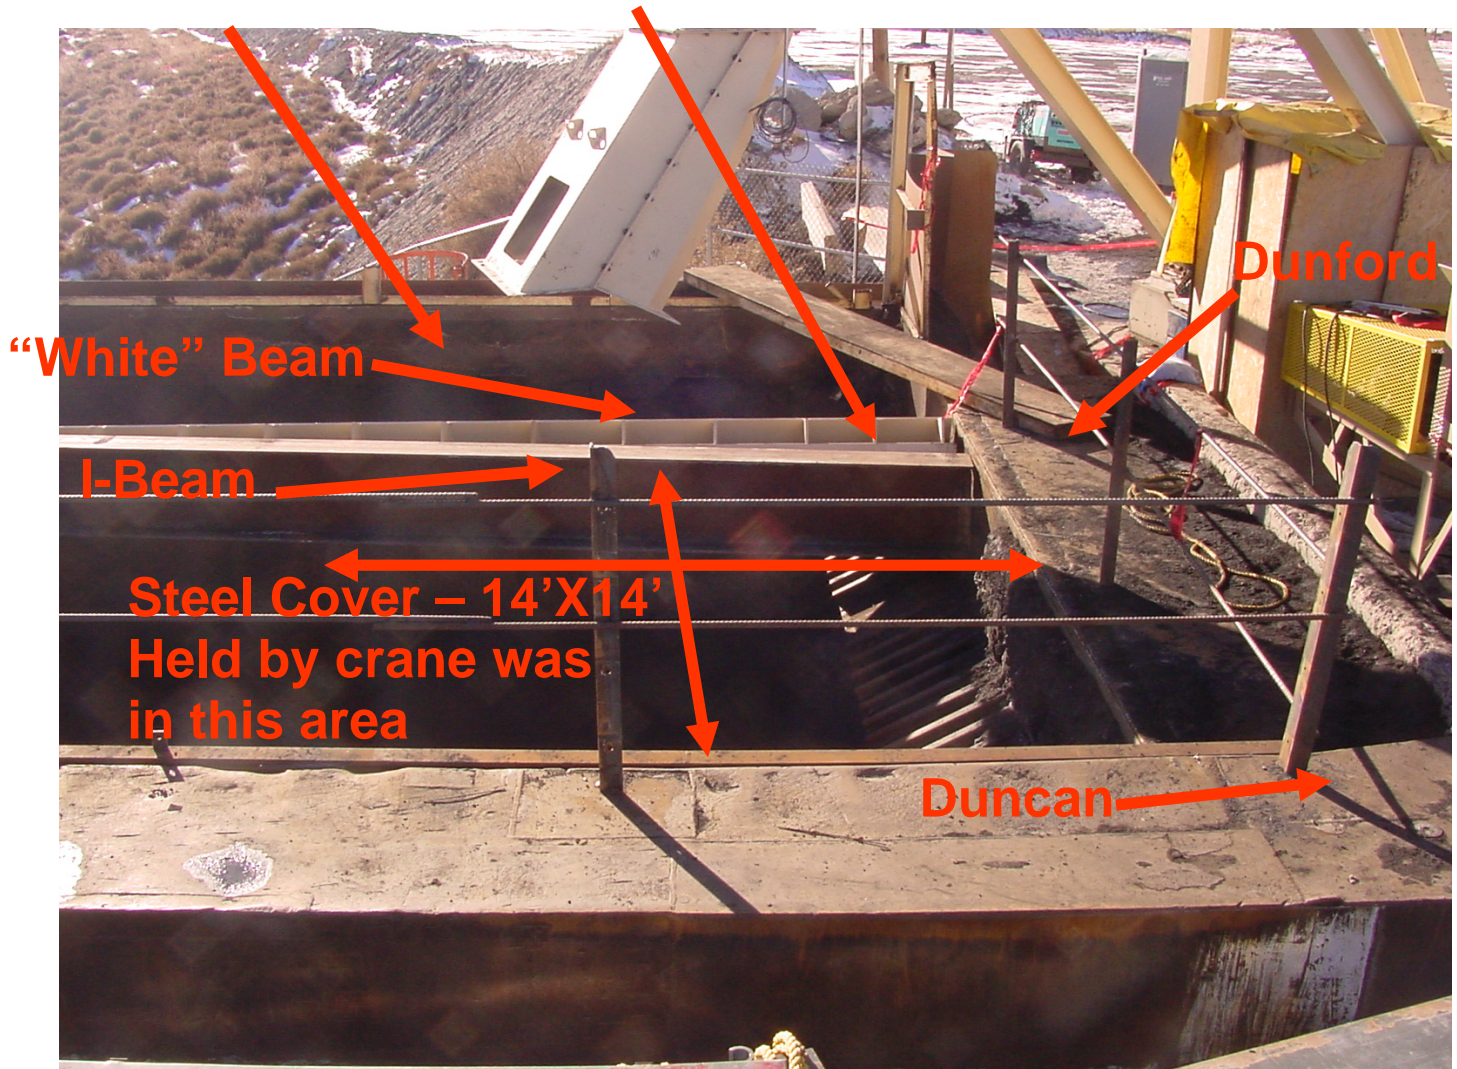
PICTURE OF ACCIDENT SITE – TOP OF HOPPER

Open Part
of Hopper Oneida Fell
From This Area

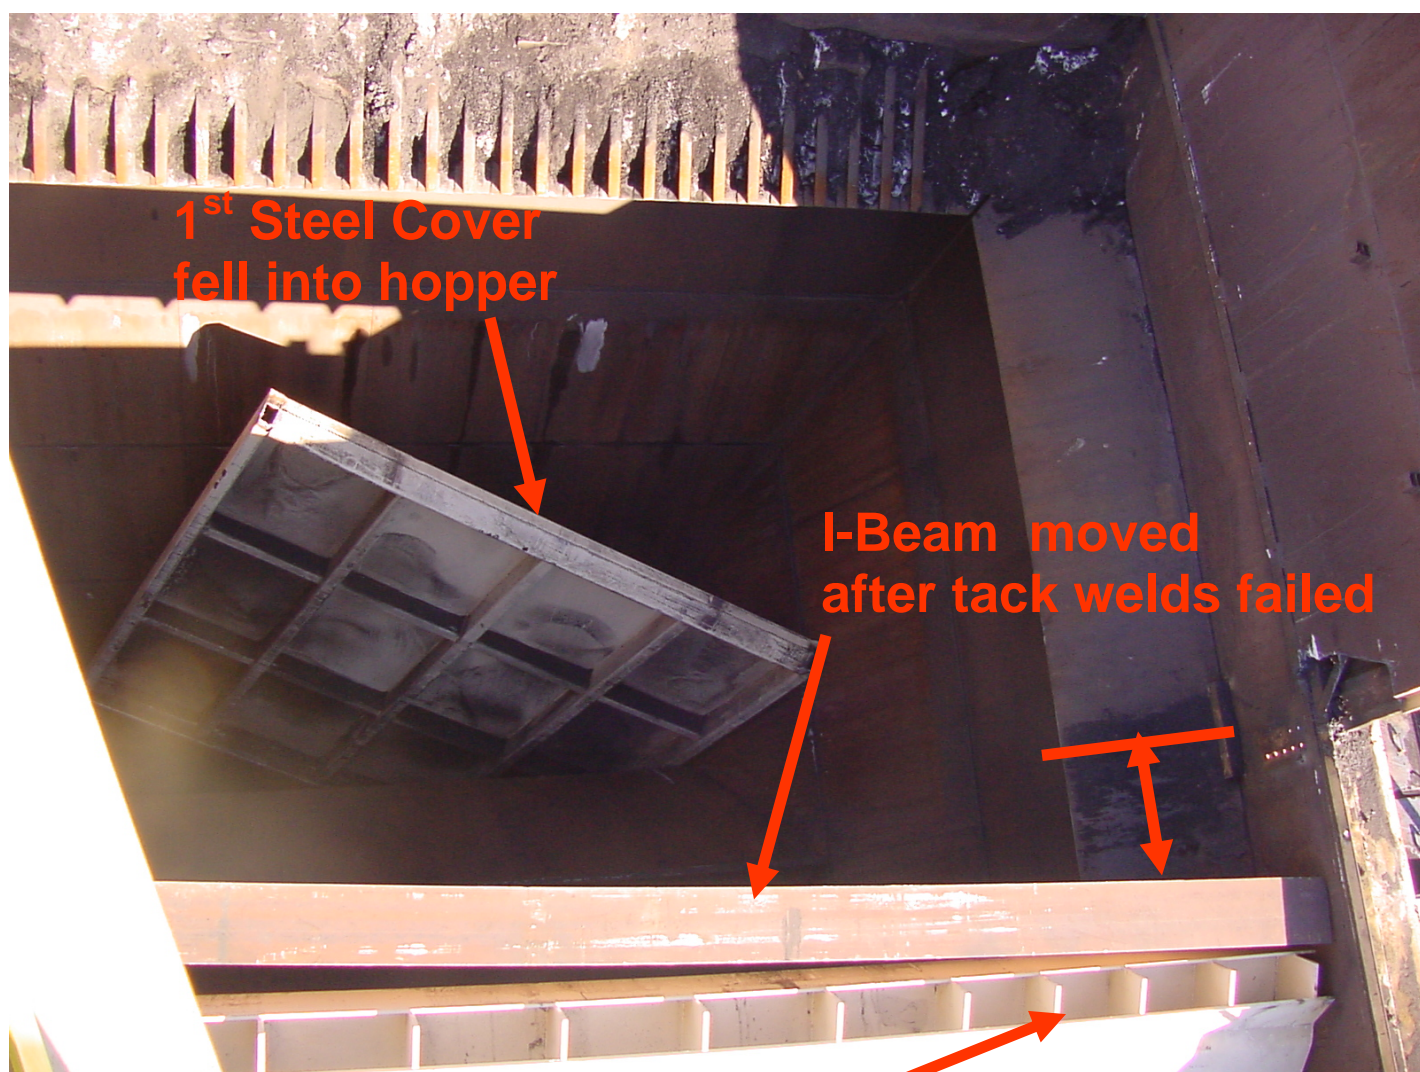
PICTURE OF FAR END OF HOPPER/I-BEAM SHOWING 1ST STEEL COVER IN HOPPER

2. Root Cause: Bodell management did not ensure that the loose beam fit-up procedures for installing the I- and white beams were followed. Failure of the tack welds on the south end of the I-beam allowed the beam to shift and the white beam to topple causing Oneida to fall.

White Beam toppled
off I-Beam

Corrective Action: More substantial welds could have been made or the procedures outlined on the hand-written construction drawing for a loose beam fit-up should have been followed.
