REPORT OF INVESTIGATION

Surface Nonmetal Mine
(Cement)
Fatal Machinery Accident
January 25, 2005

Artesia Quarry and Mill
Holcim (US), Incorporated
Artesia, Lowndes County, Mississippi
Mine I.D. No. 22-00313

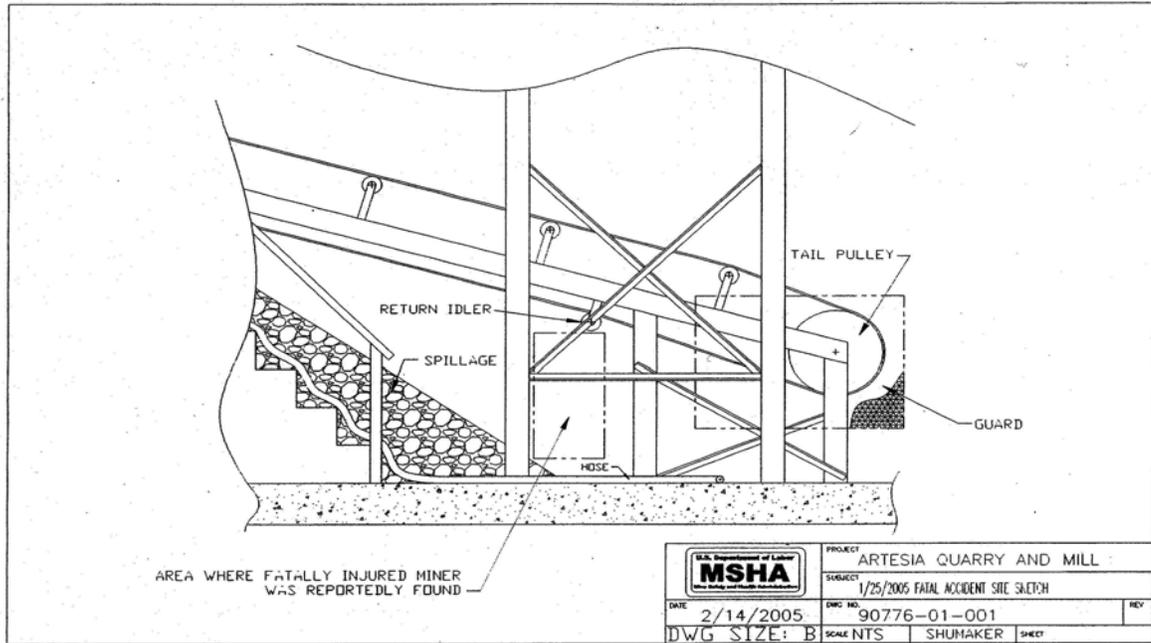
Figure No. 1

The return idler, which measured 44 inches long and 5 inches in diameter, was located about 5 1/2 feet from the tail pulley. The distance from the floor to the pinch-point created by the return idler was 44 1/2 inches. See figure No. 1.

Causal Factor: Operating procedures and controls were inadequate and failed to ensure that the examination of this work area identified all possible hazards. Inspections conducted in and around the primary crusher conveyor belt failed to identify possible exposure to the return idler. A guard had not been provided to protect miners from contacting the return idler on the primary crusher conveyor belt.

A fatal accident occurred at this operation on January 25, 2005, when an employee became entangled in a return idler of the basement tunnel conveyor. The idler was located about 42 inches above floor level. The employee was cleaning up spillage and pumping around the conveyor tail pulley area. A guard was not provided to protect persons from contacting the moving machine parts.

Corrective Action: Management should implement procedures to include recognition of all identifiable hazards. Policies should prohibit miners from performing work underneath operating conveyors.

This citation was terminated on February 18, 2005. The mine operator has installed a guard under the moving conveyor belt preventing access under the conveyor belt.
