REPORT OF INVESTIGATION

Surface Nonmetal Mine
(Limestone CB)

Fatal Sliding Material Accident

Grassy Stone LLC
Grassy Stone LLC
Grayson, Carter County, Kentucky
Mine ID No. 15-17312

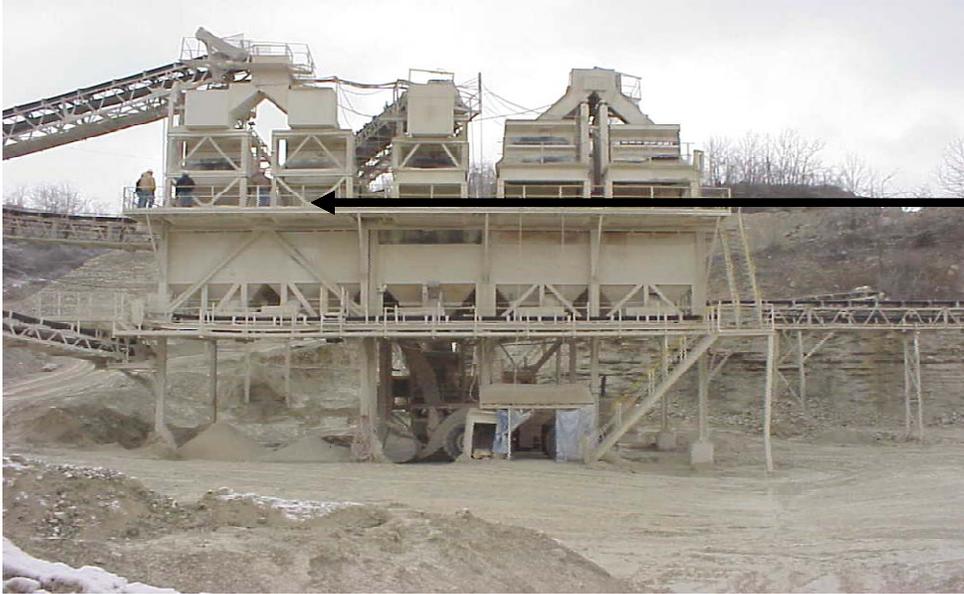
Figure 1 General Overview of Storage bins

**Victim
entered here**

There were no drawings of the bins and it could not be determined when the bins were installed. The general layout of the # 2 Dust Bin is shown in Figure 1. The accident occurred in the # 2 Dust Bin, one of five bins located side-by-side on the southeast side of the plant. At the time of the accident, these bins were used to store material that had passed through the plant. There was no evidence that indicated whether the victim lost his balance, whether material on which he was standing gave way, or how he was engulfed inside the bin. There were no eye witnesses to the accident.

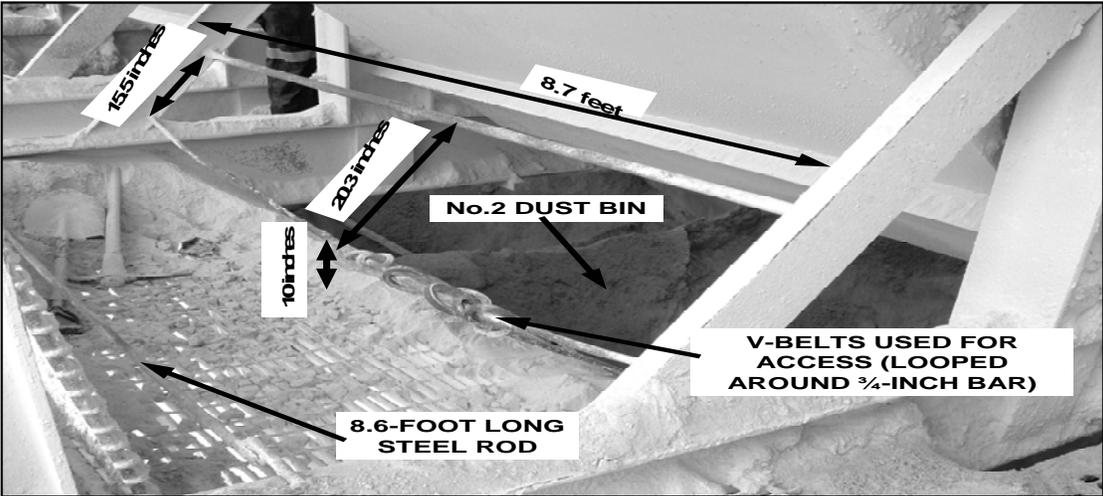
Figure 2 No. 2 Dust Bin Access

At the time of the accident, there were six V-belts hanging in the # 2 Dust Bin (Figure 2 and 3). Three V-belts were hanging from a 3/4-inch bar located above the top edge of the bin. Two of the belts had a second belt looped on them, forming a belt of double length. The single belt extended about 4 feet from the bar. One of the double belts extended about 7.5 feet down from the bar and the other doubled belt was embedded in the bin material. Another belt was looped over one of the cross braces inside the bin. Given the cross brace location and the length of the belt, the end of this belt was located about 7 feet above the bottom of the bin.

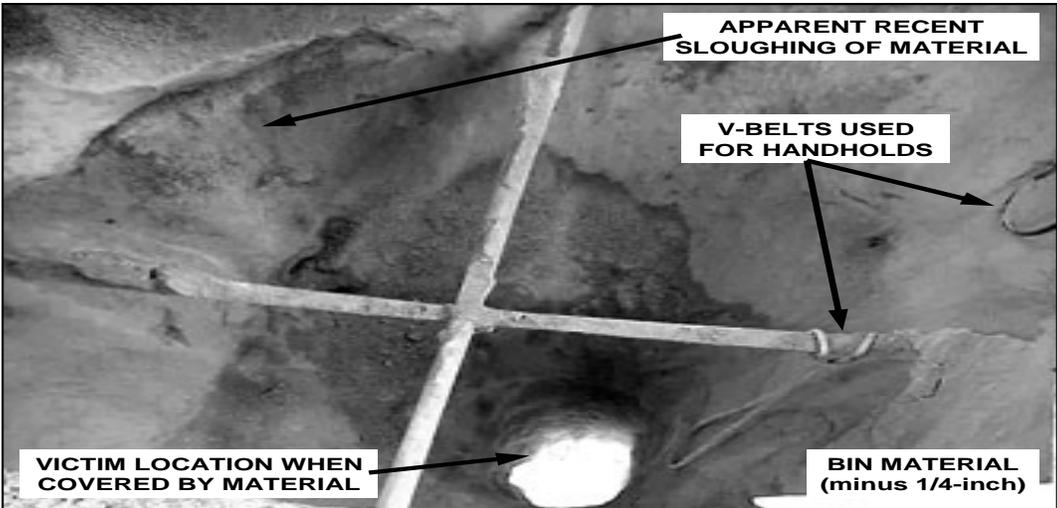
Figure 3 (View Looking Down into Bin)

Illumination at the bins was provided by a fixed 1000-watt metal-halide lamp located on the conveyor to the fines material stockpile, about 90 feet from the # 2 Dust Bin. A large amount of material was caked on the sides of the bin. Evidence was visible inside the bin indicating a section of the caked material had recently sloughed off. A "pie-shaped" section of material was estimated to be 6 feet long on one side and 8 feet along the top. The thickness of the section varied from about 8 inches along the top to a thin layer near the center of the bin. The wedge material weighed approximately 800 pounds. Conditions inside the # 2 Dust Bin following the accident are shown in Figure 3.

Material had adhered to the sides of the # 2 Dust Bin. The material thickened toward the bottom of the bin to a narrow, nearly cylindrical opening. See Figure 3. The opening extended through the caked material to the bottom bin door. Material in the bin appeared to have a significant percentage of fines, that is, material passing through a No. 200 sieve. A dry gradation check of a sample of material, obtained from a pile of material on the ground underneath the #2 Dust Bin, indicated the content of fines was about 25%. This made the material prone to "caking," especially when it absorbed moisture, which also inhibited the free flow of the material.
