REPORT OF INVESTIGATION

**Surface of an Underground Nonmetal Mine
(Limestone)**

Fatal Machinery Accident

**Kimballton Plant #1
Chemical Lime Company of VA, Inc
Ripplemead, Giles County, Virginia
Mine I.D. No. 44-00082**

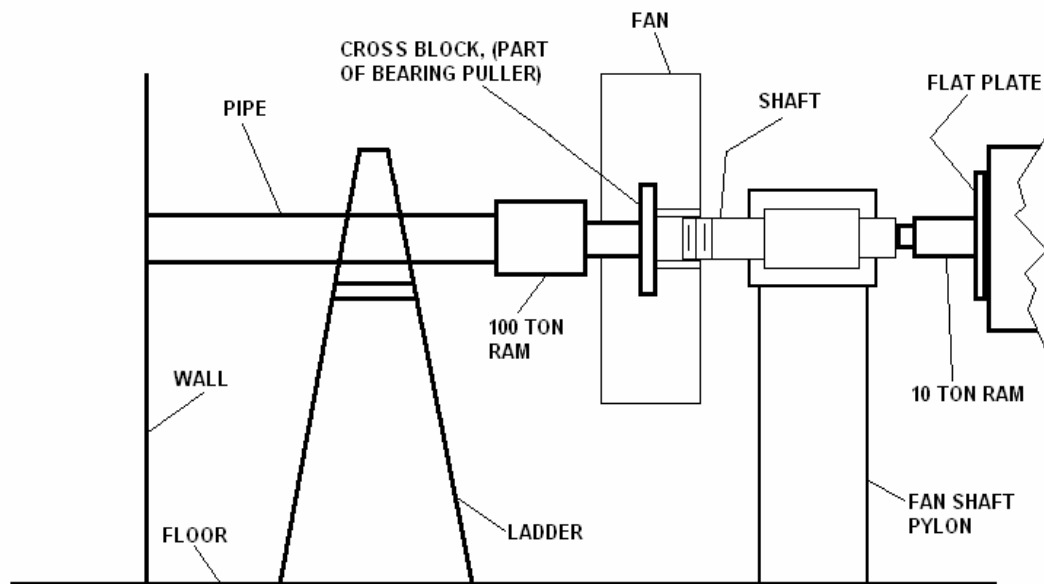
First Press Setup of Fan

The arrangement of the supports of the first press attempts were a piece of steel bar stock placed against the concrete wall to provide a flat surface over the chipped area; a piece of saw cut, schedule 80 steel pipe, temporarily supported by a step ladder; the ram unit with the body against the pipe end, and a cross block from a bearing puller. A 10-ton ram, supported by a steel plate against the mill structure, was also used to support the shaft and bearings to help prevent the damage of the newly installed shaft bearings. The arrangement would only permit the fan to be installed to the point where the cross block would make contact with the end of the fan shaft.

The conditions of the components used to install the fan were visually inspected. The bar stock used between the concrete wall and the pipe; the pipe, and the steel plate used to support the 10 ton ram, were all bent and deformed indicating that a large load was imposed during the fan installation attempts. Reportedly,

Based on design calculations performed according to the American Institute of Steel Construction, AISC Manual of Steel Construction, Load and Resistance Factor Design, the subject pipe involved in the accident has an approximate design compression strength limit of 60 tons. The 100-ton ram was capable of producing a force in excess of the 60 ton capacity of the subject pipe.

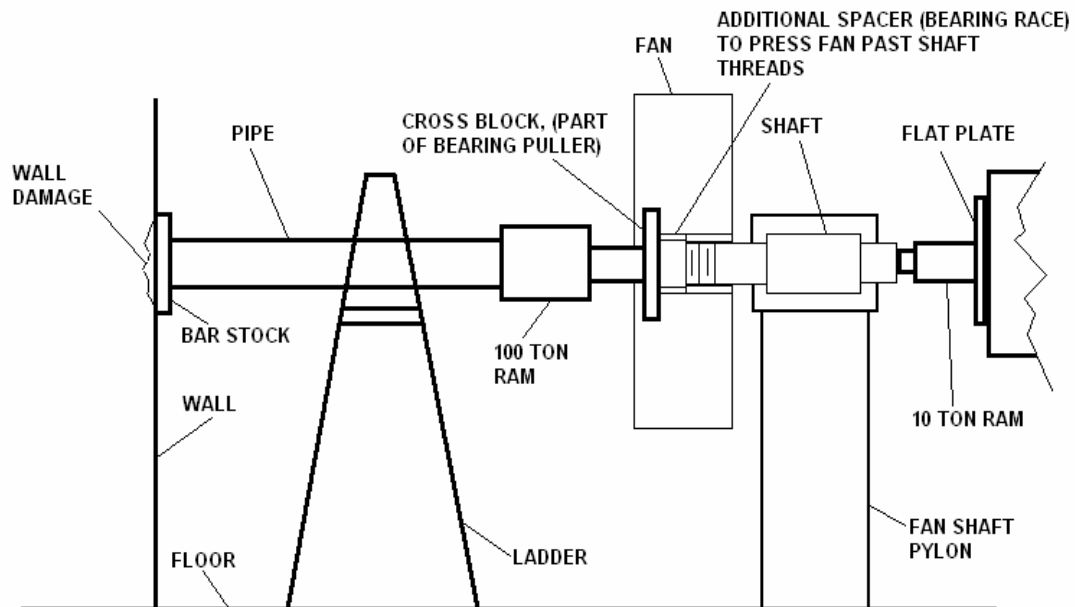
Second Press Setup of Fan

The arrangement of the supports of the later press attempts was the same as the first attempts with the addition of an inner bearing race from a discarded bearing assembly.

After multiple attempts to install the fan completely, a maintenance worker noticed that the fan hub was not fully seated against the shoulder on the shaft. A final attempt to fully seat the fan using the second set-up resulted with the arrangement becoming dislodged.

The accident was caused by the failure to evaluate the work procedures, identify all possible hazards, and establish safe procedures to install the fan housing. The steel pipe was used beyond the designed capacity intended because the force applied bent the pipe, causing it to kick out. The use of the pipe to support the amount of force the hydraulic ram exerted on it was not within the pipe's designed capacity.

Corrective Action: Conduct a thorough risk assessment before starting a task to ensure that all hazards are evaluated and eliminated. Management should develop and implement procedures that ensure repairs to the coal mill do not expose miners to hazards.

Corrective Action: Develop and implement a standard procedure that uses the safety features recommended by the manufacturer to ensure the equipment is properly blocked, secured, and utilized.

This citation was terminated on April 25, 2005. The mine operator has submitted a plan to MSHA stating that a pipe will no longer be used as a spacer to push the fan assembly back onto the shaft and that a stable base will be used on all future applications when performing this task.
