REPORT OF INVESTIGATION

Surface Nonmetal Mine
(Sand and Gravel)
Fatal Powered Haulage Accident
April 4, 2005

Darrel Volker Construction
Darrel Volker Construction
Auburn, Nemaha County, Nebraska
Mine I.D. No. 25-01224

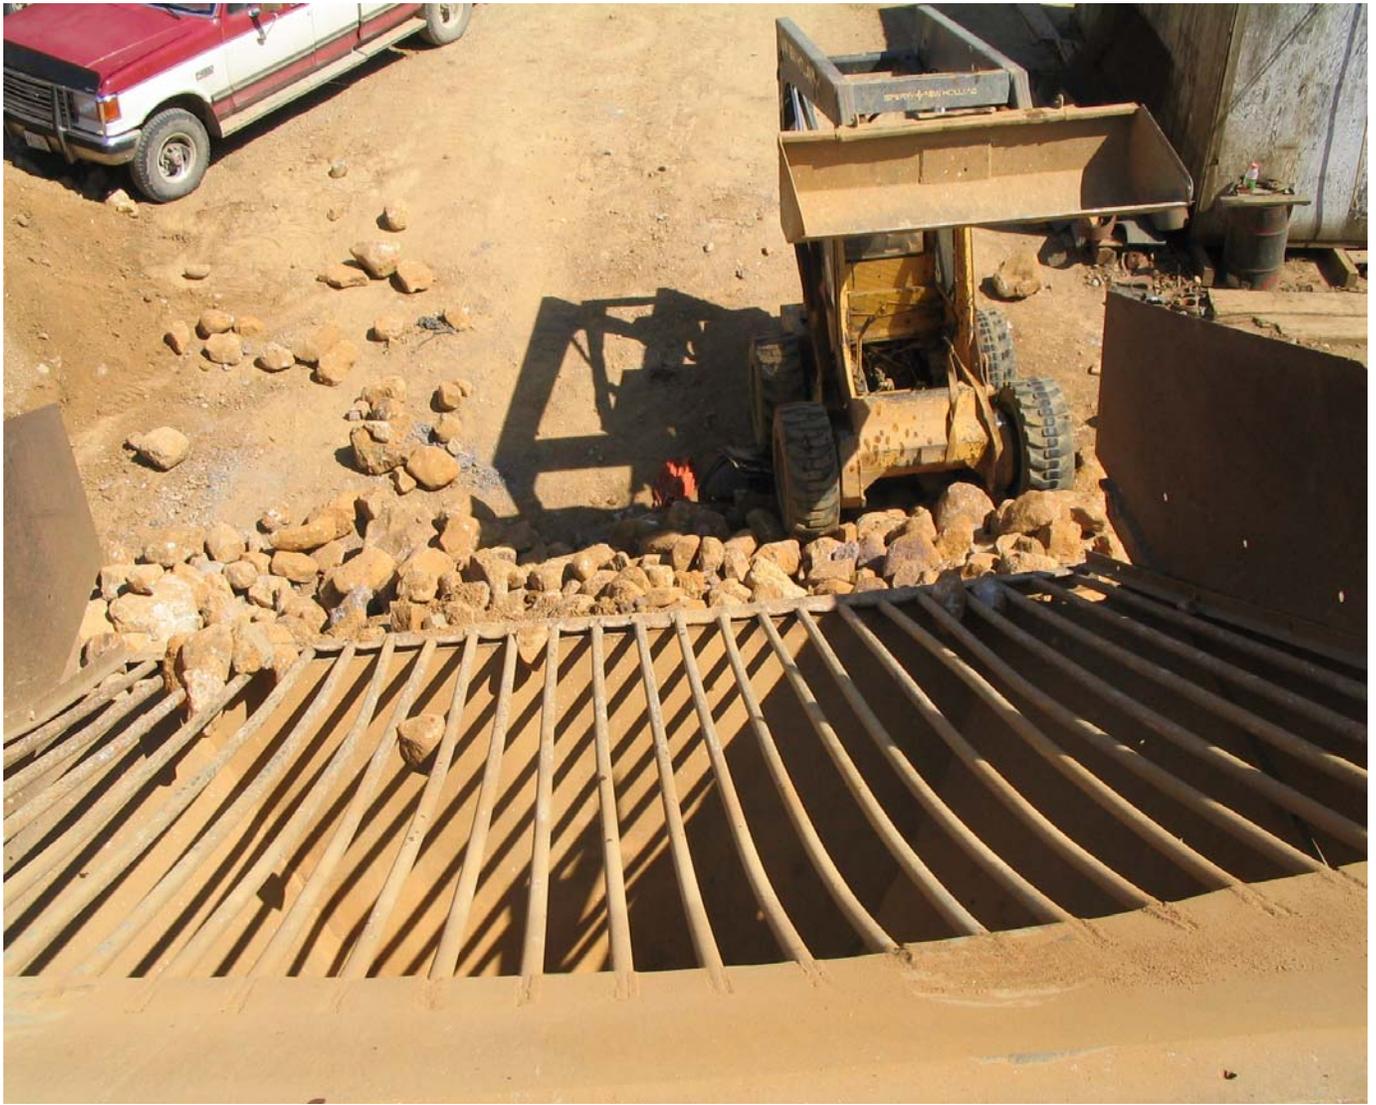
**Darrel Volker Construction
25-01224
Accident Site**

The accident occurred at the dump location for the plant grizzly. The dump location consisted of a steel bin. The grizzly, constructed of steel, was 11 feet 5 inches wide by 12 feet 2 inches long, and was positioned at a grade of 80 percent. The front edge of the grizzly extended upward 15 inches from the ground at the end of the ramp and served as the bumper block at this dump location. The top of the grizzly was 16 feet, 8 inches above the ground.
