REPORT OF INVESTIGATION

**Fatal Electrical Accident
May 23, 2005**

**Placer Turquoise Ridge, Inc.
Turquoise Ridge Mine
Golconda, Humboldt County, Nevada
Mine ID No. 26-02286**

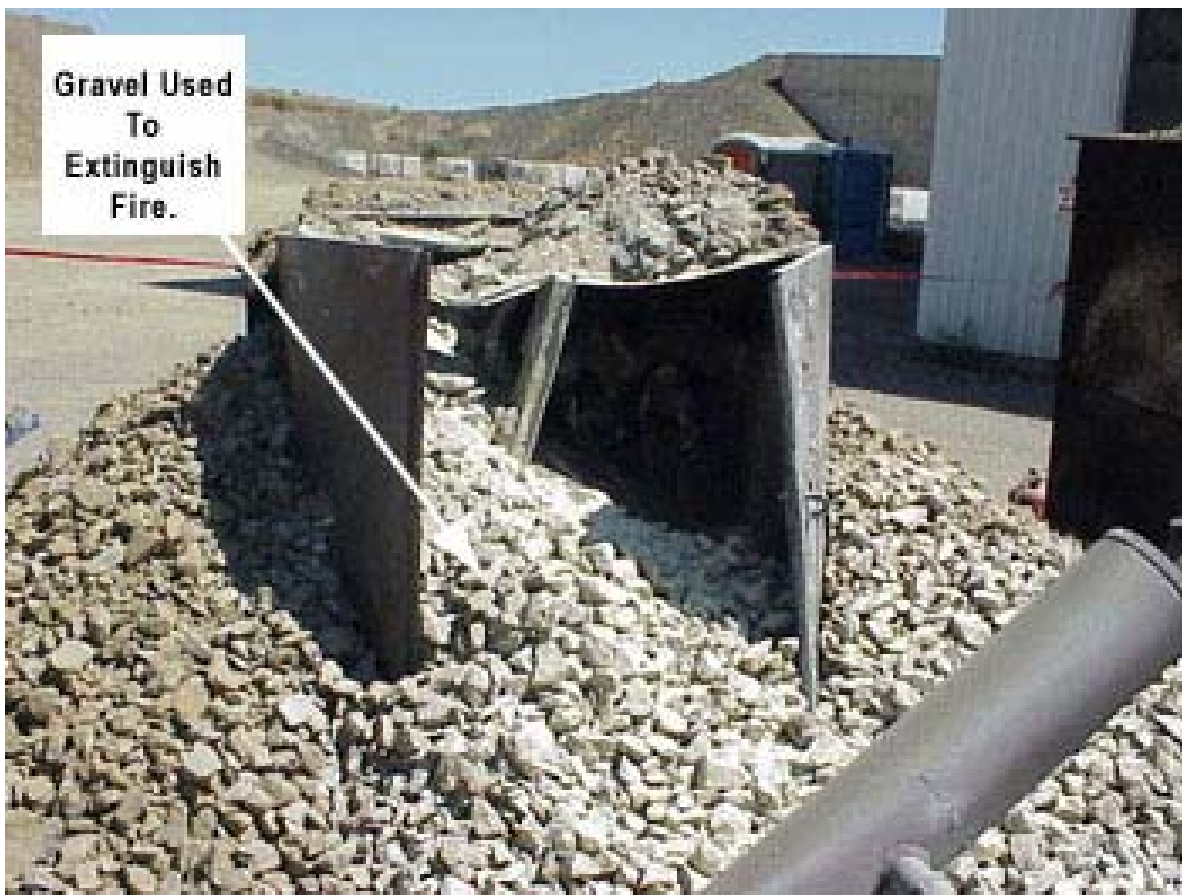
Gravel Used
To
Extinguish
Fire.
