REPORT OF INVESTIGATION

Underground Nonmetal Mine
(Limestone)

Fatal Powered Haulage Accident
May 31, 2005

The Allen Company, Incorporated
Boonesboro Quarry
Richmond, Madison County, Kentucky
Mine ID No. 15-00006

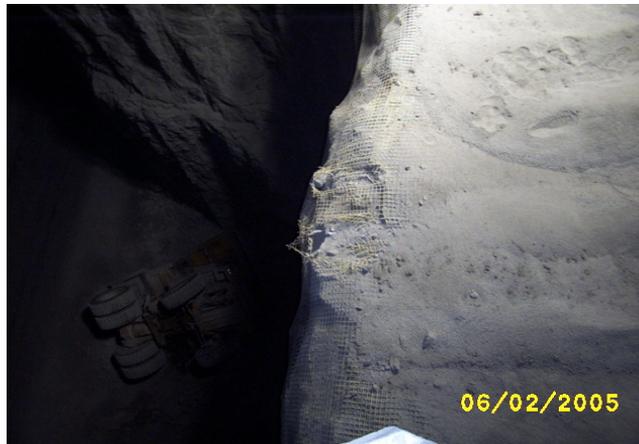
Aerial view of truck's tracks going over the berm

The number 27 crosscut was 45 feet wide. The berm was constructed from fines material and was approximately 10 feet wide at the base, 36 inches high, and extended across the crosscut. There was a scrape mark on the pillar rib 21 feet, extending to the crosscut opening, on the same side of the road as the berm. The scrape mark was eight feet from the bottom and was five feet long. The truck catwalk was eight feet from ground level and was damaged horizontally. The tire tracks through the berm were perpendicular to it and in the center of the crosscut. There were no skid marks through the berming material. The posted speed limit in this area was 15 miles per hour (mph).

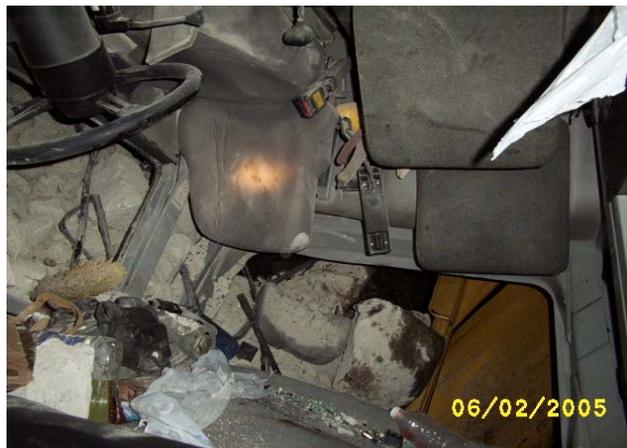
Inside view of cab

A functional seat belt was present in both the operator's side and passenger's side seating positions.

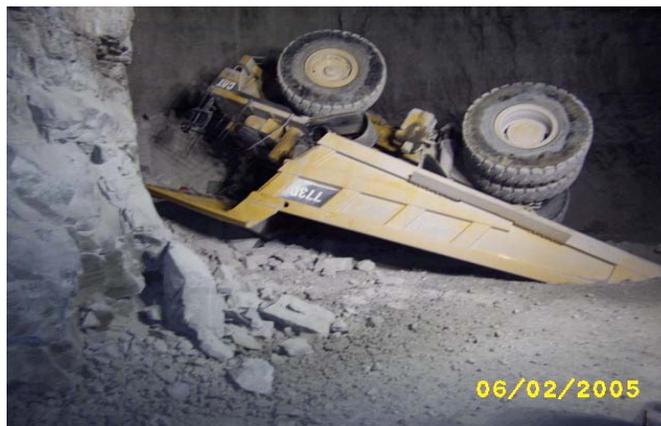
Position of truck after going through berm

As Bexley was returning to the underground loading area, he lost control of the vehicle when it started sliding and he hit the brakes. The truck hit the left rib near the berm, traveled through the berm, and over the bench to a level 70 feet below.
