REPORT OF INVESTIGATION

Surface Nonmetal Mine  
(Limestone)

Fatal Powered Haulage Accident  
November 4, 2005

Southern Rock and Lime Incorporated  
Plant No. 1  
Floralala, Covington County, Alabama  
Mine ID No. 01-03276

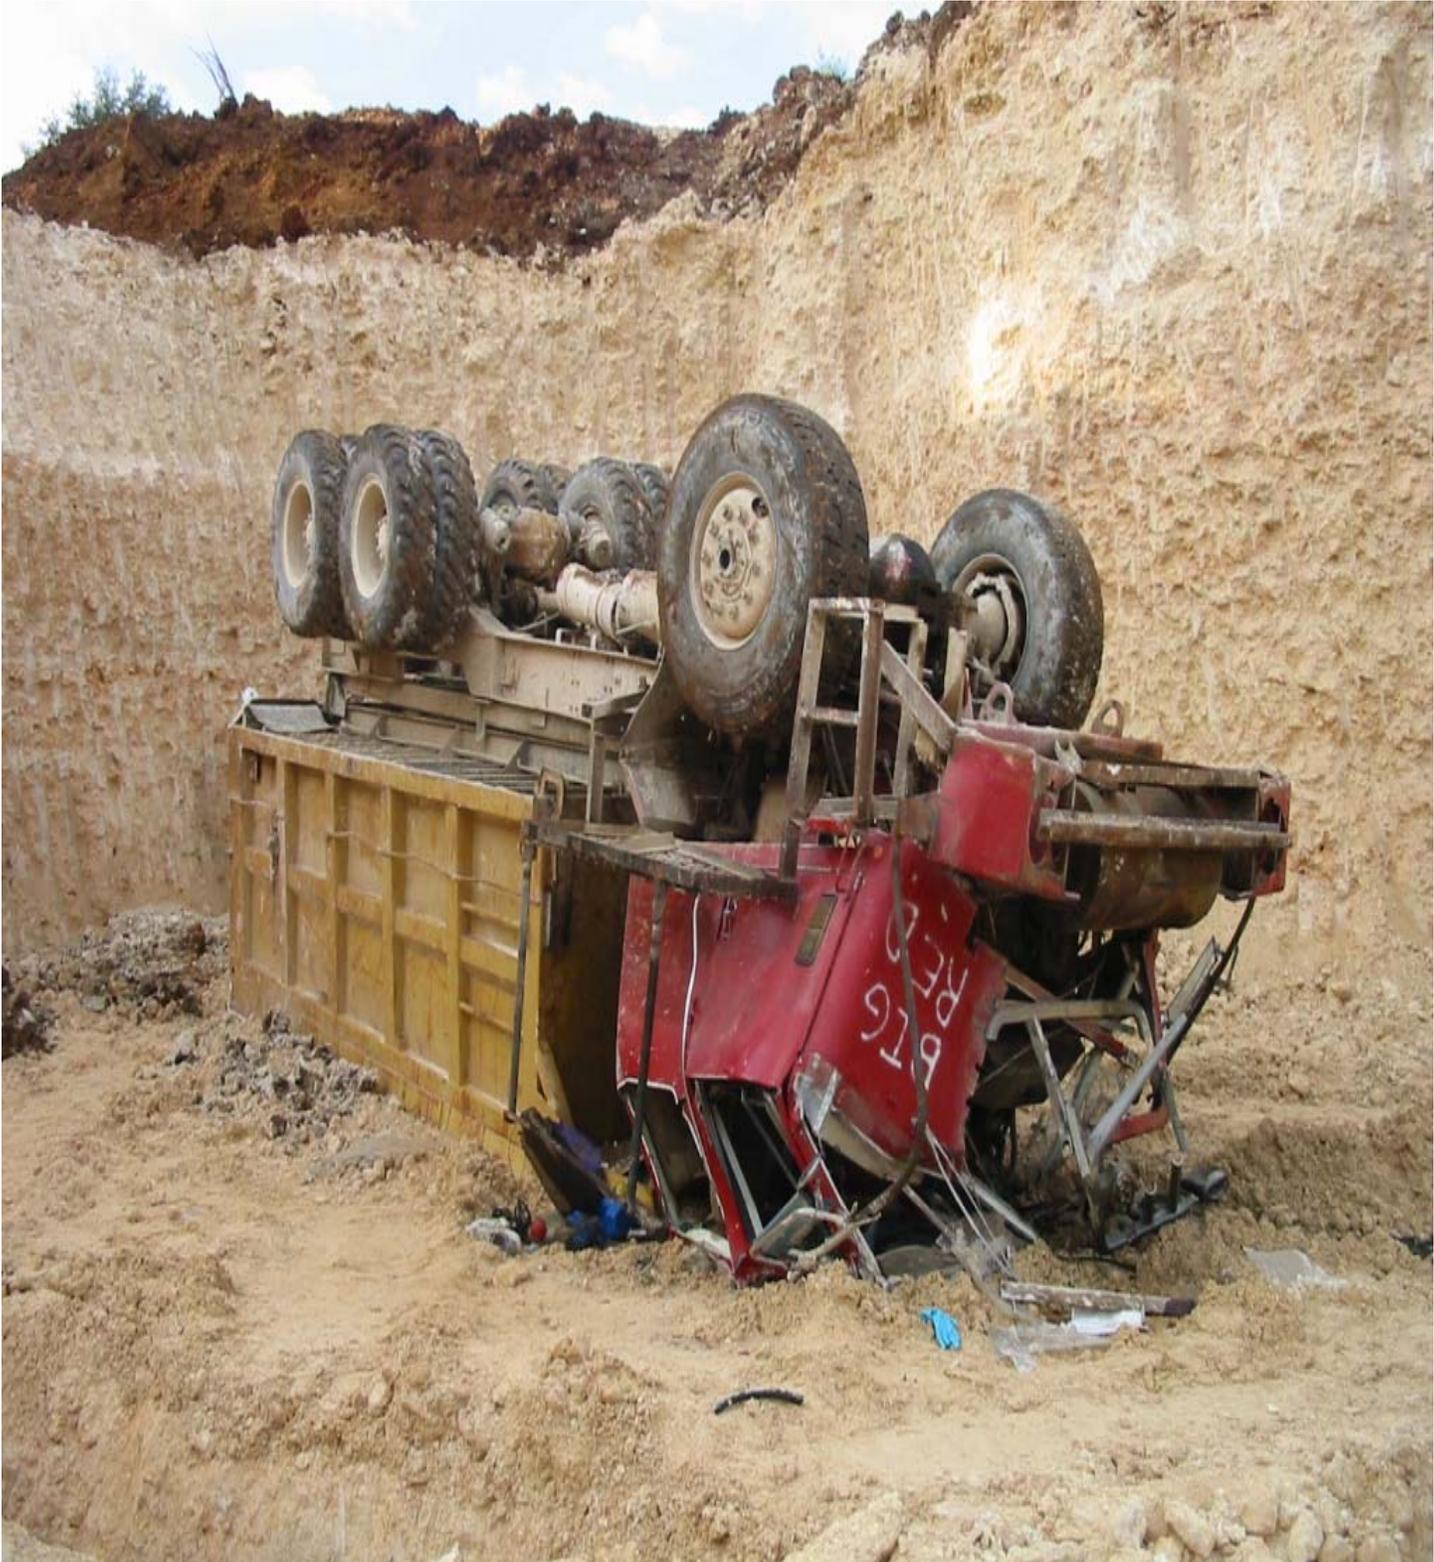
Primitivo Cuaquuhua, laborer, age 17, was fatally injured on November 4, 2005, while being task trained to operate a haul truck. The victim was backing the truck down a grade when he lost control and it traveled through a berm and fell 21 feet to a bench below.
