Coal Mine Fatal Accident 2006-16

Operator:	Andalex Resources, Inc.
Mine:	Aberdeen Mine
Accident Date:	February 16, 2006
Classification:	Fall of Face
Location:	Dist. 9, Carbon County, Utah
Mine Type:	Underground Coal Mine
Employment:	138
Production:	4,241 Tons/Day

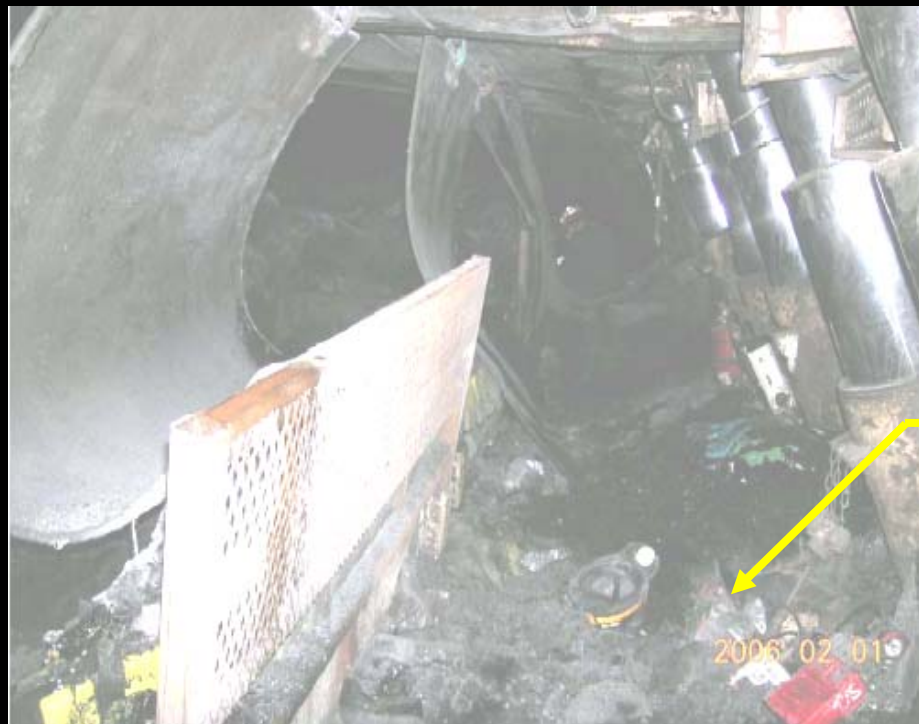
Victim's
Location

On Sunday, January 29, 2006, at 11:00 p.m. The victim, age 37, a longwall propman who was operating the tailgate drum of the shearer, was fatally injured when a coal bounce/outburst occurred and pushed him into the No. 11 shield legs on the 12th East longwall face.

Corrective Action: Conveyor belt guards and metal guards were installed from shield Nos. 5 to 135 with the bottom of the conveyor belt guards attached to the face conveyor to limit movement into the longwall walkway. The belt guards were also restrained by two horizontal chains attached to the metal guards. Requirements restricting travel on the longwall section were implemented. Shearer operators were required to position themselves behind the elevated cutter drums, shearer lump breaker, or shearer sloughing plate (deflector plate) during the cutting sequence. In addition, headgate and tailgate entries were required to be mapped for geologic features and, where sandstone channels were found, the normal 30-inch cutting web at the face would be reduced to 15 to 18 inches.

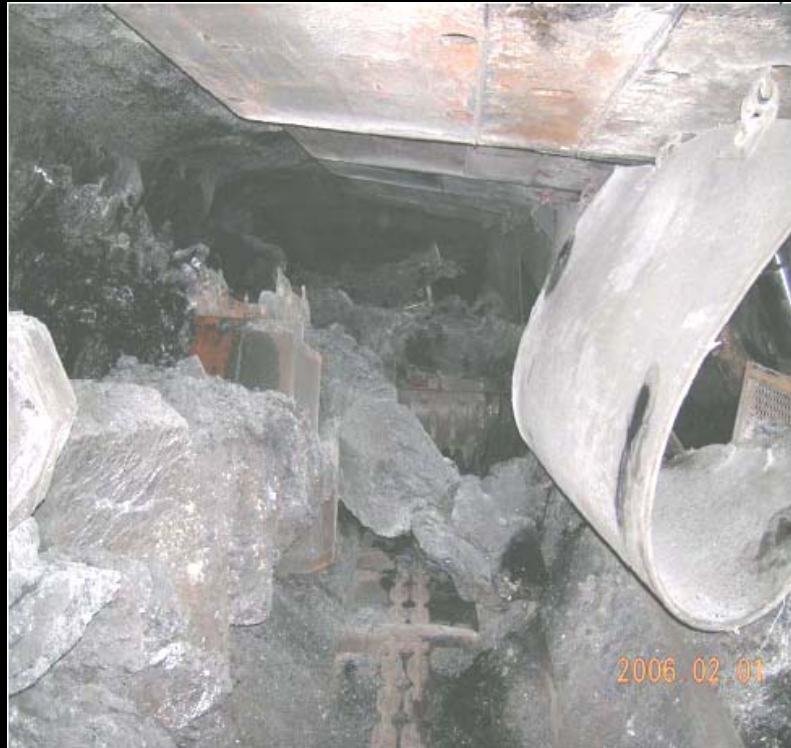
Prior to the accident, a cut was made from the tailgate to the headgate. When the cut was completed, the shearer was taken to about No. 40 shield to make a taper cut back to the headgate to catch up the lagging headgate end of the face. As the shearer entered the headgate area, The victim remained behind the operation at No. 11 shield. As the headgate drum operator was completing the cutout, a coal outburst from a bounce on the longwall face propelled coal over the face conveyor into the shield walkway area, striking the miner and causing fatal head injuries.

Causal Factor: Management did not have sufficient procedures in place to ensure that adequate barriers were installed and used in a manner to protect miners from hazards related to outbursts on the longwall face.
