Coal Mine Fatal Accident 2006-24

Operator:	Jim Walter Resources, Inc.
Mine:	No. 4 Mine
Accident Date:	March 29, 2006
Classification:	Fall of Roof
Location:	Dist. 11, Tuscaloosa County, AL
Mine Type:	Underground Coal Mine
Employment:	454
Production:	9,700 Tons/Day

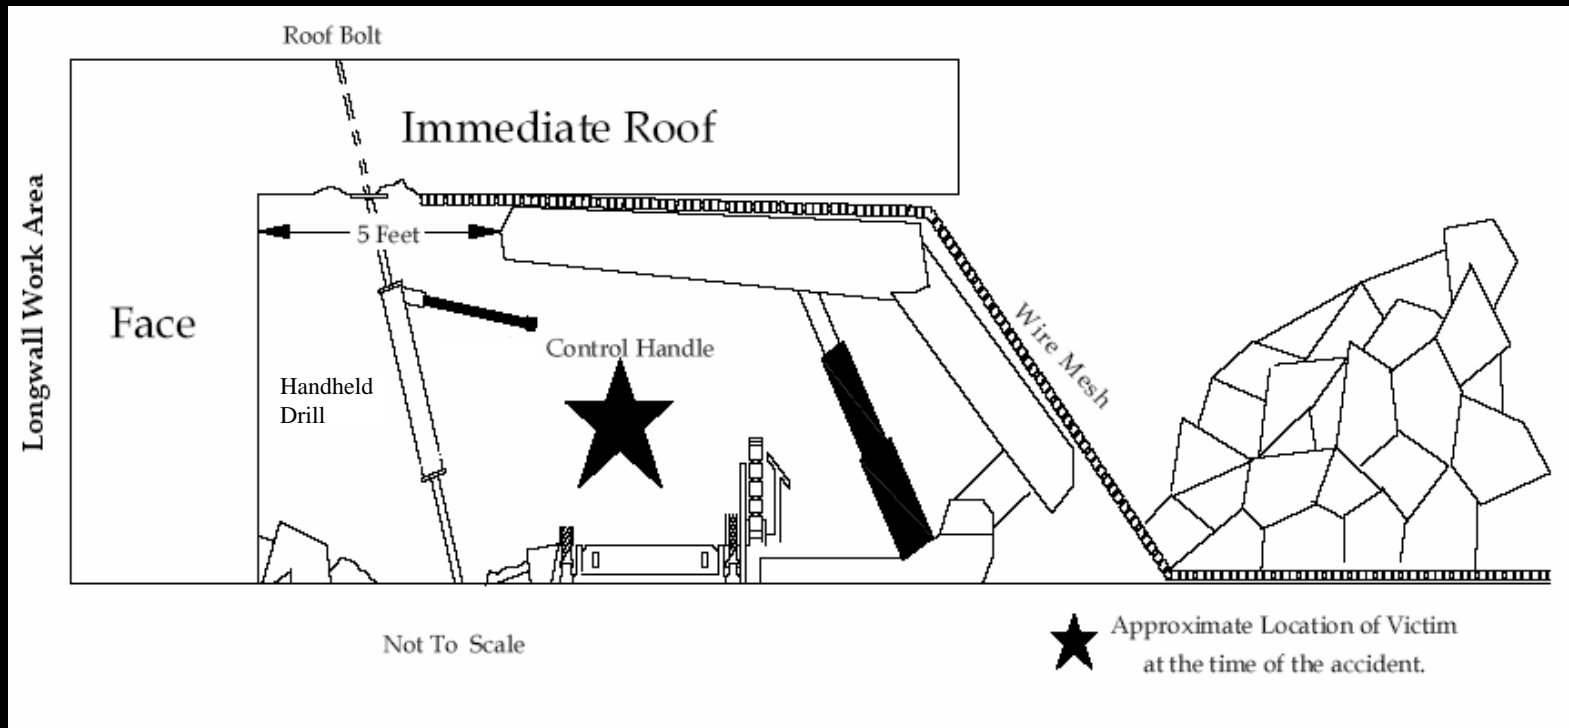
At approximately 11:25 a.m. on March 29, 2006, a miner received injuries that resulted in his death on April 10, 2006. The victim was installing roof bolts between the shield tips and the longwall face in preparation for moving the longwall mining equipment. The victim was located at the outer edge of a shield tip while preparing to drill, when a piece of roof rock fell. He was hit by the rock (measuring 4-inches x 12-inches x 24-inches), which caused him to fall, striking his head against the pan-line.

Causal Factor: The mine operator's existing procedures for installing roof bolts on the longwall face with handheld drills did not include provisions for safe positioning of the drill operator.

The operator failed to support or otherwise control the roof to protect persons from hazards related to falls of the roof on the N-13 Longwall Panel. On March 29, 2006, an area of unsupported roof fell and led to a fatal injury of a miner on April 10, 2006.

Corrective Action: The mine operator submitted and the district has approved a supplement to the Approved Roof Control Plan that reads as follows:

"The pin men will position their drill perpendicular to the faceline while standing under a shield canopy to install their first pins in all areas where pinning will be started in the mesh cycle."

"The pin men will position themselves adjacent to previously installed bolts as they progressively pin the faceline in all areas of pinning."
