Coal Mine Fatal Accident 2006-35

Operator:	Hendrickson Equipment, Inc.
Mine:	Smith Branch No. 1
Accident Date:	July 18, 2006
Classification:	Fall of Highwall
Location:	Dist. 6, Knott County, Kentucky
Mine Type:	Surface Coal Mine
Employment:	7
Production:	150 Tons/Day

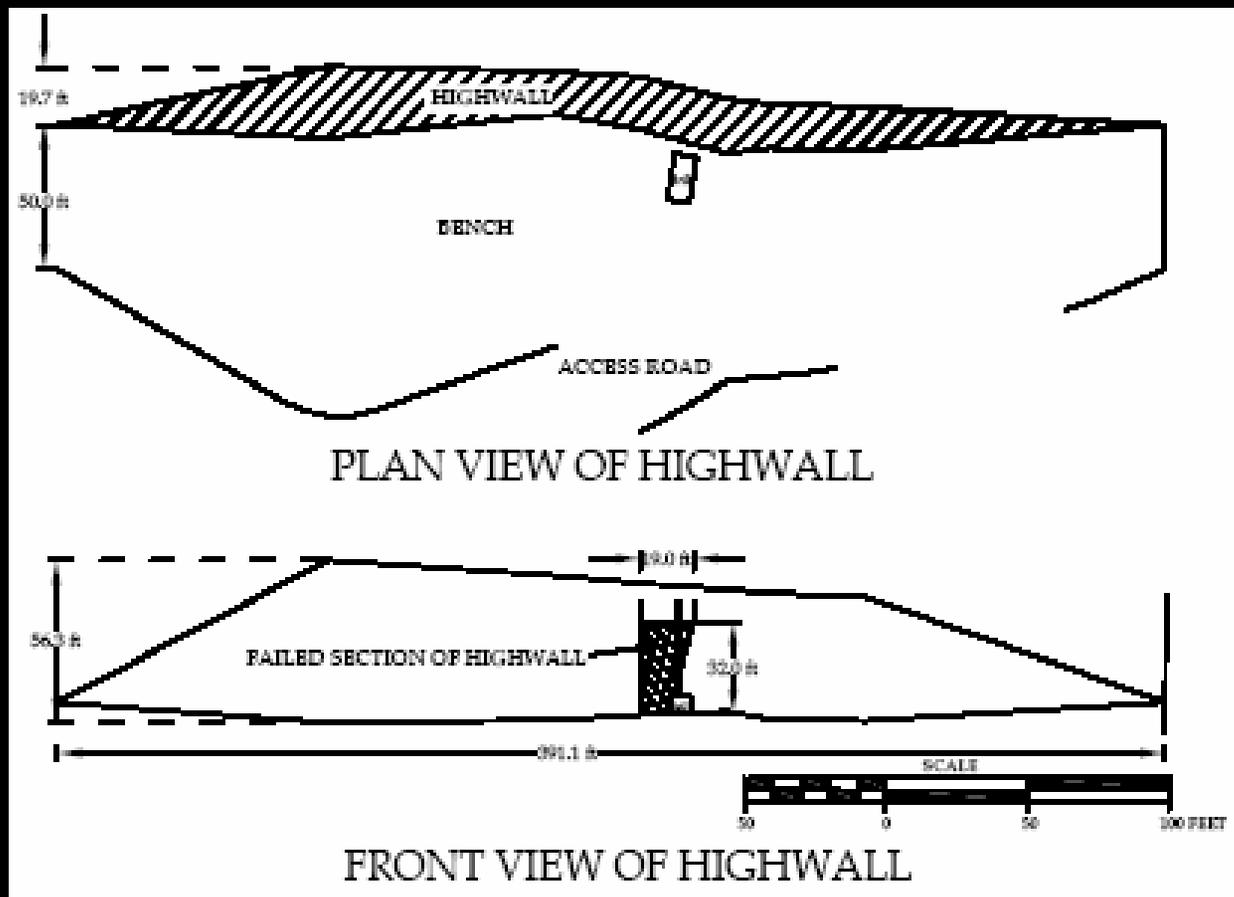
At approximately 9:45 a.m. on Tuesday, July 18, 2006, a 28-year-old highwall drill operator, was fatally injured in a fall of highwall accident at the Hendrickson Equipment, Inc., Smith Branch No. 1 mine. The victim had 6 years of total mining experience and had worked 36 weeks at this mine. The accident occurred as the victim was operating a highwall drill adjacent to a 43-foot highwall. As he was drilling the eighth hole of the day, rock fell onto the cab of the drill, resulting in fatal injuries. The rock fall measured 32 feet high by 19 feet wide by 7 feet thick.

Root Cause: Mine management did not ensure that the ground control plan was being followed. The highwall drill was positioned perpendicular to the highwall with the operator's compartment immediately adjacent to the highwall. The operator's ground control plan established for this mine states that drill operators shall not drill from positions that expose them to hazardous highwall conditions. The plan further states that the drill will be positioned with the operator's compartment on the side opposite the highwall.

Root Cause: Mine management failed to ensure that persons did not work near or under dangerous highwalls. Obvious discontinuities evidenced by a hill seam intersected by vertical jointing were present in the highwall where the accident occurred and should have been seen by examiners and management. These conditions were present when the highwall was exposed during the previous week.

Corrective Action: All persons working at this mine received additional training in all aspects of the ground control plan including the positioning of the highwall drill with the operator's compartment on the side opposite the highwall. Mine management should also institute a procedure or program to ensure that their plan is being followed during the course of the work day.

Corrective Action: All persons working at this mine, including the mine examiner, were given additional training covering the identification and correction of ground control hazards. Additionally the ground control plan was revised to include a safety bench to increase the distance between the highwall drill and the exposed highwall.
