Coal Mine Fatal Accident 2006-40

Operator:	Jim Walter Resources, Inc.
Mine:	No. 7 Mine
Accident Date:	October 12, 2006
Classification:	Fall of Roof
Location:	Dist. 11, Tuscaloosa County, Alabama
Mine Type:	Underground Coal Mine
Employment:	491
Production:	10,000 Tons/Day

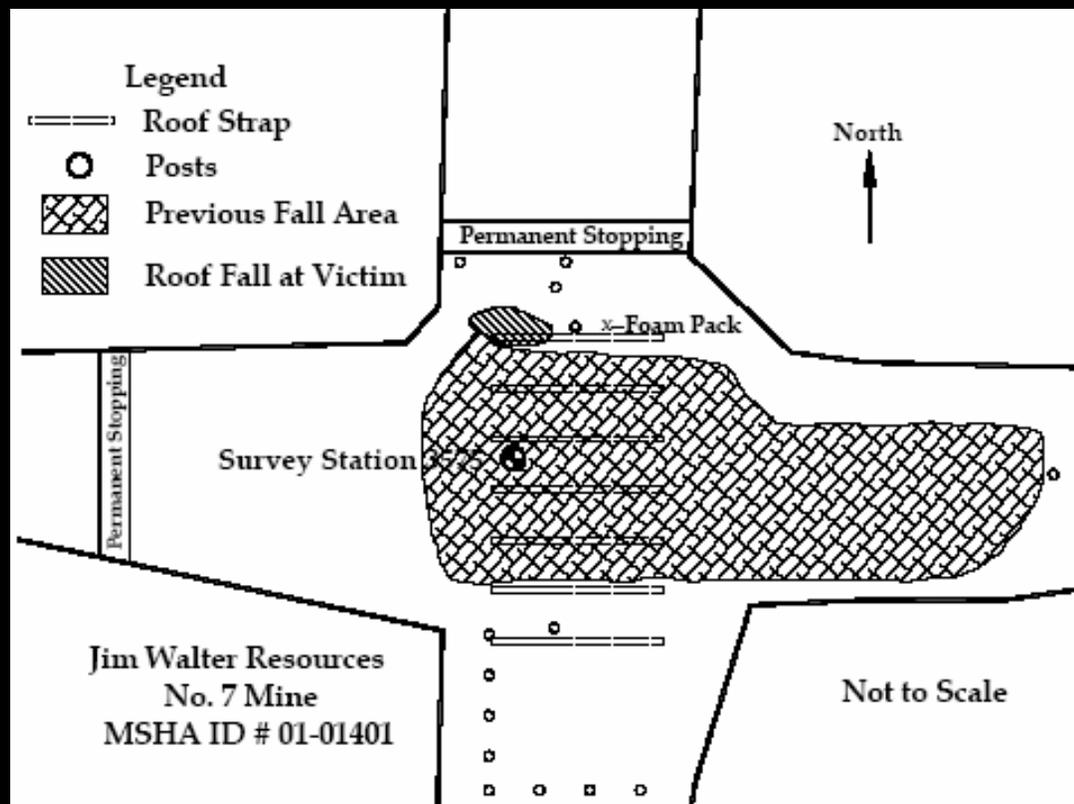
On October 12, 2006 a 56-year old Special Projects Manager, with 32 years total mining experience, was fatally injured in an underground roof fall. The rock that separated from the roof and struck the victim measured 83-inches long x 43-inches wide x 7-inchesthick, and had a roof bolt through one end which failed at or near the anchorage point. The victim was checking ventilation controls in anticipation of increasing fan ventilation pressure in the area, and was in an area of the mine that had prior roof falls and deteriorating roof conditions, affecting the immediate roof and installed support.

Root Cause: The immediate mine roof and installed roof support had deteriorated over time, resulting in hazardous roof conditions in the area traveled by the victim. Adequate precautions to eliminate the hazard were not taken.

Corrective Action: The mine operator installed additional standing support in the area of the fall to make the immediate area safe for the investigation. All entrances to the accident site area were timbered off with danger signs posted to keep miners from entering the areas of unsafe roof.
