Coal Mine Fatal Accident 2006-42

Operator: R&D Coal Company, Inc.
Mine: R&D Coal Company, Inc. Mine
Accident Date: October 23, 2006
Classification: Fatal Methane Explosion

Location: Dist. 1, Wilkes-Barre, PA
Mine Type: Underground Coal Mine
Employment: 7
Production: 60 Tons/Day

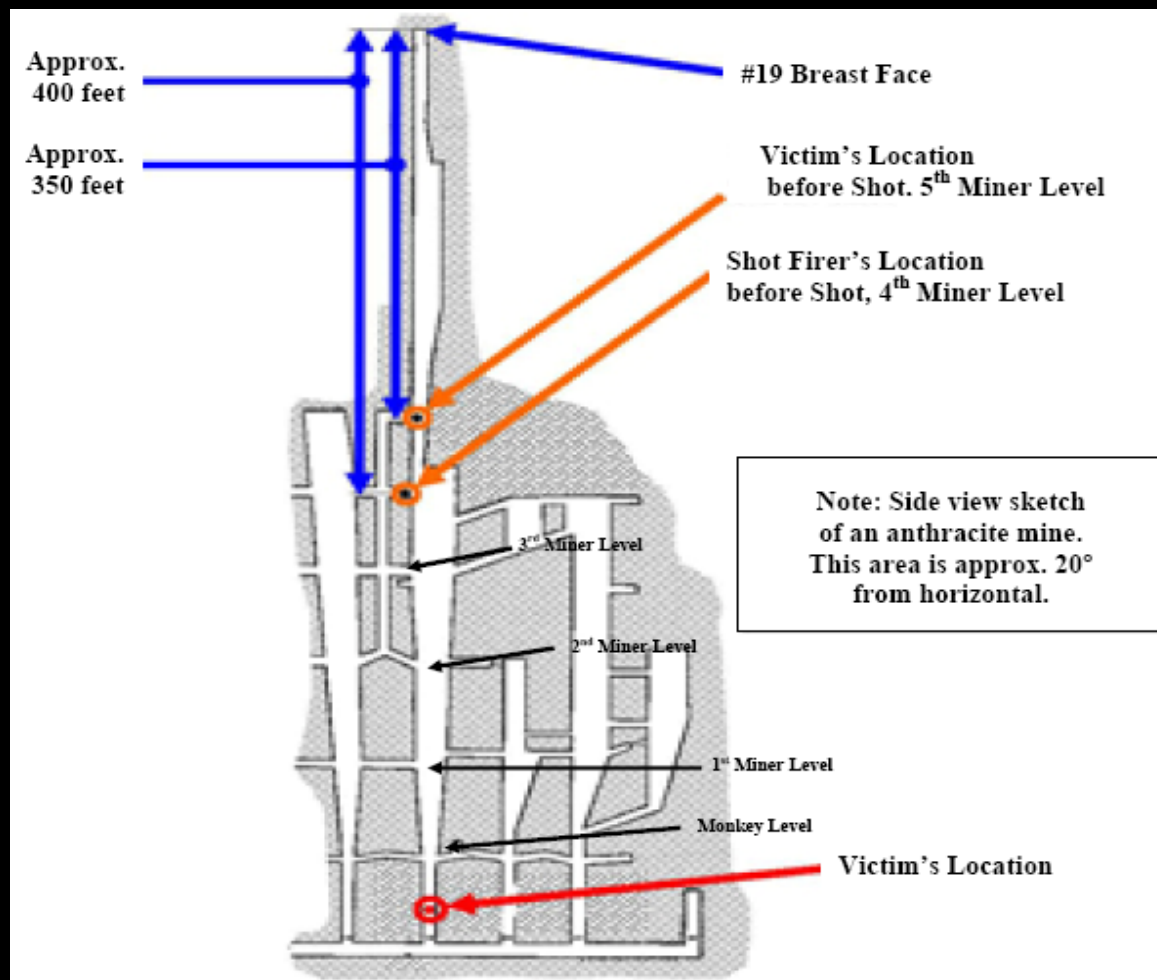
On Monday, October 23, 2006, a 43-year old miner was fatally injured when a methane explosion occurred, initiated

during an explosives detonation, in the #19 breast on the east side of the mine. The victim was located in the manway of the #19 breast in the vicinity of the 5th miner heading when the explosion occurred. Another miner, located in the 4th miner heading off the #19 breast, had just fired the working face of the #19 breast when the explosion occurred.
