## Coal Mine Fatal Accident 2006-43

Operator:	Double Bonus Coal Company
Mine:	No. 65
Accident Date:	October 30, 2006
Classification:	Machinery
Location:	Dist. 4, Wyoming County, West Virginia
Mine Type:	Underground Coal Mine
Employment:	40
Production:	4,000 Tons/Day

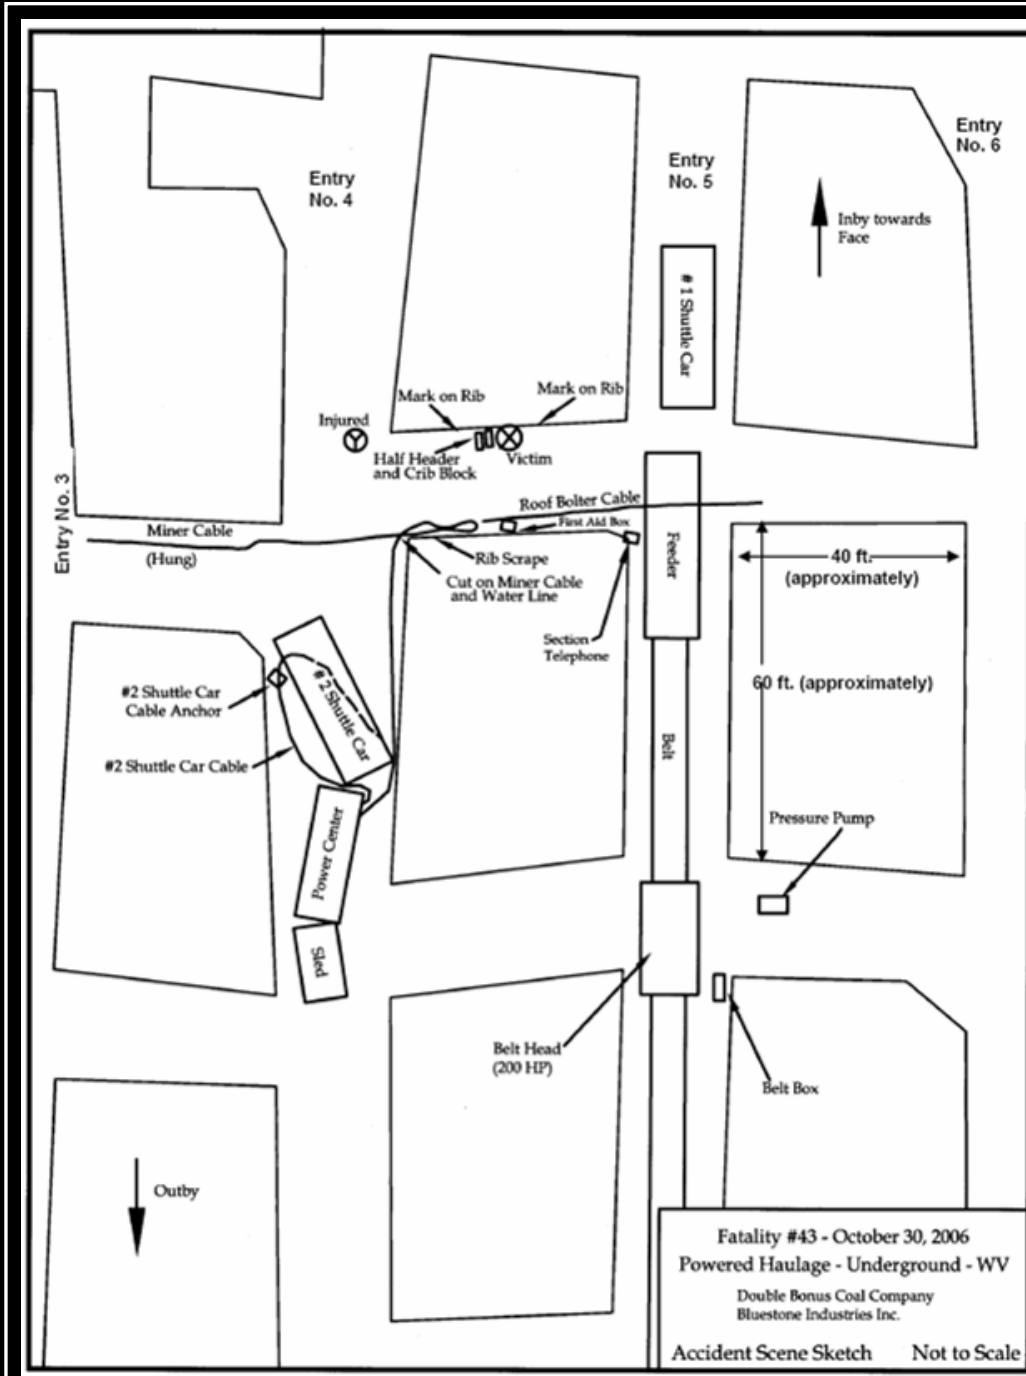
At approximately 7:05 a.m. on Monday, October 30, 2006, a 31-year-old shuttle car operator was fatally injured when he was crushed between a shuttle car and the coal rib. The accident occurred when the victim and a section mechanic were attempting to free-up a sticking tram pedal on the #2 shuttle car. Both miners were positioned between the shuttle car and the inby solid coal rib of the #4 to #5 crosscut. The shuttle car was energized, the park brake was not set and the controls were set to fast tram. The shuttle car trammed and struck both miners. The section mechanic received life-threatening injuries when he was rolled along the solid coal rib.

Root Cause: The operator's management systems and policies did not ensure that the #2 shuttle car's cross shafts and four journal bearings that support the two cross shafts were properly lubricated. Improper lubrication and fine coal particles caused the tram pedal to stick, causing an unsafe operating condition.

Root Cause: The #2 shuttle car was not deenergized and blocked against motion before cleaning of the deck and repair of the tram controls was performed. Two miners were positioned outside the deck of the shuttle car while the shuttle car was energized, the tram control was in the fast tram position, and the park brake was not set.

Corrective Action: The written mine training program was revised to include the following safety precaution under task training; "The operating decks on shuttle cars will be cleaned and properly greased prior to being placed into production on each shift." Management and miners were trained in the new safety precaution.

Corrective Action: The written mine training program was revised to include, "Mobile equipment operators shall not leave the equipment operating deck with the equipment running; and the shuttle car circuit breaker shall be de-energized prior to performing any repair or maintenance; this includes cleaning out the operator deck." Management and miners were trained in the requirements of the new safety precautions.
