Coal Mine Fatal Accident 2006-46

Operator:	Spring Creek Coal Company
Mine:	Spring Creek Coal Company Mine
Accident Date:	November 28, 2006
Classification:	Powered Haulage
Location:	Dist. 9, Big Horn County, Montana
Mine Type:	Surface Coal Mine
Employment:	176
Production:	45,000 Tons/Day

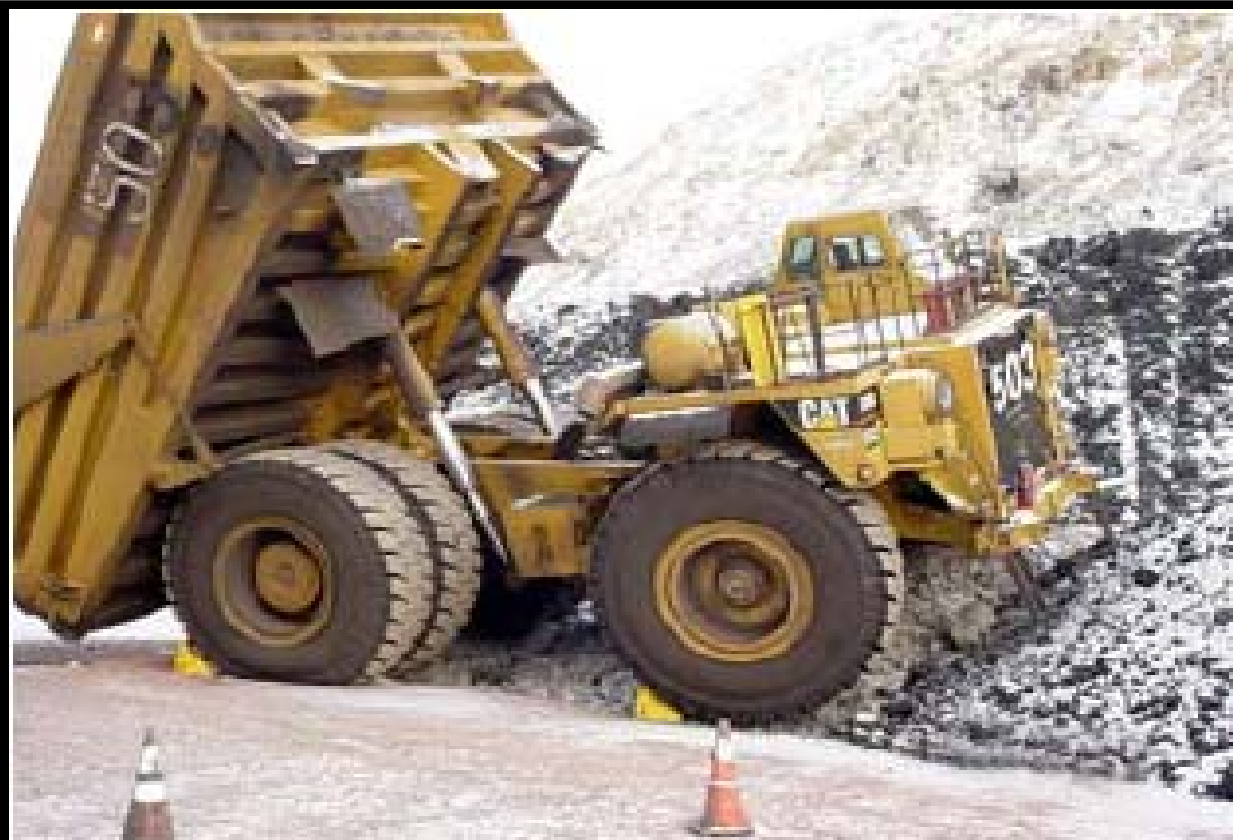
On Tuesday, November 28, 2006, at approximately 1:05 a.m. a 50-year old haul truck operator was fatally injured in a powered haulage accident. The victim had dumped a load of coal waste material from a haul truck he was driving in the pit when he called on the radio to report that the parking brakes on the truck would not release. A mechanic responded and found the truck resting against a berm with the bed up and the engine running. The victim was found crushed beneath the left rear dual tires. There were no witnesses to the accident, thus the actual events causing the miner to be crushed under the tires are not exactly known.

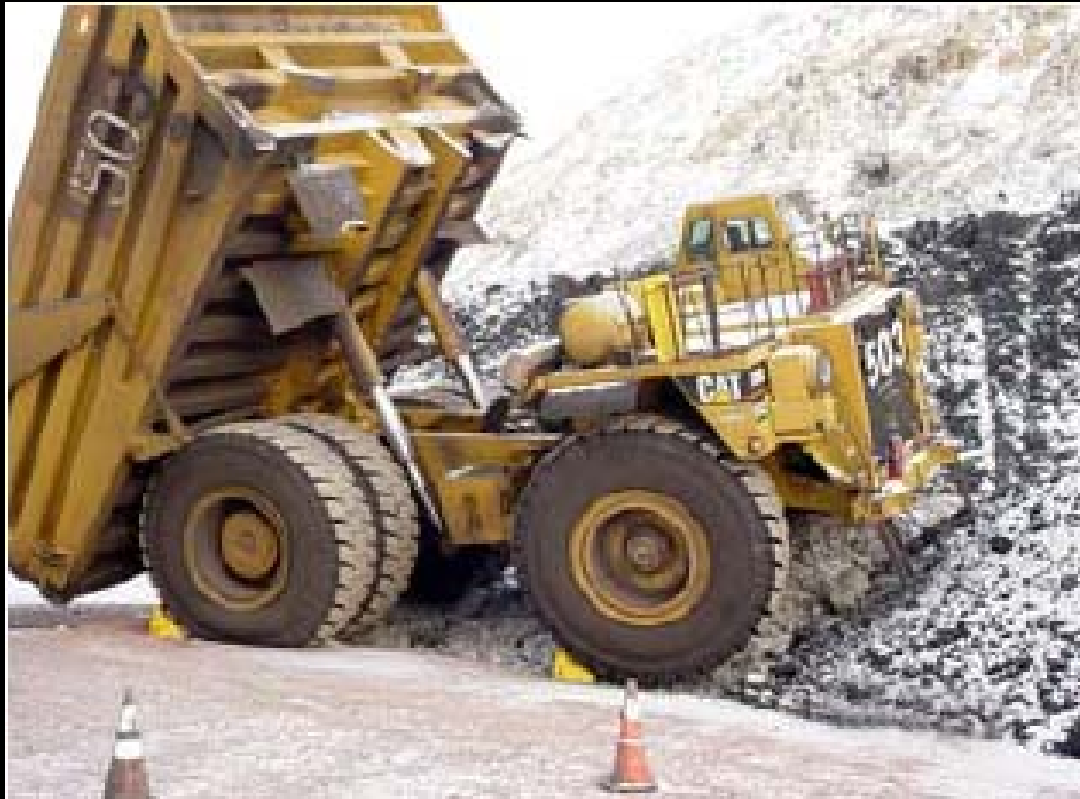
The accident occurred when the frozen parking brakes released unexpectedly allowing the truck to roll forward downgrade into the berm. The victim was either thrown from the truck and was struck and crushed by the left rear dual tires or he was on the ground and struck and crushed by the tires. The accident

occurred due to an ineffective program to ensure that truck operators set the parking brake before exiting the cab of the truck. This allowed the miner to exit the truck cab and not return the parking brake toggle switch to the "on" position after the switch had been put in the "off" position to move forward to finish dumping the load. Management did not have effective maintenance procedures to ensure that water was drained from and not allowed to accumulate in the air tank/system and caused the freezing problem that was experienced at the time of the accident when the parking brakes would not release.

Root Cause: Ineffective maintenance procedures allowed water to accumulate in the air tank/system causing the accident.

Corrective Action: The mine operator should revise and enforce equipment maintenance procedures to require air tanks to be drained according to manufacturer's recommended time frequencies.
