MNMM Fatal 2006-02

- Machinery
- January 27, 2006 (Oregon)
- Crushed Stone Operation
- Heavy Equipment Operator
- 60 years old
- 10 years mining experience

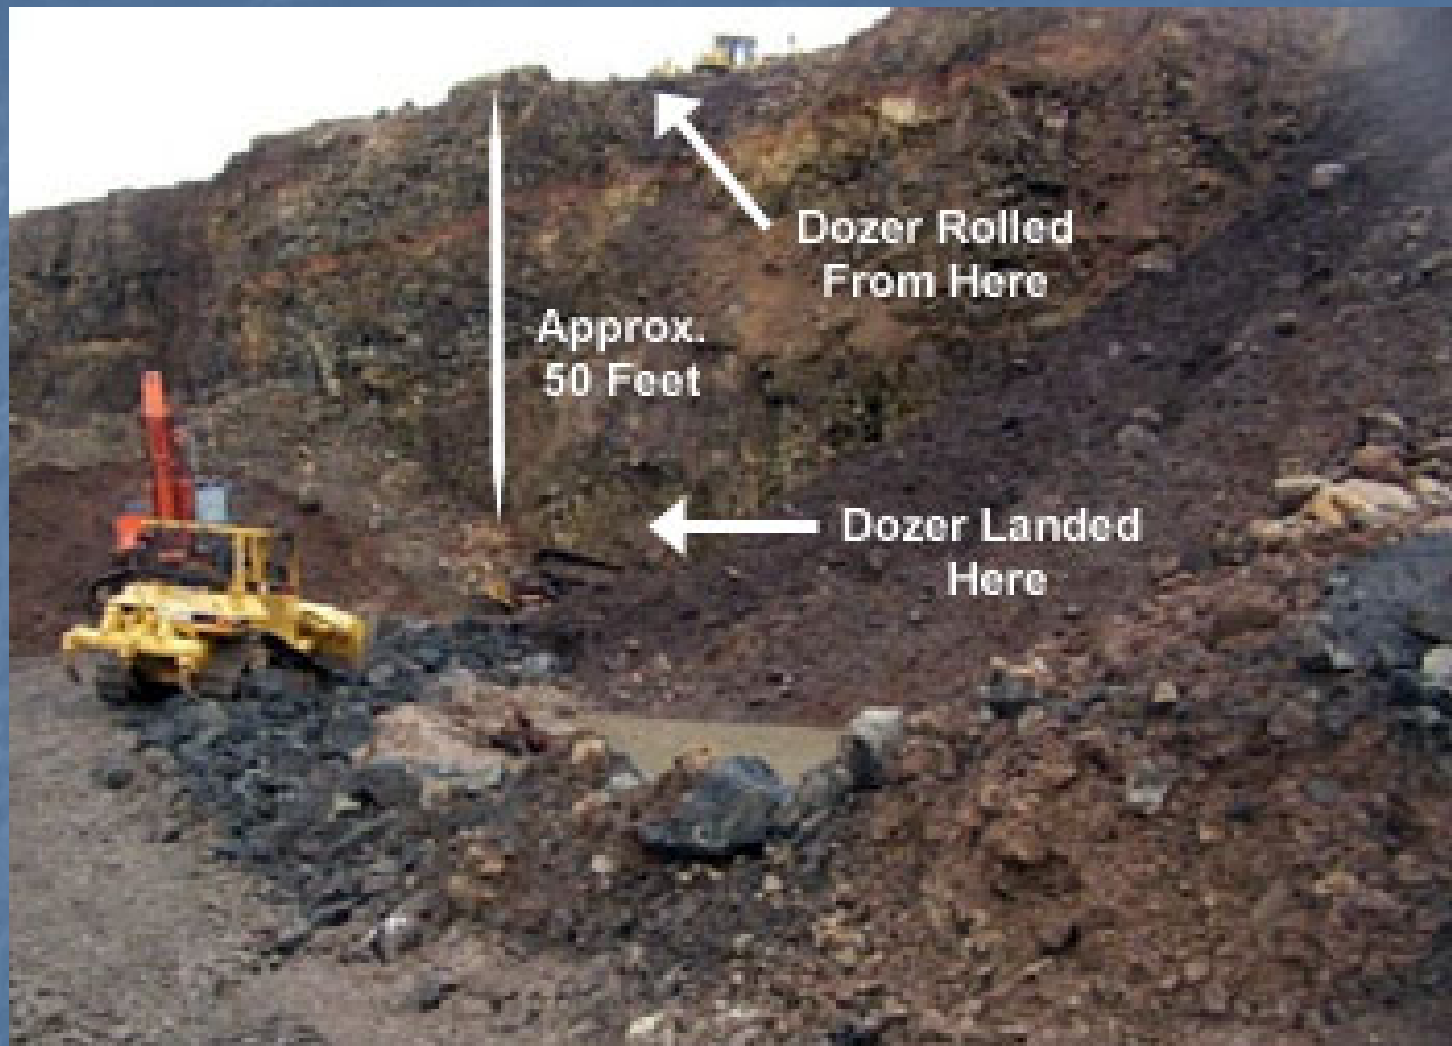
The victim was fatally injured when the dozer he was operating backed over the edge of a highwall and fell approximately 50 feet. The dozer landed in mud and water which had accumulated on the level below.

- Standards and controls were inadequate and failed to require auxiliary lighting to be installed when work was performed near elevated areas during darkness.
- Controls were inadequate and did not ensure the operator of the dozer wore his seat belt when operating the equipment.

- Stop, Look, Analyze, and Manage (SLAM) each task to identify all potential hazards before performing work.
- Maintain and wear seat belts when operating machinery.
- Always keep the blade between yourself and the edge of the highwall when operating a dozer on the highwall bench.

- Operate equipment so that control is maintained.
- Reduce the throttle position and know how to immediately stop the dozer when working near the edge of the highwall.
- Provide adequate illumination when work is performed during non-daylight hours.
