MNMM Fatal 2006-11

- Powered Haulage
- May 23, 2006 (Kentucky)
- Crushed Stone Operation
- Secondary Plant Operator
- 44 years old
- 11 years mining experience

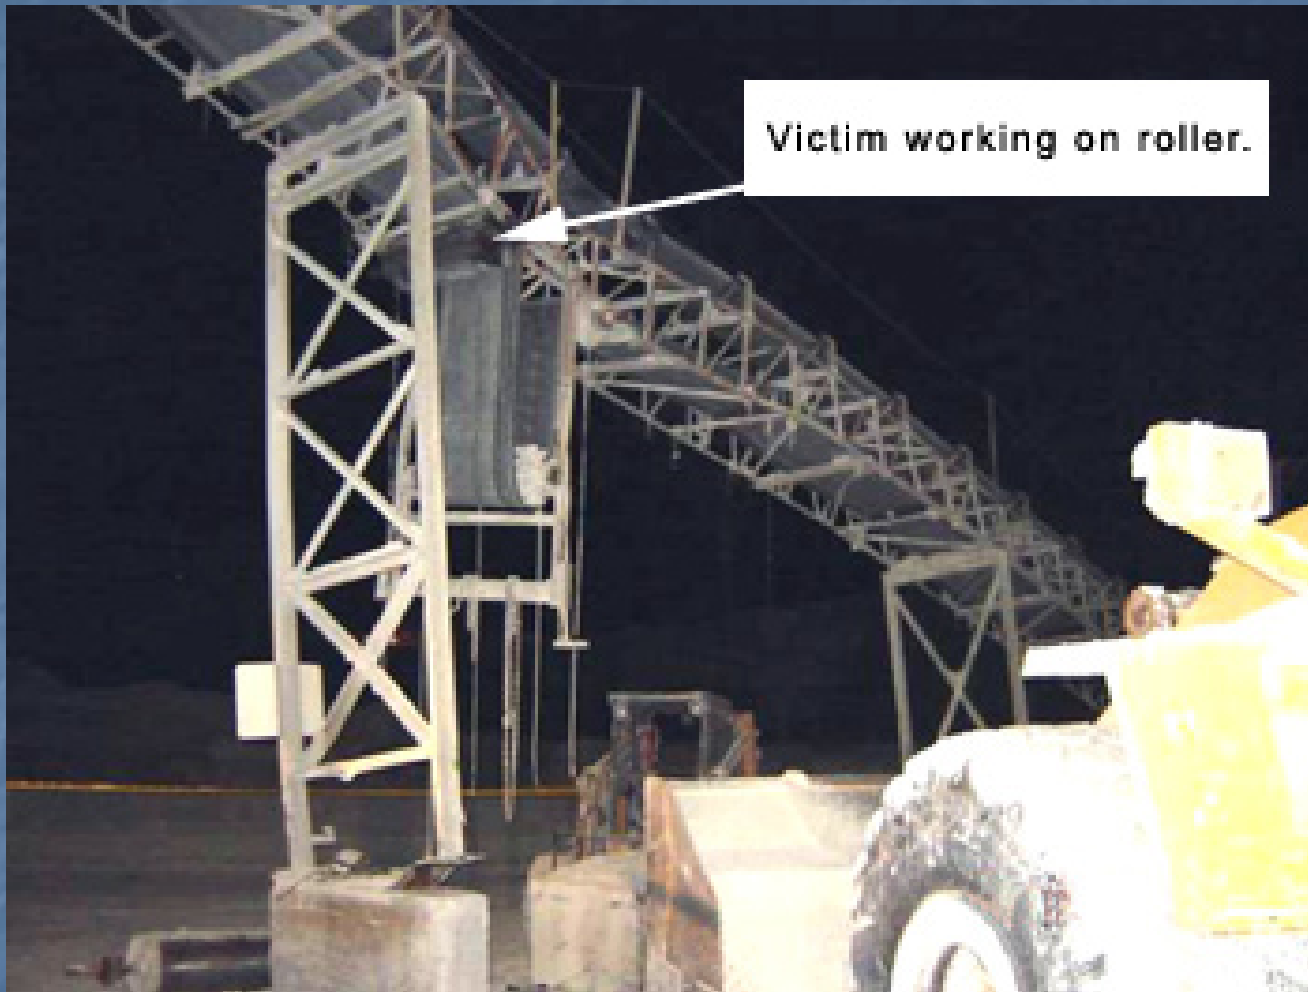
The victim was crushed between the frame of a conveyor belt and the elevated bucket of a front-end loader that he was standing in. He was working from the raised bucket of the front-end loader installing a take-up roller for the No.1 belt conveyor.

Victim working on roller.

Management policies and controls were inadequate and failed to require that the proper equipment was provided to safely complete the repair task. Management's supervision was inadequate and did not ensure that the raised loader bucket was secured and the equipment was blocked to prevent movement prior to persons working from the loader bucket. Management policies and controls were inadequate. Management failed to ensure that employees received adequate training in the health and safety aspects and safe working procedures relating to the task they were assigned. The miner operating the loader did not demonstrate the correct skills or knowledge to maintain control of the equipment he was assigned to operate.

- Discuss work procedures and identify all possible hazards associated with the work to be performed along with the methods to protect personnel. Stop, Look, Analyze, Manage (SLAM).
- Ensure that the appropriate equipment and tools are available for the task and all miners have been trained to recognize work place hazards.
- Do not permit persons to work from the bucket of a front-end loader. Man lifts should be utilized when persons are required to perform work at elevated locations where work platforms have not been installed.
