Fatality #38 - May 4, 2006
(Jurisdiction determined 09/05/06)
Electrical – Surface – Virginia
Consolidation Coal Company – Buchanan Mine #1

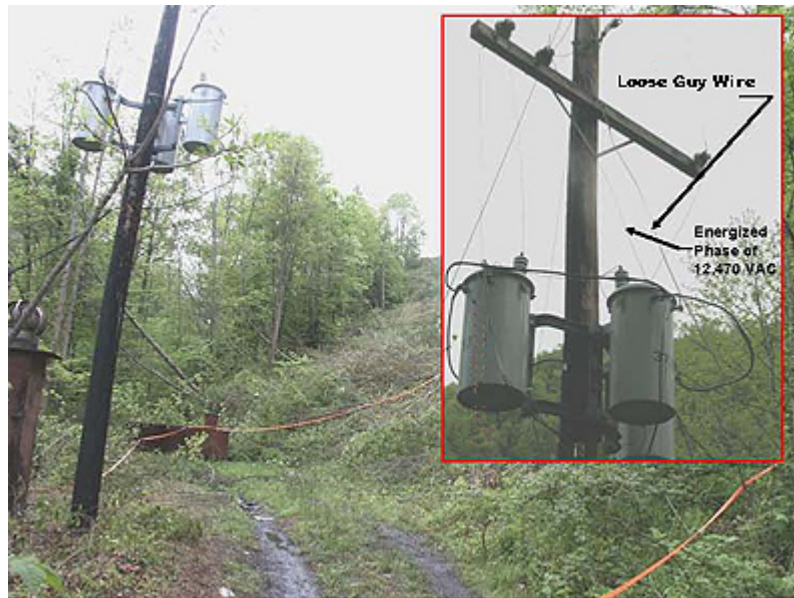
COAL MINE FATALITY - On Thursday, May 4, 2006, a 40 year old contractor with 2 1/2 years of experience was electrocuted while clearing brush from the right-of-way of a 12,470 VAC transmission line. The miner touched a loose guy wire causing it to contact an energized conductor on the pole. There was no insulator, ground, or proper anchor at ground level preventing the guy wire from becoming energized.

- Connect guy wires securely to the system ground, and/or properly install insulators to protect miners in the event of a breakage.
- Anchor guy wires where they will not be contacted by vehicles and equipment or be disturbed by maintenance personnel.
- Examine areas surrounding electrical installations for potential hazards before beginning any work, including trimming weeds and brush.
- Mark guy wire anchor points for easy identification.
