Fatality #1 - January 5, 2006
Falling or Rolling Material - AZ - Sand & Gravel
Rinker Materials Western Inc. - Rinker Materials 19th Ave Mine

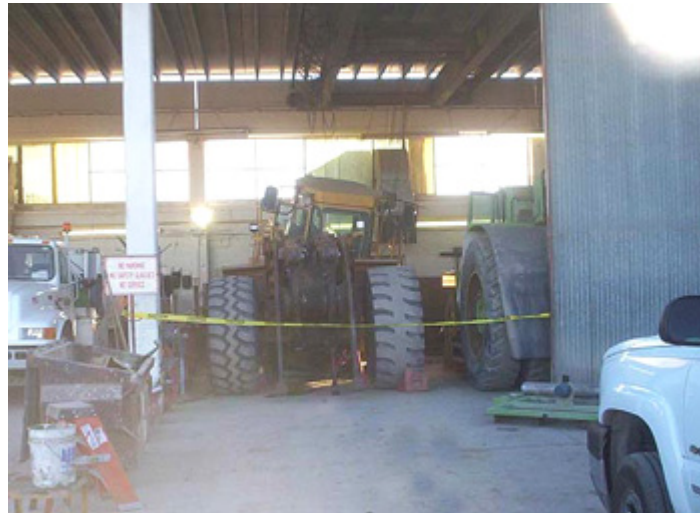
METAL/NONMETAL MINE FATALITY - On January 6, 2006, a 39-year old mechanic with 12 years mining experience was fatally injured at a sand and gravel operation while working on a front-end loader. The front and rear sections of the loader had been separated at the articulation joint and each section was independently supported with jack stands. The victim was positioned between the left rear tire and frame to remove a hydraulic hose. The frame of the loader tipped forward on the tires and swiveled to the left on the rear axle oscillation trunnion, pinning him.

- Stop, Look, Analyze, and Manage (SLAM) each task to identify all potential hazards before performing maintenance work. Practice safe work habits during the entire task.
- Consult and follow the manufacturer's recommended safe work procedures for the maintenance task.
- Train miners in safe work procedures before beginning repairs.
- Securely block equipment against all hazardous motion at all times while performing maintenance work. If the equipment being blocked has multiple degrees of movement of freedom, exercise extreme caution because some instability modes may not be obvious.
