REPORT OF INVESTIGATION

Surface Coal Mine

Fatal Ignition Accident
February 1, 2006

Black Castle Mining Co.
Black Castle Mining Co.
Sylvester, Boone County, West Virginia
MSHA I.D. No. 46-07938

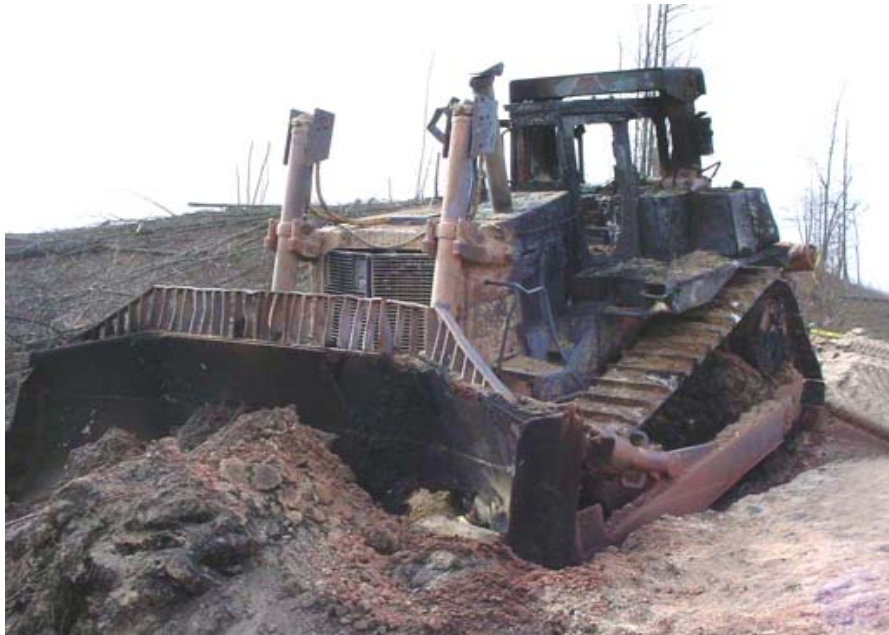
At approximately 2:10 p.m. on Wednesday, February 1, 2006, a 58-year old bulldozer operator with 15 years experience was fatally injured due to an ignition of natural gas. As the bulldozer operator was developing a drill bench, the blade of the machine contacted and ruptured a 16-inch low-pressure, high-volume natural gas line which immediately burst into flames.

At approximately 2:10 p.m. the bulldozer contacted and ruptured the 16-inch, low-pressure, high-volume natural gas line while making the first push of brush, 260 feet above the Clarion coal seam. The bulldozer was immediately engulfed in flames. Moss exited the cab of the bulldozer and traveled on top of the right track toward the cutting blade. Booth and Black heard coal truck drivers talking on the CB radio about a dozer fire at the East of Stollings Amendment site and immediately drove to the area. Black observed the open door on the bulldozer, but was unable to find Moss. Both foremen tried to get close to the bulldozer, but had to retreat due to the heat and flames.

Corrective Action: The Ground Control Plan was revised to establish safety precautions to be taken when gas lines are in close proximity to active work areas. The Ground Control Plan has been received and acknowledged by the District Manager, District 4, Mine Safety and Health Administration.

Corrective Action: Mine management conducted retraining for all persons designated to conduct on-shift examinations. The retraining focused on the topic of hazard recognition.
