REPORT OF INVESTIGATION

Fatal Fall of Roof Accident  
February 16, 2006

HZ4-1  
Perry County Coal Corporation  
Hazard, Perry, Kentucky  
ID No. 15-02085

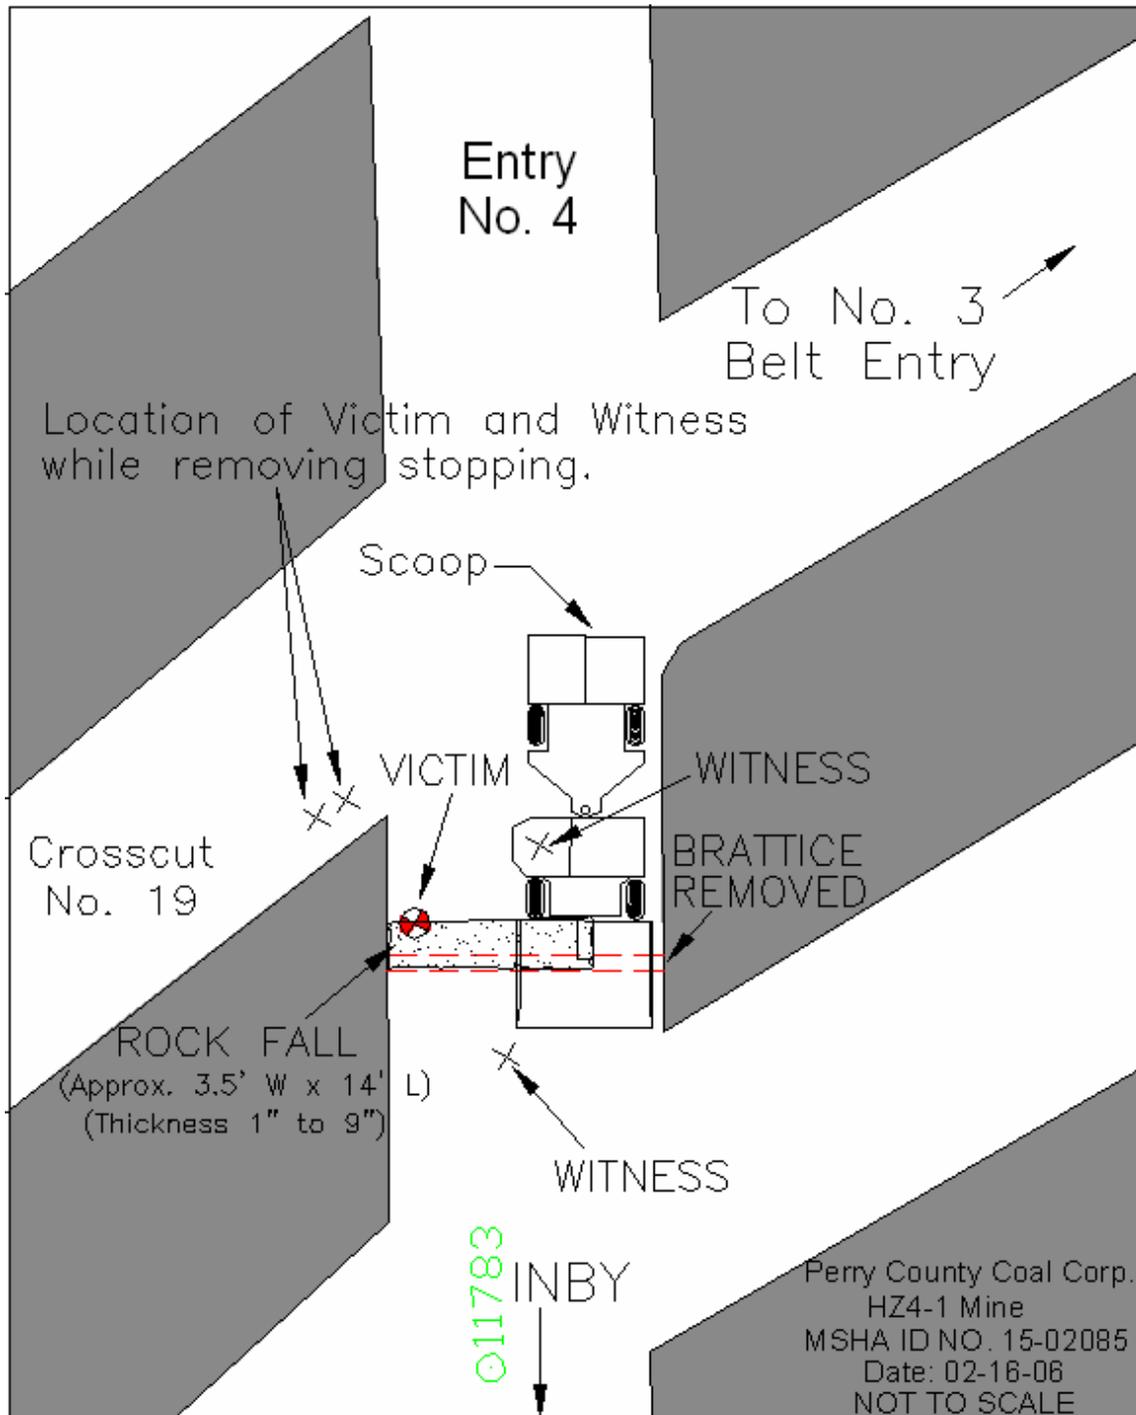
**ACCIDENT SITE**

The immediate roof on the 012 working section was composed of sandy shale, measuring approximately one inch to nine inches in thickness. The section of mine roof that fell had a brow present. This brow was created by the continuous mining machine cutting up into the mine roof and then over correcting, leaving a protruding segment of rock projecting between the roof bolts.

*Root Cause:* An effective procedure or Roof Control plan requirement was not in place and followed to ensure that roof irregularities would be adequately supported. The roof rock that fell was not adequately supported. The rock that fell had a brow present that resulted from the continuous mining machine cutting up into the mine roof and then over-correcting, leaving a protruding segment of rock projecting between the installed roof supports. The permanent stopping was constructed directly under the protruding segment of mine roof and held it in place. After this permanent stopping was removed, the roof fall occurred that caused the death of Mr. Caudill.

*Corrective Action:* The operator's approved Roof Control plan was changed to address inadequately supported roof and brows. Task training was added to the training plan to require safe procedures to be followed when permanent stoppings are removed.
