UNITED STATES
DEPARTMENT OF LABOR
MINE SAFETY AND HEALTH ADMINISTRATION
COAL MINE SAFETY AND HEALTH

AMENDED REPORT OF INVESTIGATION

Fatal Powered-Haulage Accident
April 7, 2006

Candice 2
Mystic LLC
Wharton, Boone Country, West Virginia
I.D. No. 46-08429

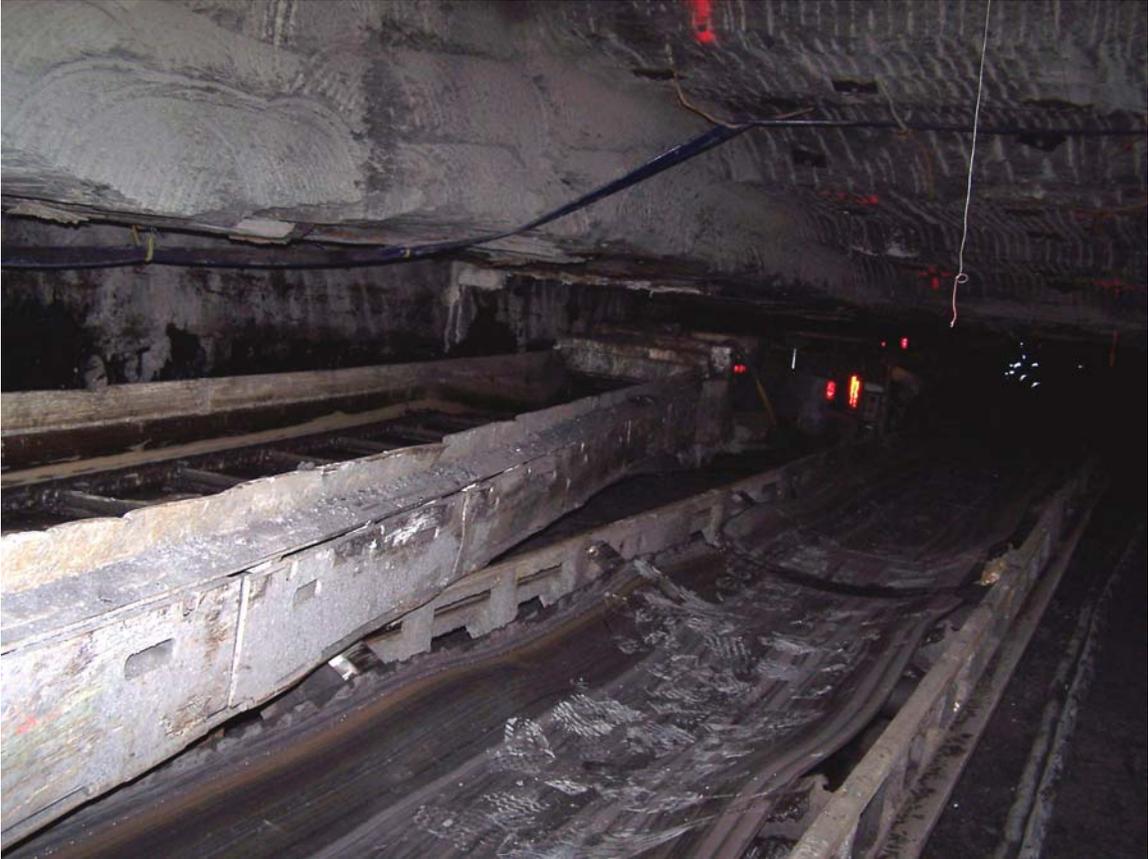
At approximately 12:15 p.m., on Friday, April 7, 2006, a 53-year old mobile bridge operator was fatally injured when he was caught in the pinch point between the mobile bridge conveyor boom, the low-low belt framing and the tail dolly.

The accident occurred because the continuous haulage system was restarted without following the proper communication procedure to ensure all mobile bridge operators were ready to move the system. Other factors contributing to the occurrence of the accident were safety devices installed on the continuous haulage system which did not reliably disable the machines, the continuous haulage system was not disabled prior to the #1 mobile bridge operator exiting the operator's compartment, and the location of the victim in the pinch point area between the mobile bridge conveyor and the low-low belt structure. Work practices and procedures contributed to the accident.

The connection between the mobile bridge conveyor and low-low belt structure creates a pinch point. The distance from the operator's compartment to the low-low belt was two feet, the distance from the edge of the chain conveyor of the #1 mobile bridge conveyor to the low-low belt was approximately 3½ feet and the low-low belt is approximately 26 feet out by the operator's compartment. Toler was apparently in the pinch point area when the bridge train unexpectedly moved forward. As the #1 mobile bridge conveyor was pulled forward by the advancing bridge train, skid marks were created on the mine floor which measured approximately 11 feet long.
