REPORT OF INVESTIGATION

Fatal Machinery Accident
April 21, 2006

Huff Creek No. 1
Lone Mountain Processing Inc.
Cumberland, Harlan County, Kentucky
ID No. 15-17234

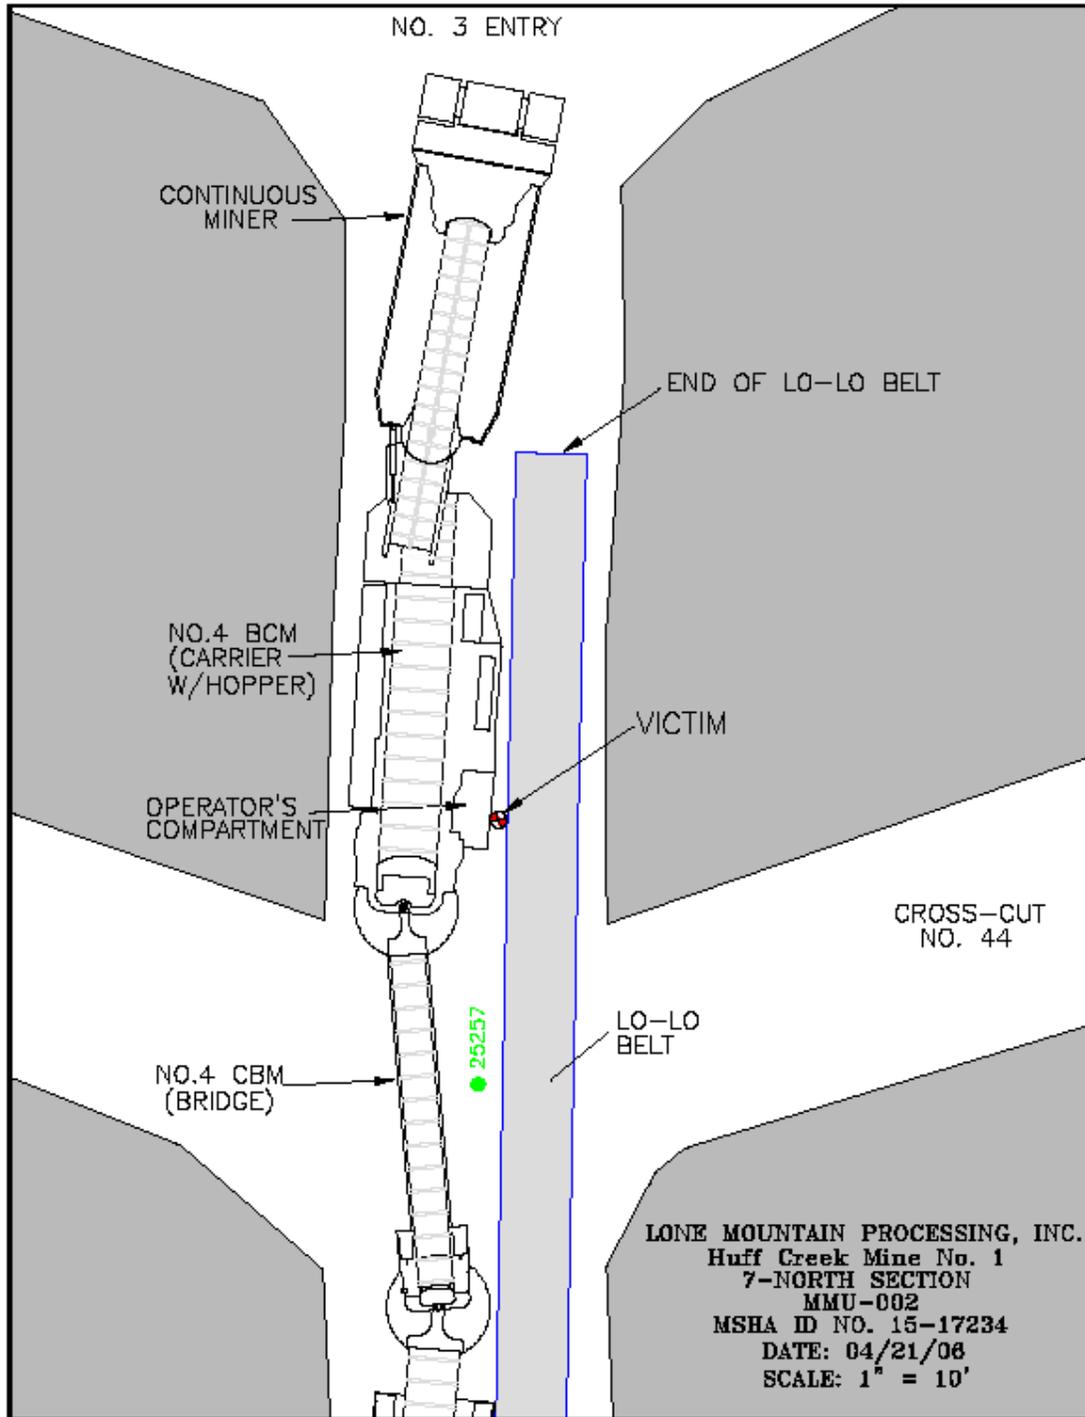
ACCIDENT SITE
Not to Scale

The accident occurred on the 002 MMU in the No. 3 entry, 20 feet inby spad No.25257 located at the 44th crosscut of the 7 north panel, approximately 5 ½ miles from the portal. The mining height averaged 84 inches on the section. Entry and crosscut centers were 80 feet with crosscuts turned on 70 degree angles left and right out on the No. 3 (belt) entry. The advancing section was driving 5 entries under 450 feet of cover.

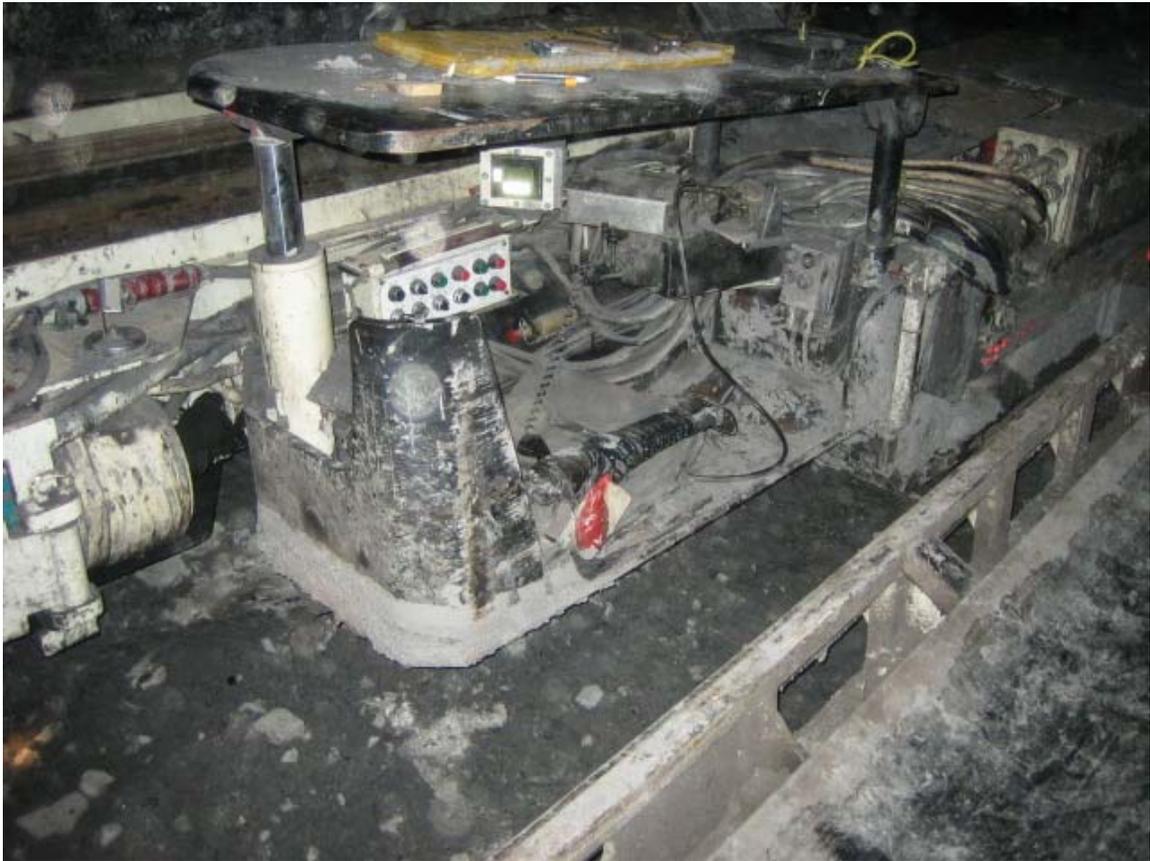
Photo of accident site

The left tram lever was activated in reverse, causing the BCM to pivot, pinning the victim. The activation of the tram could have been caused by the intentional movement (striking or bumping) of the lever by the victim to check hydraulic pressure, or by unintentional contact with the telephone after it was loosened to allow access to the hydraulic test ports.

The communication phone was a Gai-Tronics Femco permissible page phone. The page phone was mounted above the operator's tram control station. All but one of the bolts that attached the phone to the machine was removed at the time of the accident. The phone enclosure was turned counterclockwise toward the tram levers at approximately 45 degrees on its single mounting point.

Root Cause: The mine operator did not have written procedures or policies in place to require blocking machinery against motion before performing repairs or maintenance. The victim was fatally injured when the BCM moved due the BCM not being blocked from motion. The victim's position, being located in a pinch point area, exposed him to hazardous conditions when the No. 4 BCM was started up and the left tram was engaged in reverse.

Corrective Action: The operator developed and implemented an action plan that was added to the training plan to require safety procedures to be followed when operating or performing maintenance on equipment.
