REPORT OF INVESTIGATION

Fatal Machinery Accident  
July 20, 2006

CAM Mining LLC  
Slate Branch  
Freeburn, Pike County, Kentucky  
I.D. No. 15-18915

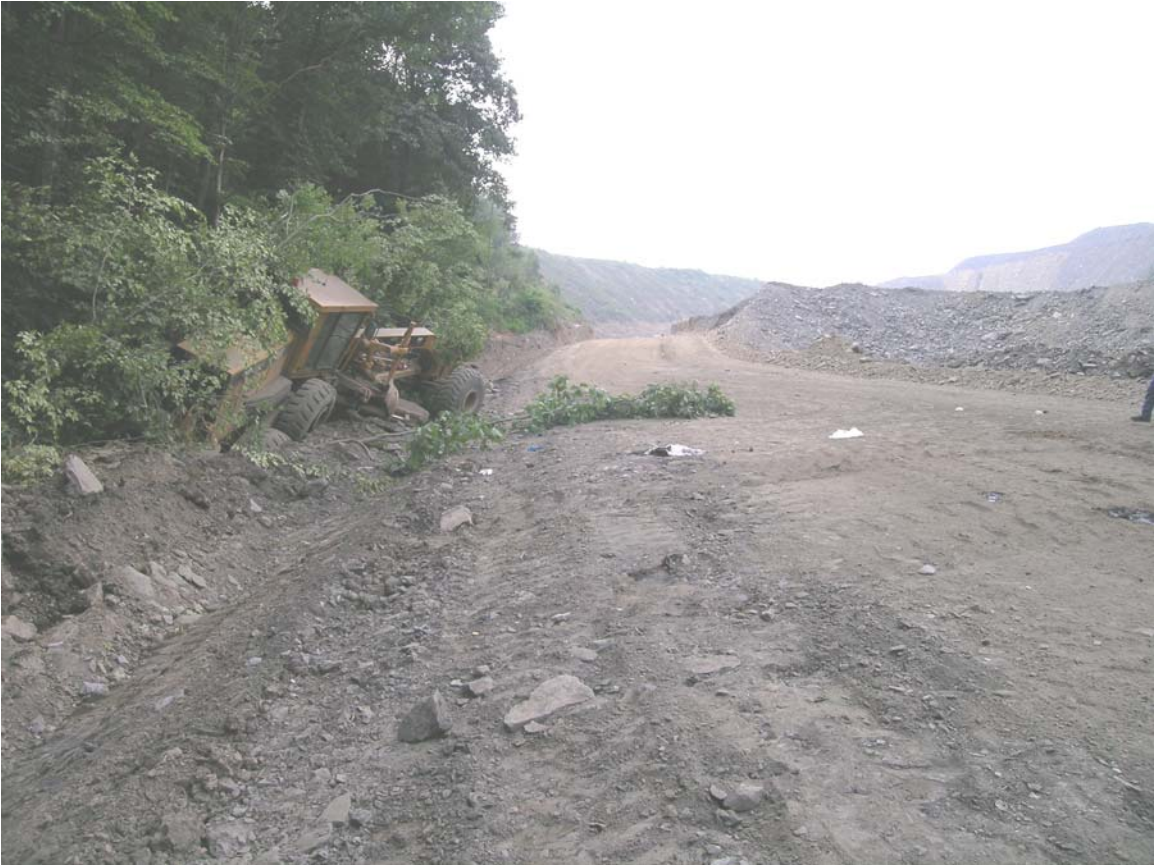
Photo of Accident Scene

Elkins. Delaney observed the cab unoccupied, the left side cab door open, the transmission in neutral, and the engine running. Elkins found the victim on the ground at the rear end of the grader, beneath the ripper mechanism, with no vital signs. Attempts to resuscitate by company and arriving medical personnel were unsuccessful. He was pronounced dead at 8:50 p.m. by Ernest Casebolt, Pike County Deputy Coroner.

The section of the haul road traveled by the grader during the accident began at the branch intersection and continued approximately 540' downgrade to the point where the grader left the roadway and crossed the rock filled ditch before contacting the hillside. The grader traveled an additional distance of approximately 100 feet through the ditch and hillside area before coming to rest in the ditch.

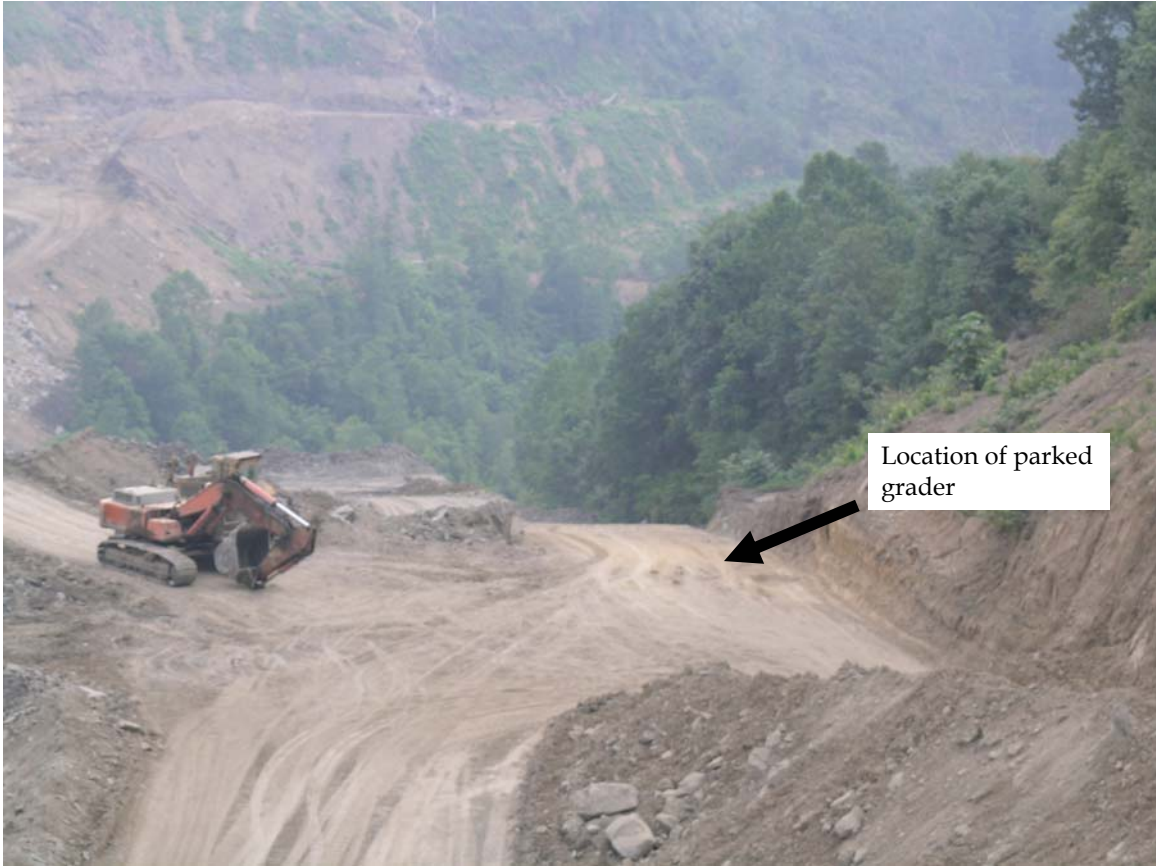
The mine access/haul road to the various work areas extended from the mine office and equipment parking area located on top of the mountain to the Thacker coal seam pit near elevation 1325. A branch of the road turned off to the Williamson pit, close to the halfway point, near elevation 1425. It is assumed that the victim parked his grader at this intersection. The area of the road at the branch intersection appeared to be relatively flat compared to the rest of the haul road, but surveyed measurements provided by CAM Mining, LLC indicated the grade to be 2-3%. The overall grade of the road below the branch intersection to the Thacker dump was 16%.

Photo showing area where the grader had been stopped at intersection of haul road to Williamson pit.

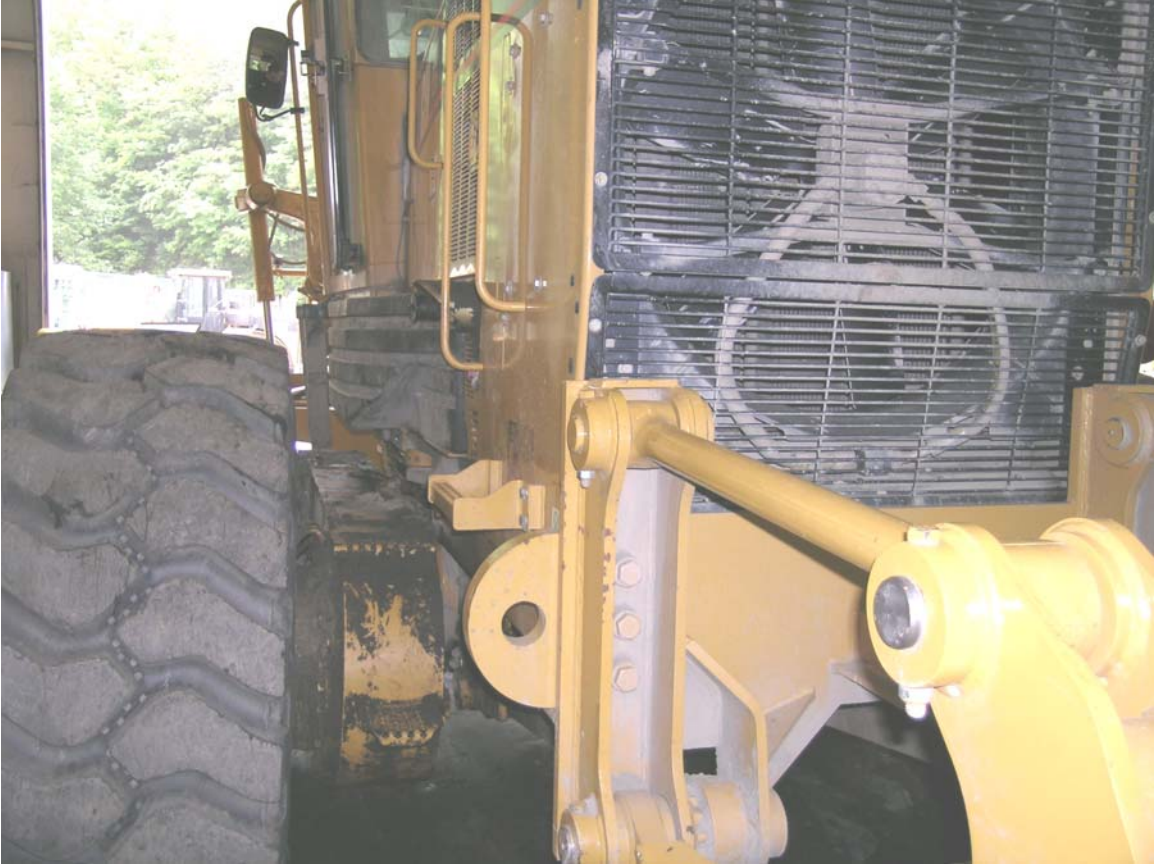
The service brakes were air-actuated oil-disc brakes located in each of the four rear wheel spindle housings. Independent air circuits were provided for the right and left side of the machine. The service and parking brakes were tested according to the Caterpillar Operation and Maintenance Manual and found to perform within the specifications. Damage to the grader resulting from the accident included flattening of the two right rear tires, repairable damage to the tandem housing, final drive, and left articulation cylinder and other assorted minor damage. No defects or deficiencies that would have contributed to the accident were found on the Caterpillar 16H Motor Grader.

Photo showing left side of grader viewed from the rear. Grader was relocated to Wayne Supply shop for evaluation.
