**UNITED STATES
DEPARTMENT OF LABOR
MINE SAFETY AND HEALTH ADMINISTRATION**

REPORT OF INVESTIGATION

**Fatal Exploding Vessel Under Pressure Accident
July 30, 2006**

**Star Bridge Preparation Plant-Rail Loadout
Carter Roag Coal Company
Starbridge, Randolph County, West Virginia
I.D. No. 46-06736**

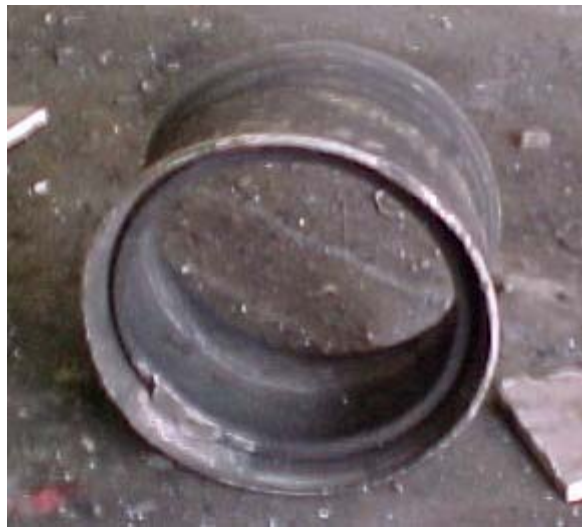
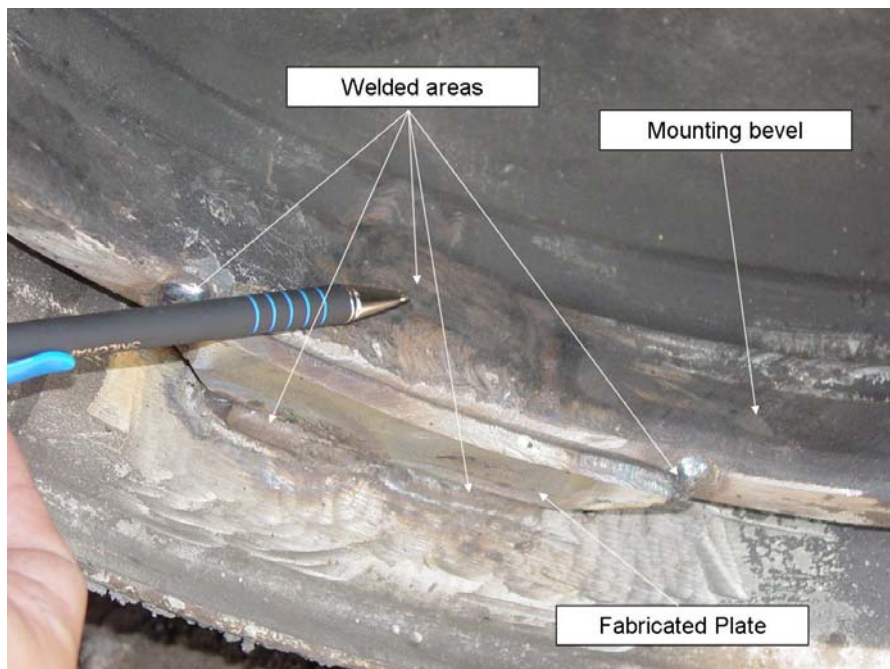
On Sunday July 30, 2006, at approximately 3:00 p.m., Jeremy Todd Heckler, a 30 year old contractor truck driver and welder employed by Circle M Enterprises, Inc., I.D. No. T7I, with approximately 10 years of welding experience, was fatality injured while welding and grinding on a tire rim that had an inflated tire mounted on it. The victim had been employed by the contractor for 23 days, and had approximately 10 years of welding experience and 23 days mining experience. The heat from welding and grinding resulted in an ignition and explosion as the interior of the tire released combustible gases as the tire was heated.

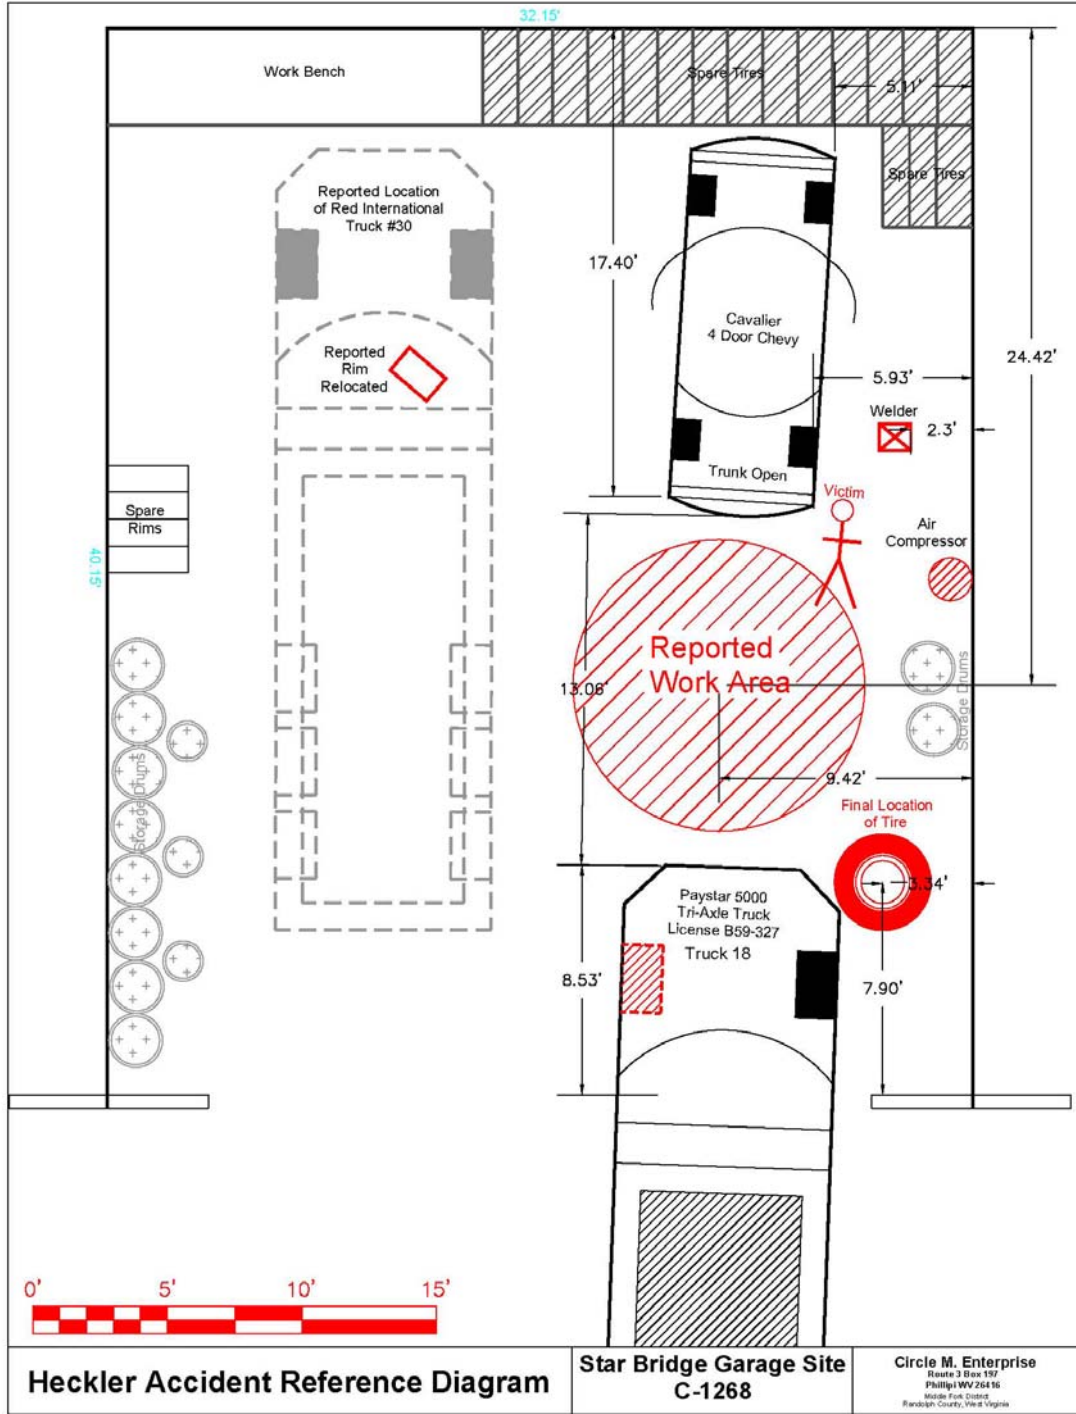
APPENDIX B Accident Site

At the time of the explosion, a Paystar dump truck, company number 30 and a 1999 Chevrolet Cavalier, the personal vehicle of Ms. Caroline Watson, was also parked inside the truck shop. Two mounted tires that would fit or replace the left front tire of the number 18 truck were located in the shop. The tire and rim assembly was inflated with air during the welding/grinding process when the accident occurred.
