**UNITED STATES
DEPARTMENT OF LABOR
MINE SAFETY AND HEALTH ADMINISTRATION
COAL MINE SAFETY AND HEALTH**

**REPORT OF INVESTIGATION
Surface Coal Mine
Fatal Electrical Accident
November 5, 2006**

**Kayenta Mine
Peabody Western Coal Company
Kayenta, Navajo County, Arizona
ID No. 02-01195**

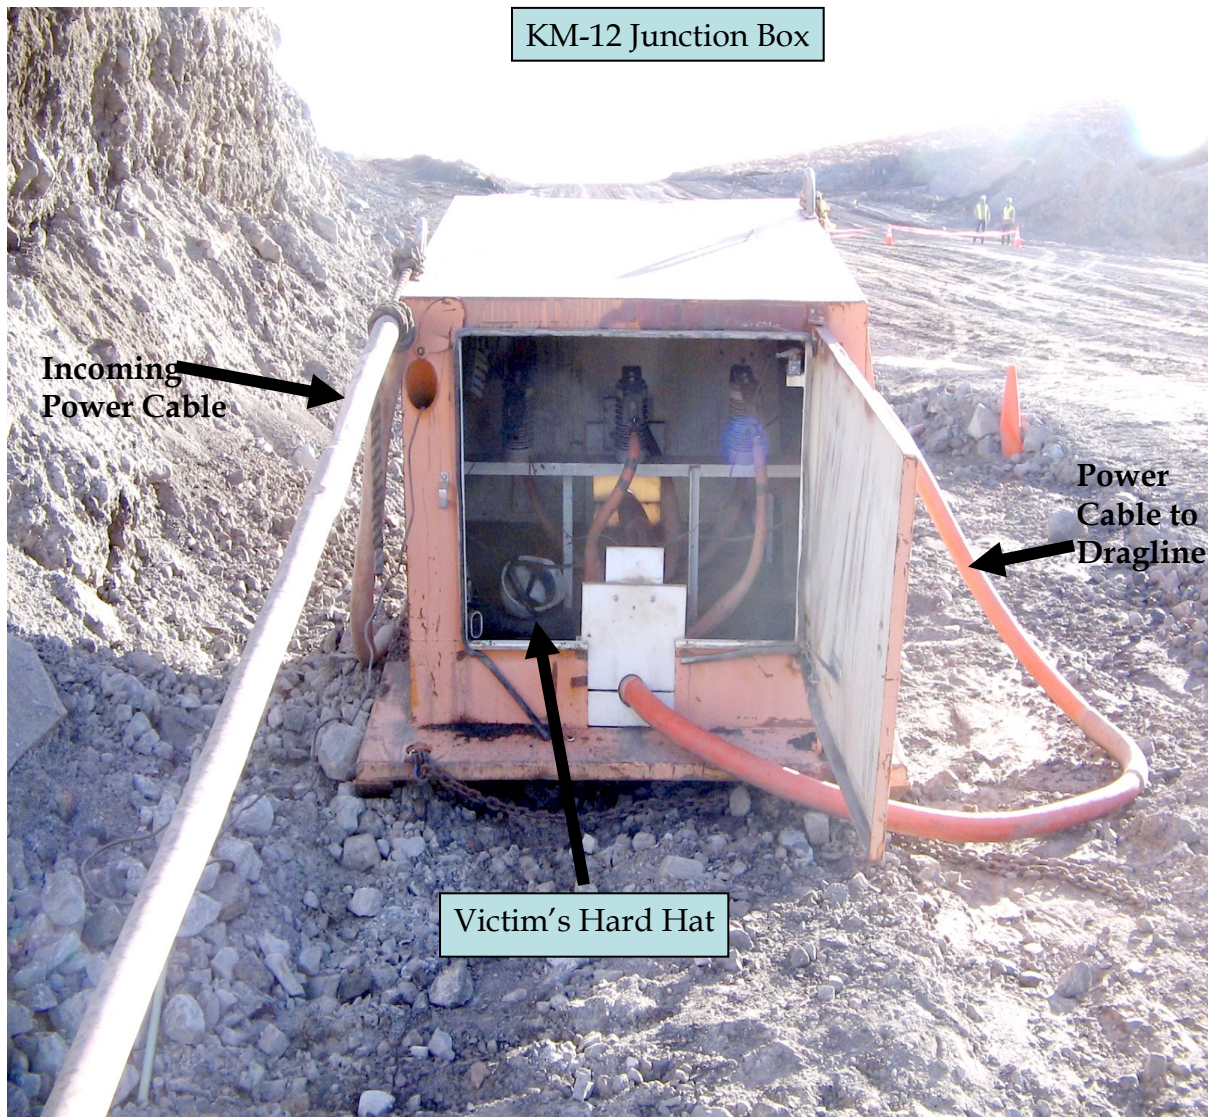
**PHOTO OF ACCIDENT SCENE
23KV HIGH VOLTAGE JUNCTION BOX, KM-12,
LOCATED IN THE J-19 PIT, RAMP 48**

The accident occurred at the Atkinson-type KM-12 junction box. The junction box was provided with door and cover limit switches that cause the KM-321 circuit breaker for the 23 KV incoming power to open if the doors or cover are opened. These switches were General Electric Part No. CRZISH-11 and were connected in series with the ground check monitor circuit. The Atkinson Model A-2 8000 (BTS N.091780AA) ground monitor circuit originated at the KM-321 switch house.

Evidence indicated that Harvey, while working on the pilot circuit at the KM-12 junction box, contacted the left and middle phase buss bars inside the junction box causing a phase to phase fault through his body resulting in fatal injuries. The amount of electrical power was approximately 23 KV.

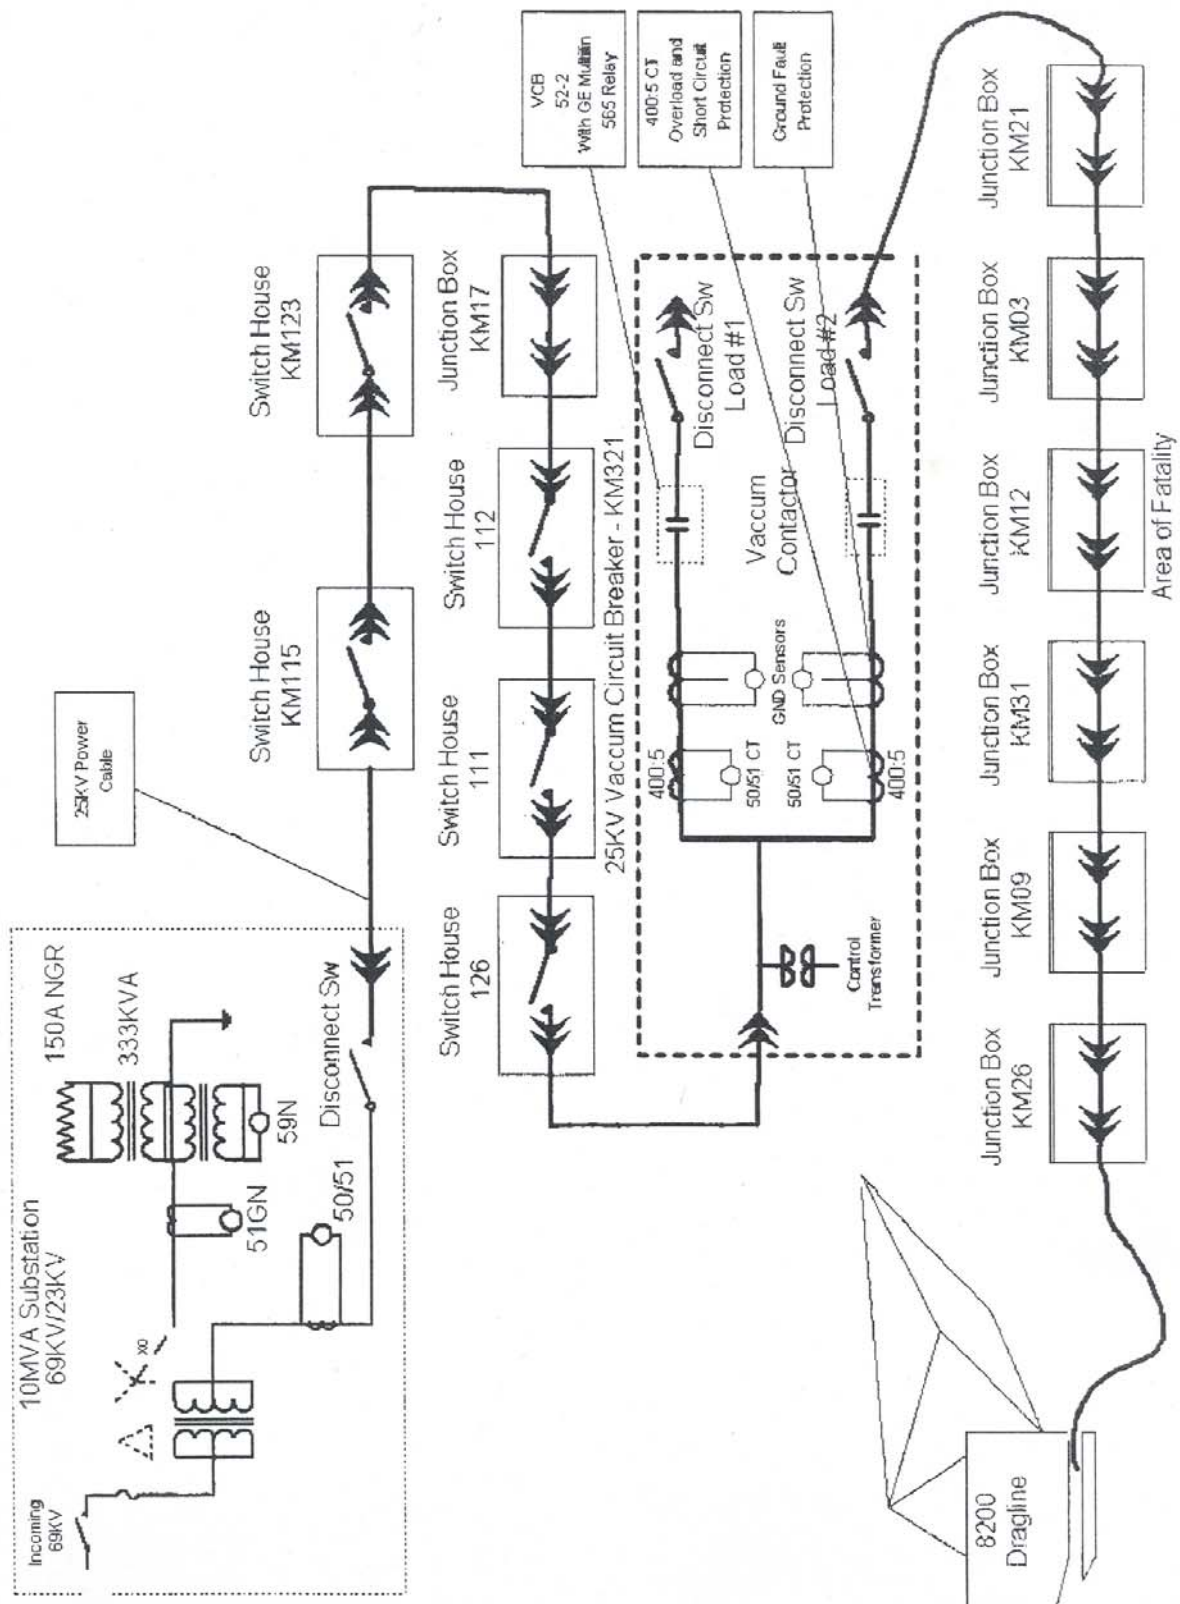
APPENDIX B **SKETCH OF J-19 PIT ELECTRICAL SYSTEM**

The electrical system for the J-19 pit consisted of a 23 KV alternating current, resistance grounded circuit, originating at a substation (see Appendix B for a sketch of the electrical system). The substation was rated 10,000 KVA (10 MVA). Incoming voltage was 69 KV. The main transformer was configured delta-wye and the wye secondary was resistance grounded. The 23 KV circuit, which provided power to portable and mobile equipment, was protected with circuit breakers and protective relays to guard against the harmful effects of under voltage, grounded phase, short circuit, and over current conditions. Power was transmitted to the dragline through a series of trailing cables with junction boxes used to connect the multiple lengths of cable.

A switch house, KM-321, was installed in series with the cables and junction boxes. This switch house was equipped with two 25 KV vacuum circuit breakers, protective relays (the same relays as the substation), and visual disconnect devices. The circuit that supplied the dragline was labeled the No. 2 circuit. An Atkinson high voltage (pilot wire type) ground check monitor monitored the grounding conductor from this location to the dragline frame. The visual disconnects at KM-321 did not provide automatic grounding of the phase conductors when the disconnect was in the open position. Harvey installed his lock on the disconnect at this location. Harvey's name was etched into the lock and was found installed on the disconnect during the investigation. The key to the lock was found on the victim. The phase conductors were not grounded to the system ground while the electricians performed their work.

Power in the No. 2 circuit flows from the KM-321 vacuum circuit breaker switch through a system of trailing cables connected between six junction boxes, KM-21, KM-03, KM-12, KM-31, KM-09, and KM-26. These junction boxes were located along the highwall and roadway at J-19 pit to the dragline and spanned a distance of approximately 7,500 feet. The junction boxes were also referred to as "rabbit" boxes. Junction boxes were installed at approximately 1,500-foot intervals so that cable could be easily added or removed as needed. The 23 KV circuit entered the dragline through collector rings located on the dragline and then to various on-board transformers for utilization.

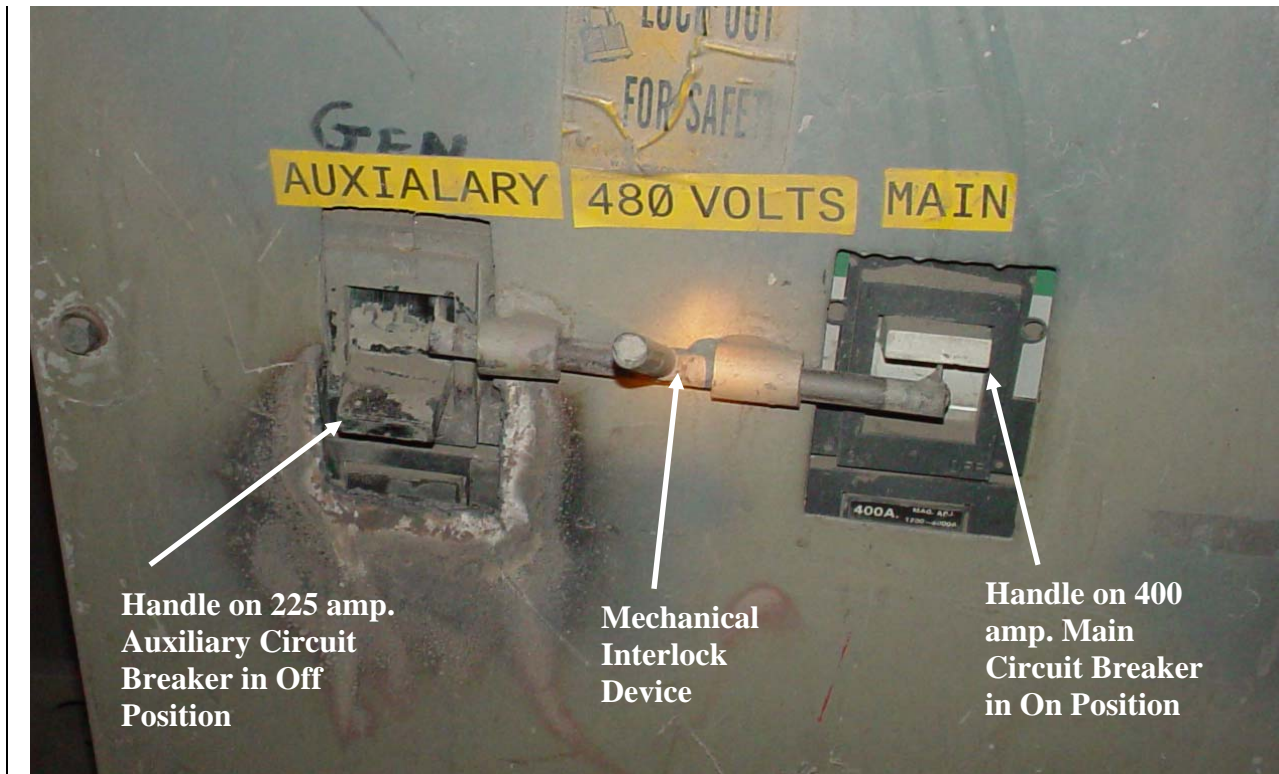
PICTURE OF MECHANICAL INTERLOCK AND CIRCUIT BREAKER HANDLES
LOCATED ON METAL PANEL IN LOCKED AREA ON DRAGLINE

During the investigation, a wiring diagram was found on-board the dragline and was presented to the investigation team. The wiring diagram illustrated a safety transfer switch that should have been installed, but was not. Interviews did not determine why this switch was not installed. Its purpose was specific for use with the auxiliary power supply. The wiring diagram illustrated that in position 1, 480 volts from the generator would be directed to MCC-B and normal power would be prevented from entering MCC-B. If the switch was manually moved to position 2, it would isolate the generator circuit from the normal circuit and would then permit normal power to be transmitted to MCC-B. The wiring diagram also showed a mechanical interlock device installed between the auxiliary power molded case circuit breaker (225 ampere) and the normal power molded case circuit breaker (400 ampere). The purpose of the mechanical interlock was to prevent the normal power and auxiliary power circuit breakers from

being in the closed position at the same time. The mechanical interlock device (metal bar) was installed between the circuit breakers but did not prevent them from being closed at the same time. The safety transfer switch or a functional mechanical interlock between the circuit breakers would have prevented the fatal accident. See appendix C for a picture of the interlock and circuit breaker handles. The 225 ampere auxiliary circuit breaker was a General Electric No. CAT-TJK436F000. The 400 ampere General Electric main circuit breaker had a 225 ampere trip unit No. CAT-TJK436T225.

30 CFR 77.502 and 77.502-2 require monthly examinations of electrical equipment. The required monthly examinations failed to recognize that the mechanical interlock was present but was not installed or maintained to perform its intended function and that the safety transfer switch was missing. Absence of the transfer switch and a properly installed mechanical interlock resulted in 480 volts from the generator to be applied to on-board transformers increasing the voltage to approximately 23 KV to the machine trailing cable. The faulty circuit breaker interlock and the absence of the safety transfer switch appeared to have existed for years.

Corrective Action: Management removed the auxiliary generator, which was heavily damaged in the accident, and does not intend to replace the generator or use an auxiliary power system on this dragline.
