REPORT OF INVESTIGATION

Fall of Roof or Back
December 17, 2006

Prime No 1
Dana Mining Company Inc
Maidsville, Monongalia County, West Virginia
(I.D. No. 46-04387)

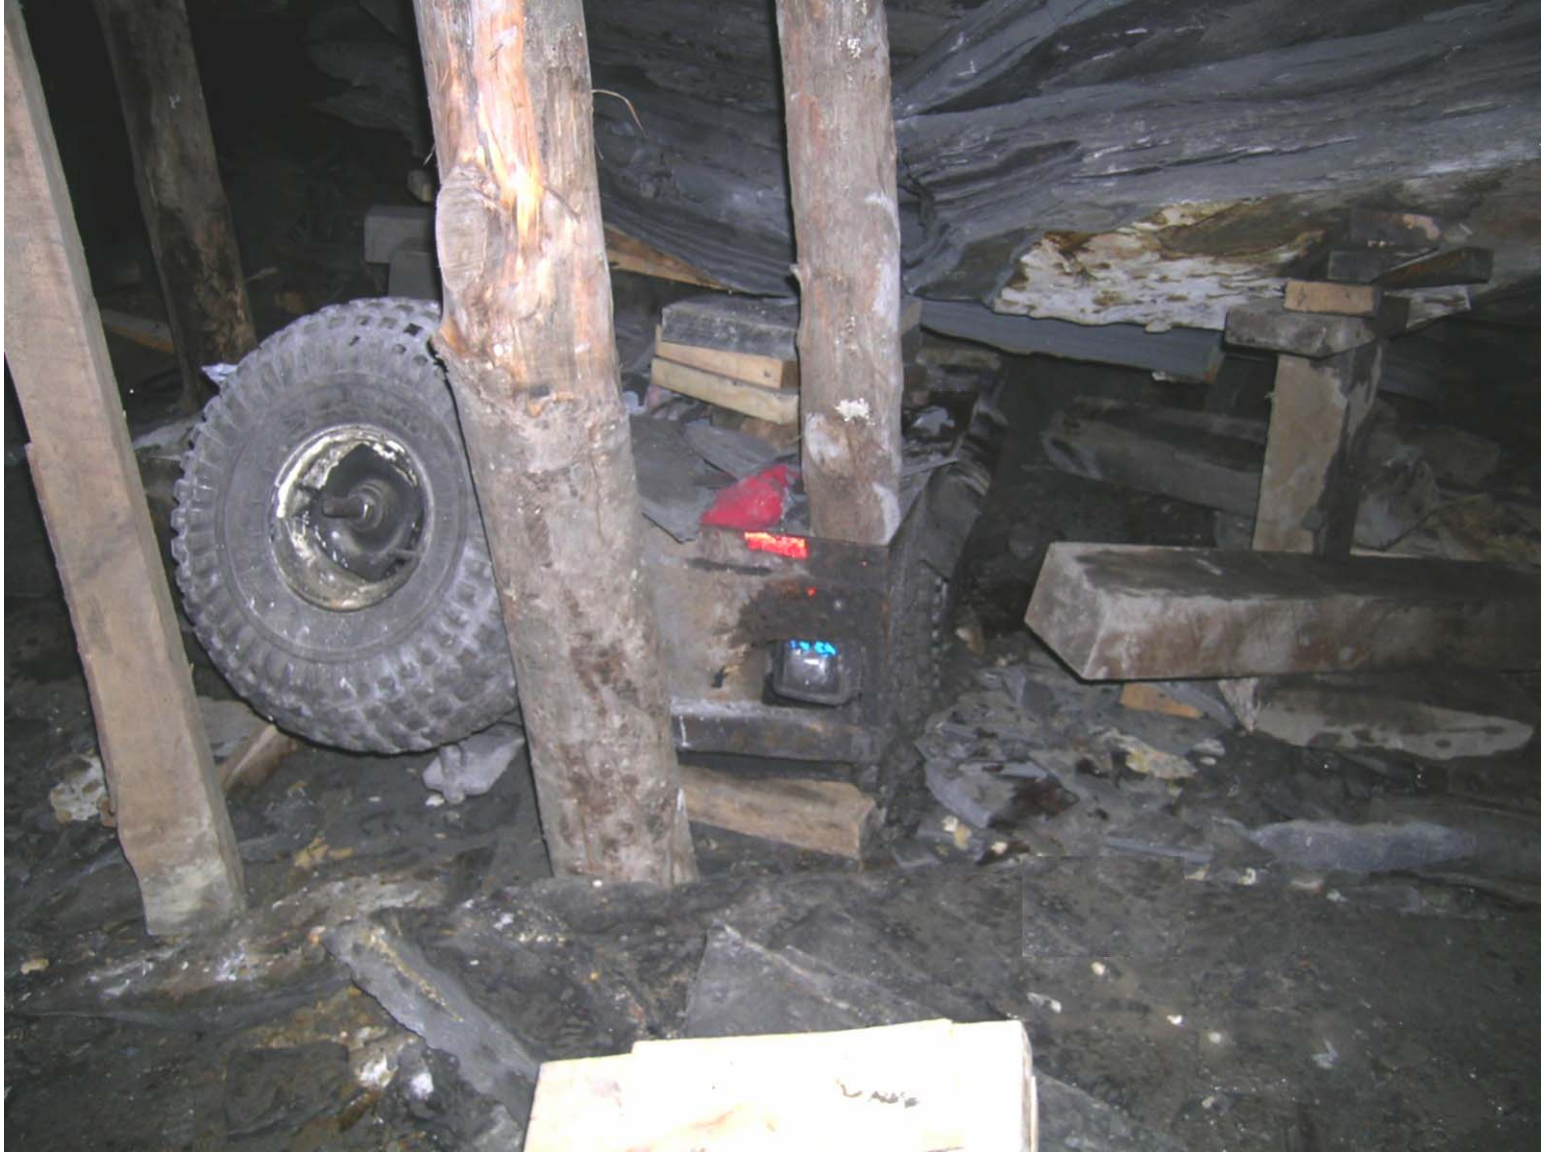
APPENDIX A

On December 17, 2006 at approximately 7:30 p.m., John Elliott, a 26-year old mechanic was fatally injured in a roof fall. The victim and 2 co-workers were traveling through the No. 18 block intersection (No. 2 entry) on a rubber tire personnel carrier when the top began to work and fall. The fall was approximately 28 feet long, 20 feet wide and 5.5 feet thick. (see Appendix A).

The roof fall appears to have resulted from several geological conditions present in the No. 18 crosscut area of the mains. First, ground water inflow over time weakened the rock in the immediate roof susceptible to moisture. The roof fall appears to have started on the inby side of the intersection where moisture had caused weathering or weakening of the immediate roof and progressed along a vertical fracture that cut through the intersection, parallel with the entry.

At the accident site, the fallen immediate roof consists of a black thinly bedded claystone (less than 2 inches) overlain by several feet of laminated, silty, micaceous gray shale. Fall debris consisted primarily of 3 to 12 inch thick tabular slabs. Many of the slabs were laterally continuous from the left rib line to a

prominent N50°W trending, oxide stained joint that intersected the fall cavity parallel with the entry approximately 5½ feet from the right rib line.

Picture of the Accident Scene

Corrective Action: Examiners and miners were provided additional training in the recognition of adverse geologic conditions. The approved roof control plan was updated to supplement roof support in the regularly traveled haul road intersections from the No. 1 belt head to the No. 2 belt tail piece. Supplemental support consists of a minimum six cable bolts, 8-14 feet and 6 foot fully grouted roof bolts will be installed with 18 inch by 18 inch roof mats. The provision of supplemental support also was extended to all regularly traveled haul road intersections in the travel entry where adverse geologic conditions are recognized.

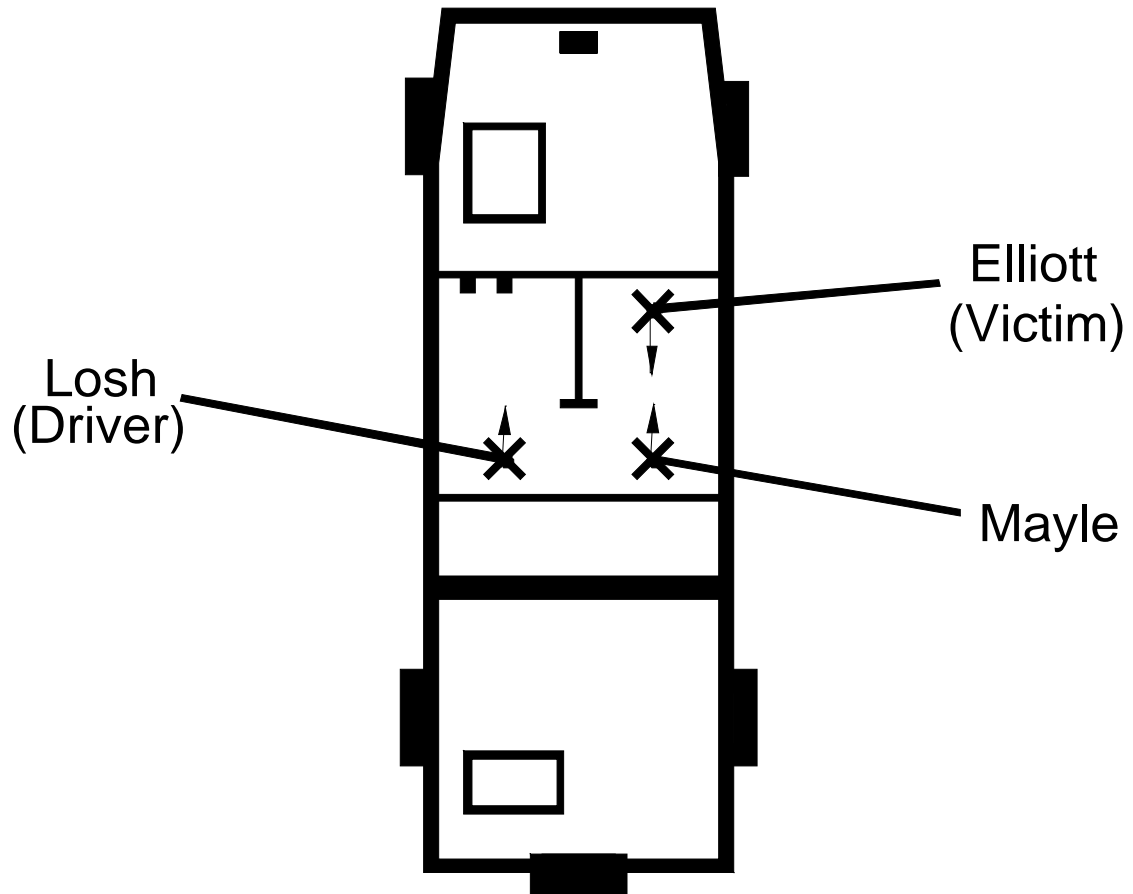
APPENDIX B

travel while Elliott was facing outby (Appendix B). The crew traveled to the No. 18 block intersection, in the No. 2 entry, when they observed the roof working overhead (Appendix C). Mayle yelled the roof was going to come in and Losh put the personnel carrier in reverse in an attempt to escape. Mayle jumped off the ride prior to the roof collapsing. Elliott also jumped off the ride, but was pinned against the back of the personnel carrier. The rock knocked Losh down into the seat, but he was able to crawl out from under the rock. Losh saw Elliott and checked for vital signs, but none were detected.

Diagram of the Personnel Carrier

↑ = the direction the miners were facing

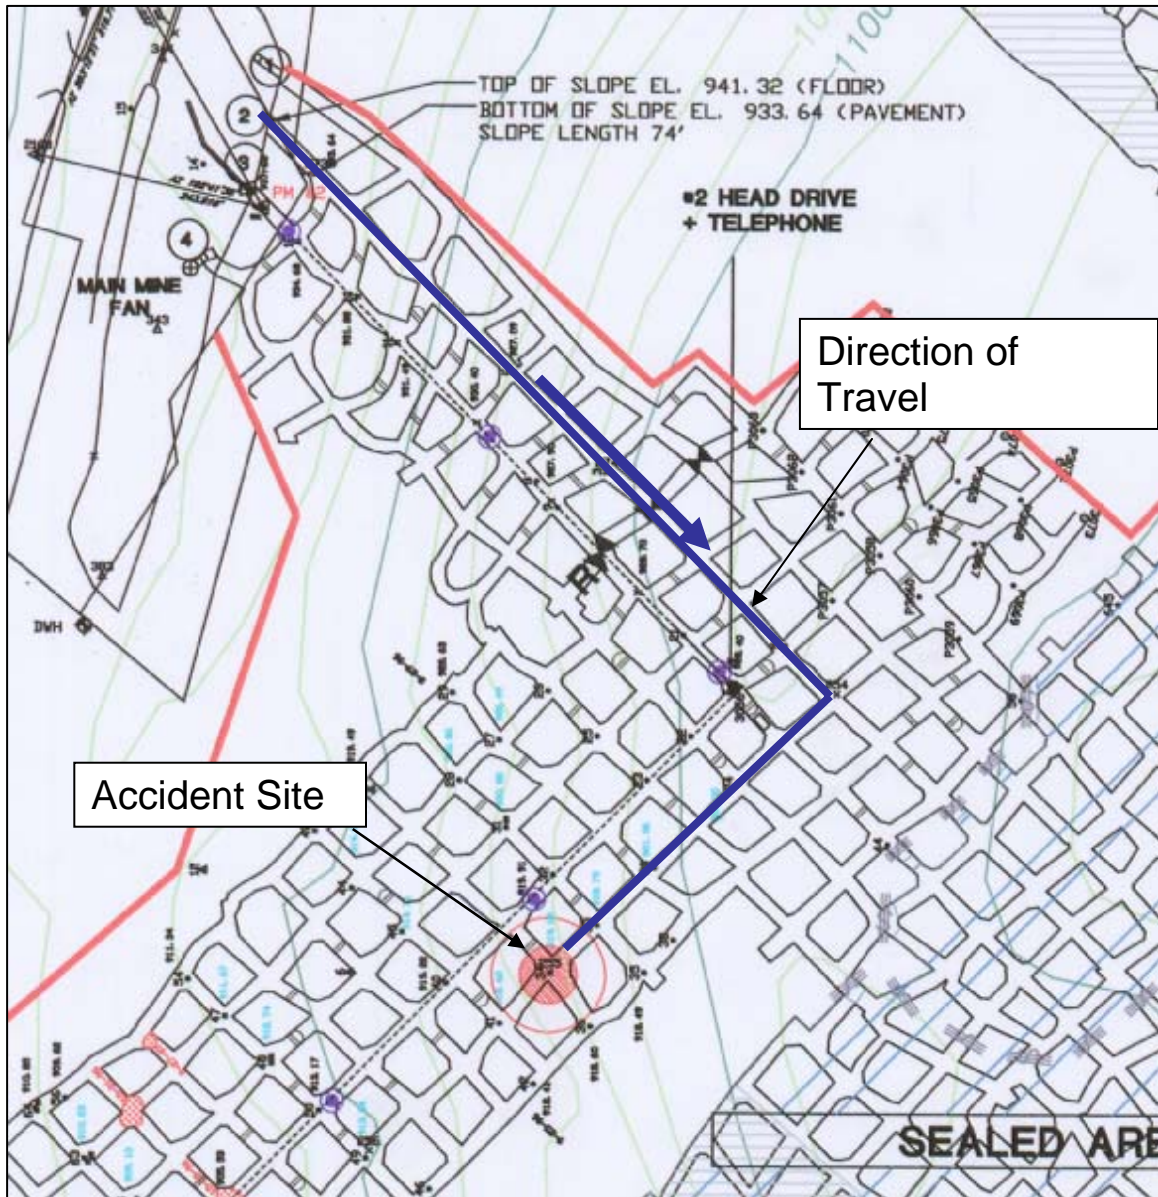
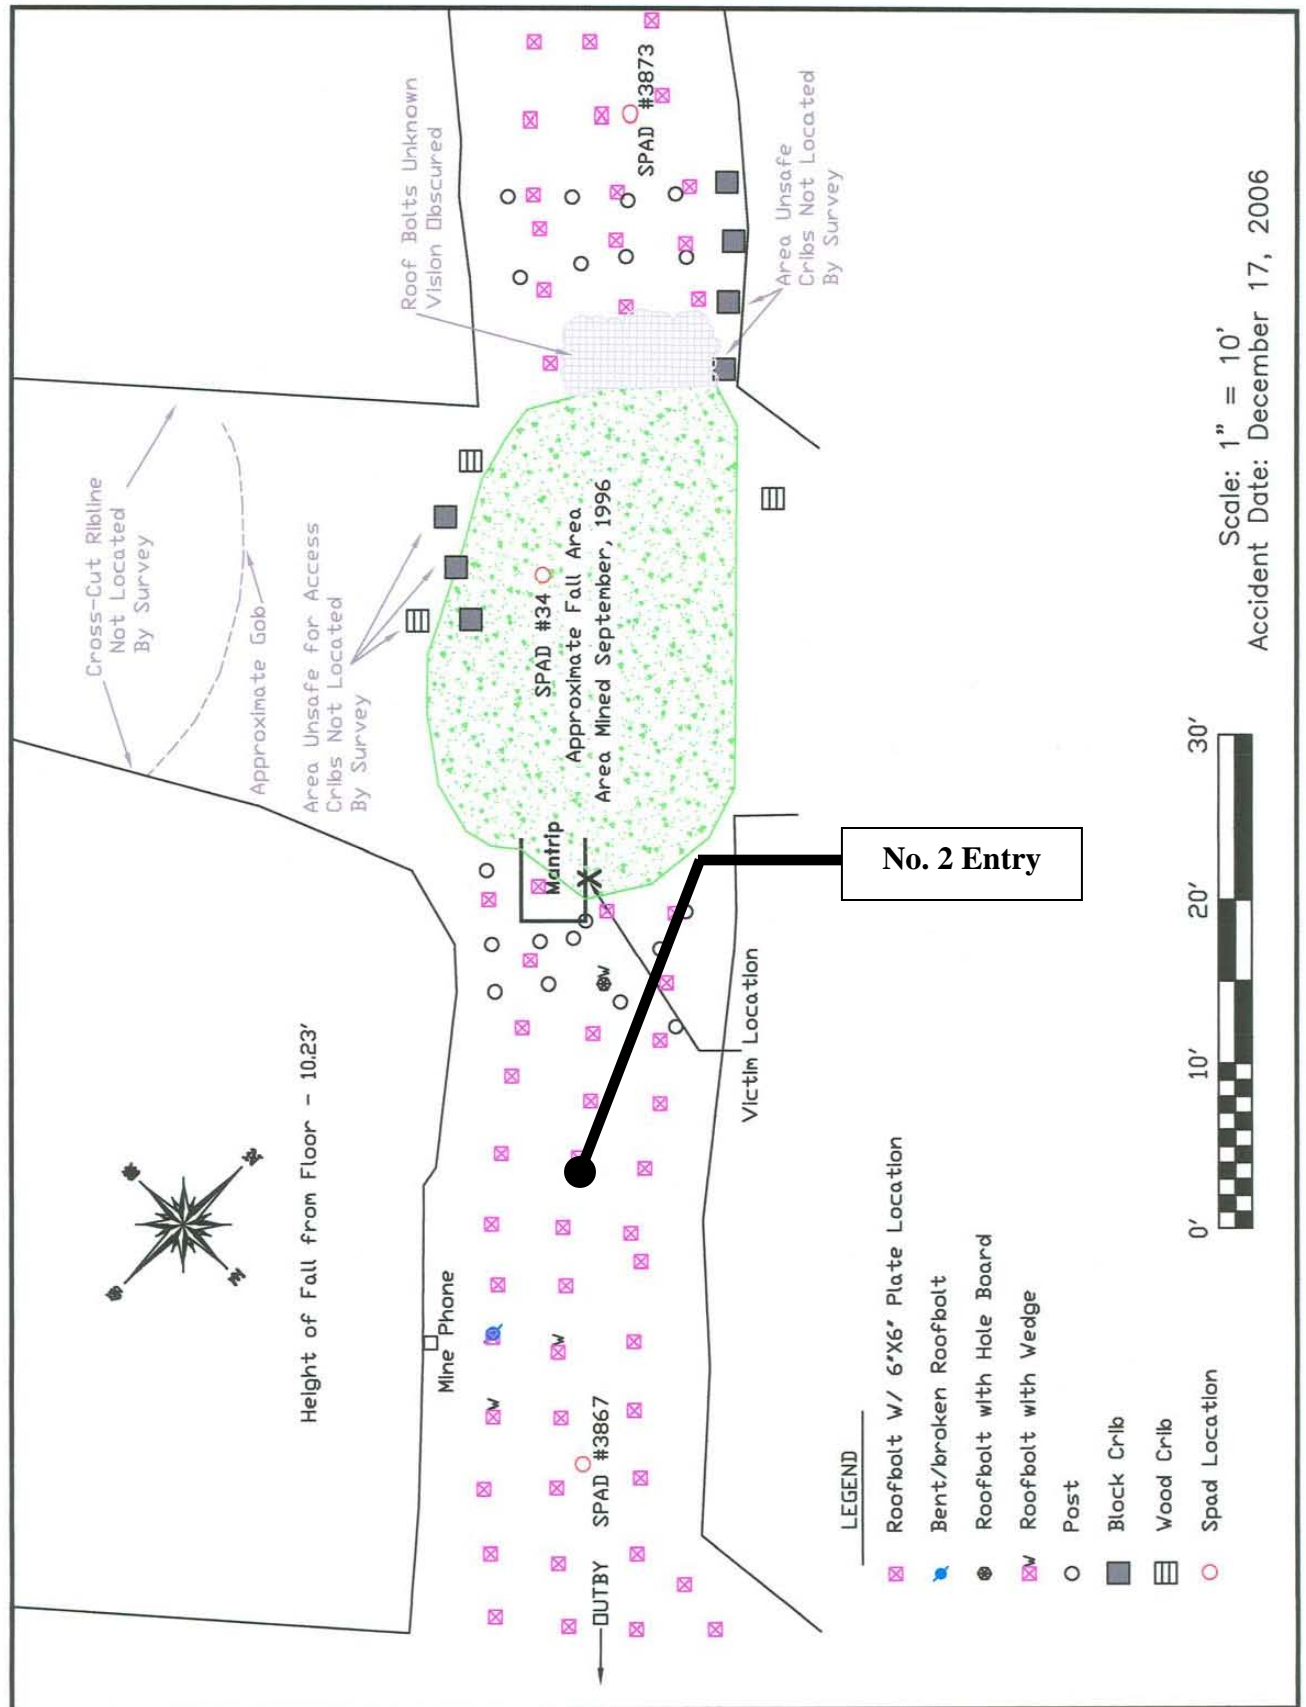
APPENDIX C

Entry widths immediately inby and outby the failed intersection were 17 ft. 2 in. and 16 ft. 6 in., respectively. Prior to the accident there were concrete piers set in the connecting crosscuts and entry to reduce the width. The investigation revealed that on Friday, December 15, 2006 a rock fell out between the bolts approximately 1 foot thick at the No. 18 block intersection. There were two wood cribs built across the mouth of the No. 1 to No. 2 crosscut and one crib built across the mouth of the No. 2 to No. 3 crosscut on Saturday, December 16, 2006 to reduce the entry width. After the accident, the cribs did not appear to be taking weight. Although cribs were built, no additional support was added to the entry.

Mine Map & Accident Scene Drawings
