UNITED STATES
DEPARTMENT OF LABOR
MINE SAFETY AND HEALTH ADMINISTRATION
METAL AND NONMETAL MINE SAFETY AND HEALTH
REPORT OF INVESTIGATION

Surface Nonmetal Mine
(Dimension Limestone)

Fatal Fall of Highwall Accident
April 21, 2006

Maple Hill Quarry
B. G. Hoadley Quarries, Inc.
Bloomington, Monroe County, Indiana
Mine I.D. No. 12-01039

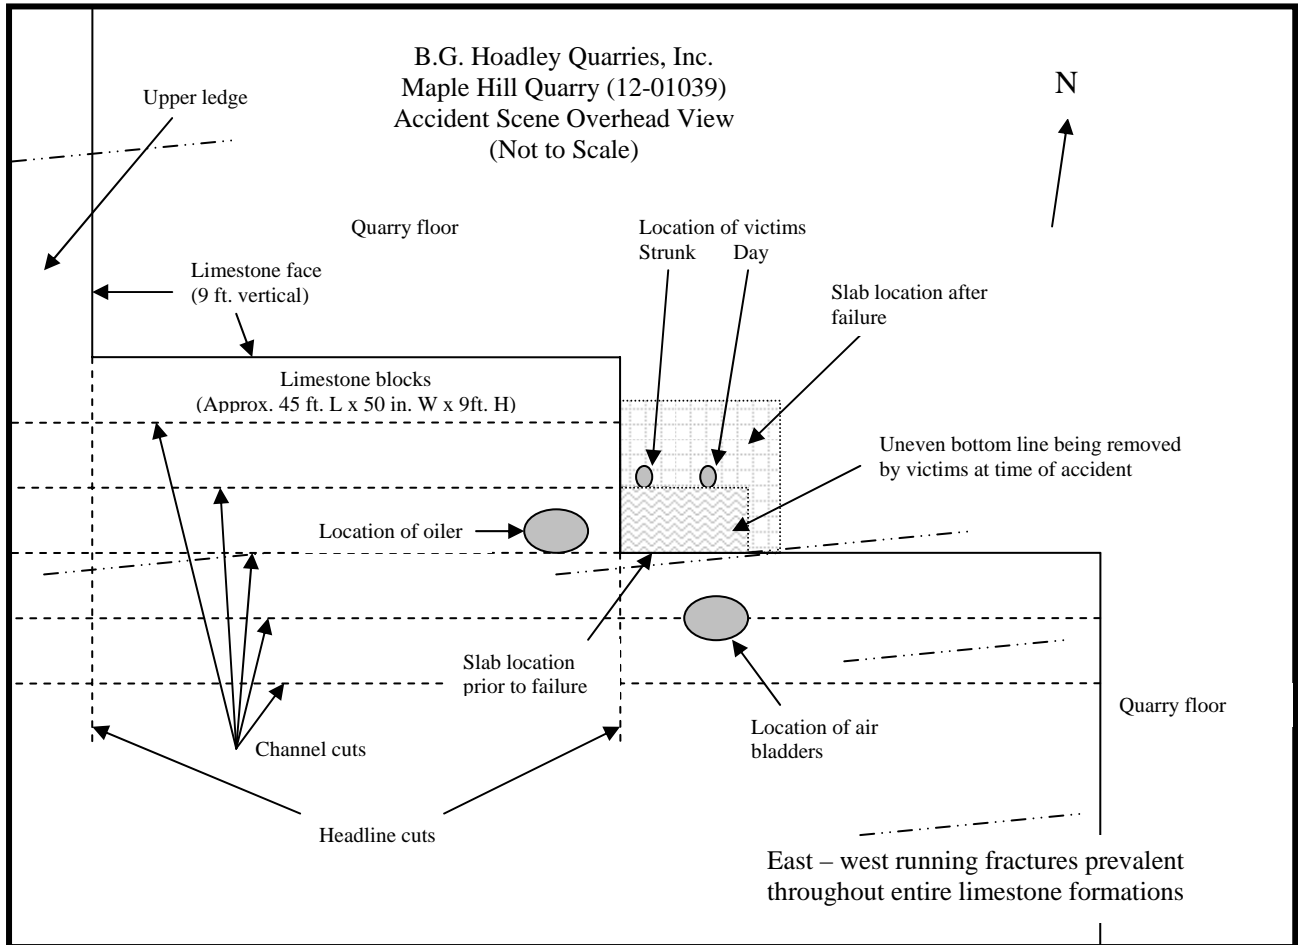
APPENDIX B

Strunk and Day had moved to the toe area so they could remove an uneven section of the quarry floor (See Appendix B). The section that they were attempting to remove was the bottom of a limestone pillar that had broken unevenly from the formation. Strunk had shoveled loose material away from the uneven area and began drilling horizontal holes along the bottom line while Day was in the area placing slips-and-wedges. At approximately 8:55 a.m., a slab of limestone fractured from the block due to the incidental inflation of the bladders left in the channel cut, and fell on both men.

The accident occurred at the toe of the west end of the eastern row of limestone blocks (see Appendix B).
