REPORT OF INVESTIGATION

Surface Nonmetal Mine
(Sand and Gravel)

Fatal Falling Material Accident
October 4, 2006

Bollmeier Construction Company
Contractor I.D. No. B04
at
Cemstone Products Company
Henderson Pit
Henderson, Sibley County, Minnesota
Mine I.D. No. 21-03557

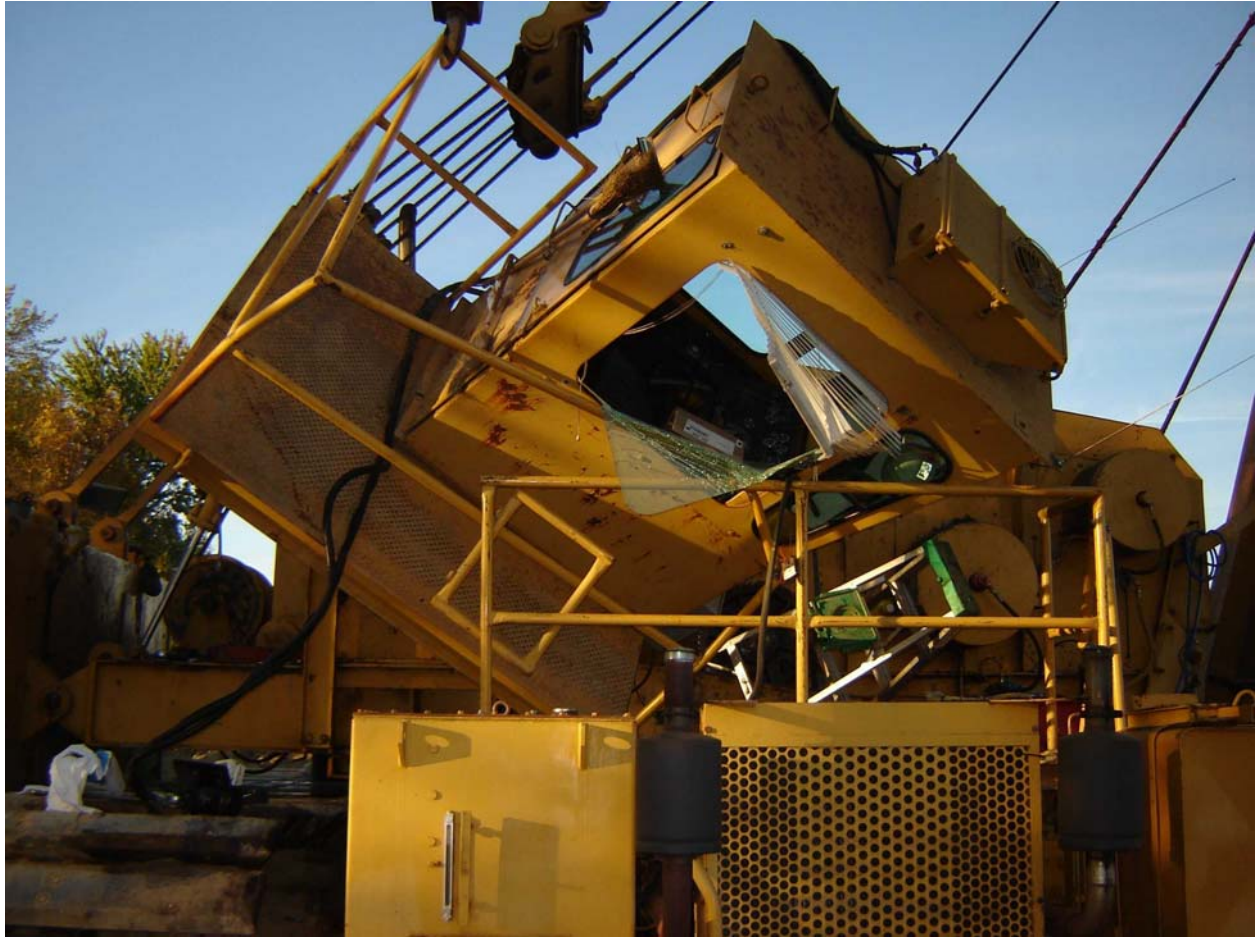
Glen A. Phillips, dragline operator, age 59, was fatally injured on October 4, 2006, when the operator's cab of a dragline that he and two other miners were removing, fell and pinned him. The operator's cab was being removed to access the transmission for repairs.

The accident occurred because procedures were not established to block the operator's cab on the dragline against hazardous motion prior to removal of the cab mounting bolts.

Corrective Action: Procedures should be established that require a risk assessment to be conducted to identify all potential hazards associated with the task to be performed. These procedures should include a joint discussion of the actions that will be taken to protect all persons from possible hazards.
